# Post-Flood Recovery Assessment and Stream Restoration Guidelines for the Colorado Front Range

Eric E. Richer, Matt C. Kondratieff, and Benjamin D. Swigle

*Colorado Parks and Wildlife, Fort Collins, Colorado*

*April 29, 2015*

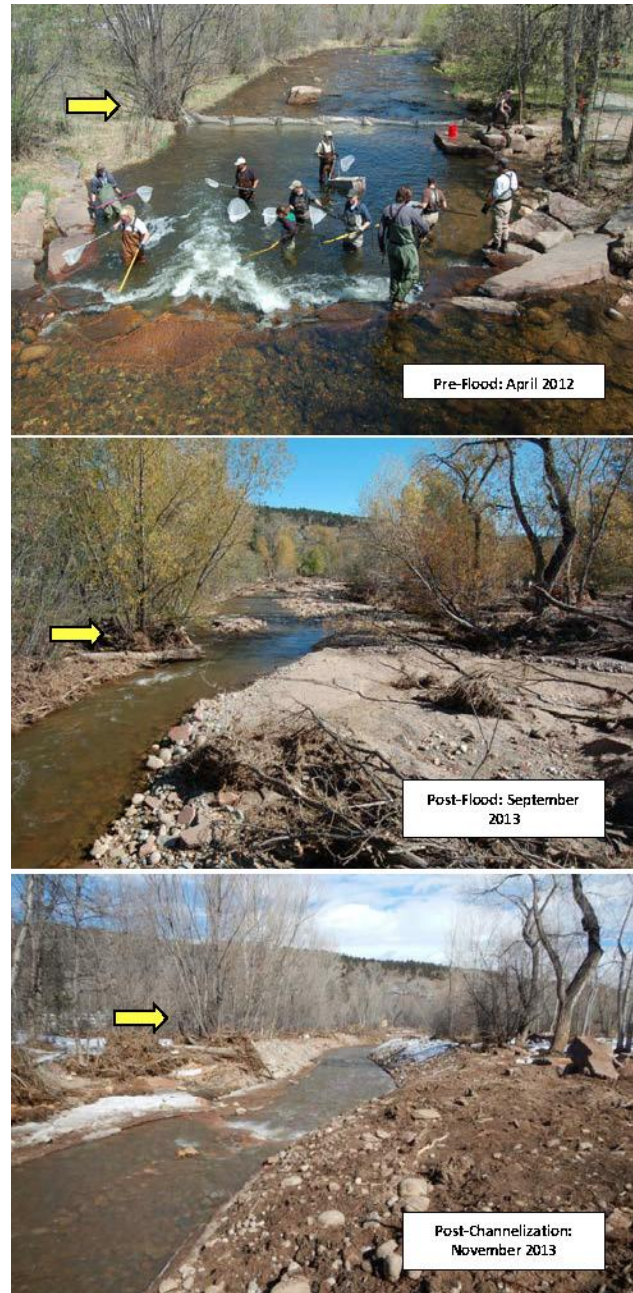
**Figure 1.** Pictures of the South Fork of St. Vrain Creek through Bohn Park showing pre-flood condition, post-flood condition, and post-channelization condition.

The yellow arrow denotes the same river birch.

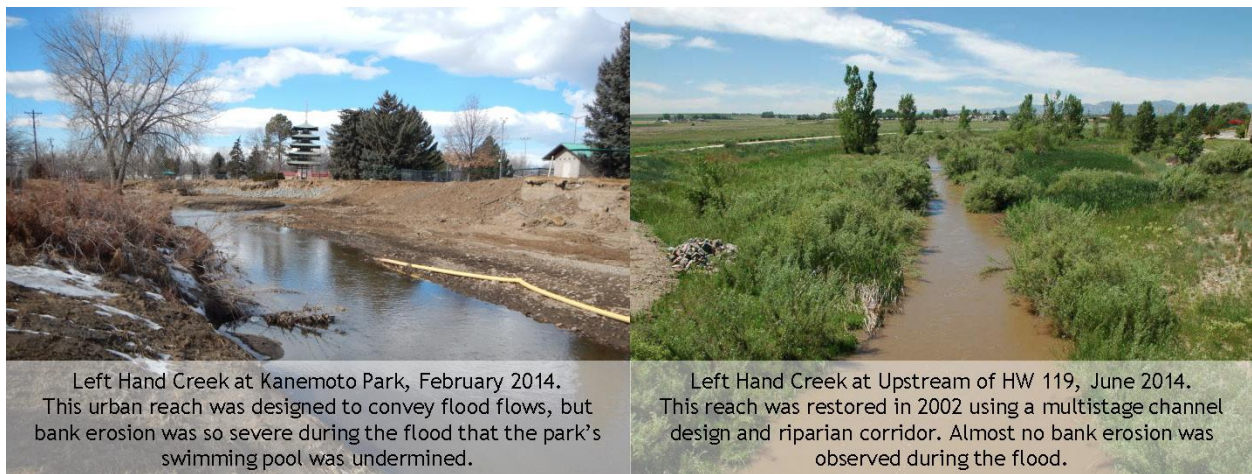
**Figure 2.** Pictures of the two locations on Left Hand Creek illustrating the value of multistage channel designs and functioning riparian corridors for flood conveyance and channel stability.

This issue with trapezoidal channel failure is illustrated by two contrasting reaches on Left Hand Creek (Figure 2). The upstream reach is an urban site near Kanemoto Park with a trapezoidal and armored channel designed to convey floods. The Kanemoto reach experienced substantial bank erosion during the flood. Bank erosion was so severe that the park’s swimming pool was undermined. The bank erosion observed at Kanemoto Park is a stark contrast to a downstream reach near Highway 119. The reach near Highway 119 was restored in 2002 using a multi-stage channel design with a functional floodplain, and almost no bank erosion was observed at this site during the flood (Figure 2). The stark contrast between these sites also extends to the cost of reconstruction and habitat restoration. The Kanemoto reach will require substantial investment to stabilize and restore the river channel, whereas the Highway 119 reach will require no funds for stabilization or restoration. This example illustrates the value of riparian floodplains for flood conveyance, channel stability, and protection of property and infrastructure.

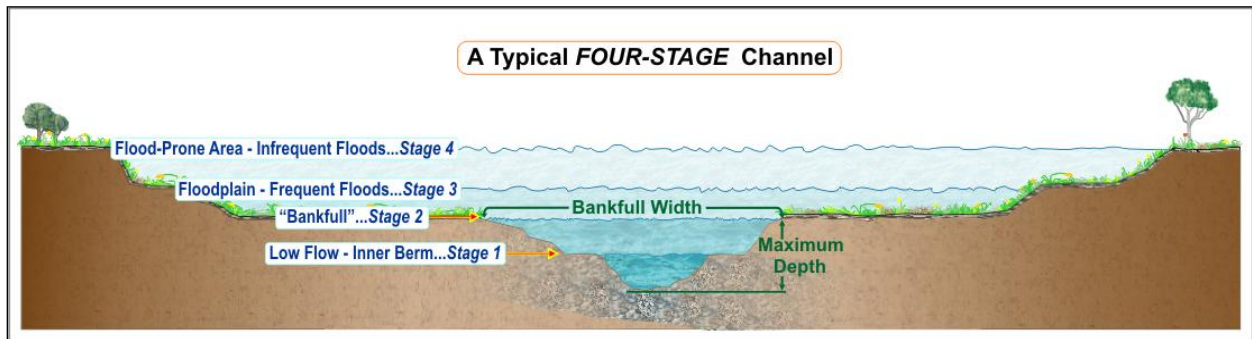
Figure 3. A typical four-stage channel design for a C4 stream type in a Valley Type VIII (Used with permission from D.L. Rosgen).

There is a new paradigm in river engineering that embraces riparian floodplains as the most effective and sustainable means to convey floods and dissipate energy. Natural channels typically contain multiple stages that are inundated at different flows. For example, a four-stage channel includes (1) a low flow channel that maintains habitat during baseflows, (2) the bankfull or active channel, (3) a riparian bench to convey frequent floods, and (4) a flood-prone area between terraces to convey infrequent floods (Figure 3). We commend emergency work conducted by the CWCB, Colorado Department of Transportation (CDOT), and Natural Resource Conservation Service (NRCS) that incorporated multi-stage channel designs, but there are also many examples of trapezoidal, single-stage channels constructed after the flood. These trapezoidal channels create over-wide conditions with poor habitat quality. In nature, the trapezoidal channel often appears as an intermediate step following a disturbance that serves as a transition toward a stable end point. The length of time needed to reach a stable form depends on a range of factors including geomorphic context, vegetation, and number of steps within a channel evolution sequence. During low flows, over-wide channels create shallow conditions that elevate water temperatures and decrease dissolved oxygen. In addition, over-wide conditions often induce aggradation of sediment because the channel lacks the capacity to transport the incoming sediment load. During floods, over-wide channels concentrate energy, which increases water velocity and accelerates bank erosion. Multi-stage, or nested, channel designs provide a means to create naturally stable channels that convey floods and provide quality habitat for aquatic

organisms. During emergency reconstruction, multi-stage dimensions can be “roughed-in” thereby reducing the cost of permanent stream restoration efforts.

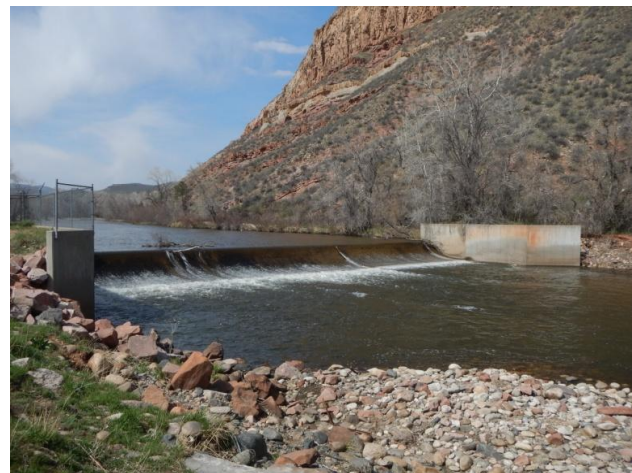
Figure 4. Diversion structure at the Watson State Wildlife Area, Cache la Poudre River.

Over 160 diversion structures were damaged during the 2013 floods. These structures typically consist of concrete walls or grouted boulders that span the width of the channel (e.g., Figure 4). These structures were designed to create upstream backwater with enough differential head to maintain flows into irrigation ditches. Substantial investments have been made to develop the water delivery infrastructure that sustains the economy of the Colorado Front Range. Unfortunately, much of this infrastructure was developed decades ago without any consideration for dynamic river processes or ecological functions. The traditional diversion structure consisting of a low-head concrete dam and head-gate has many negative effects on stream functions. Diversion structures often create barriers to the upstream migration of fish. Upstream migration is a vital component of many species' life histories. Trout are known to migrate upstream to find ideal spawning habitat and then move back downstream to over-winter in warmer, lower-velocity, and more productive waters. Barriers to migration, such as diversion or grade-control structures, can adversely impact populations of many fish species.

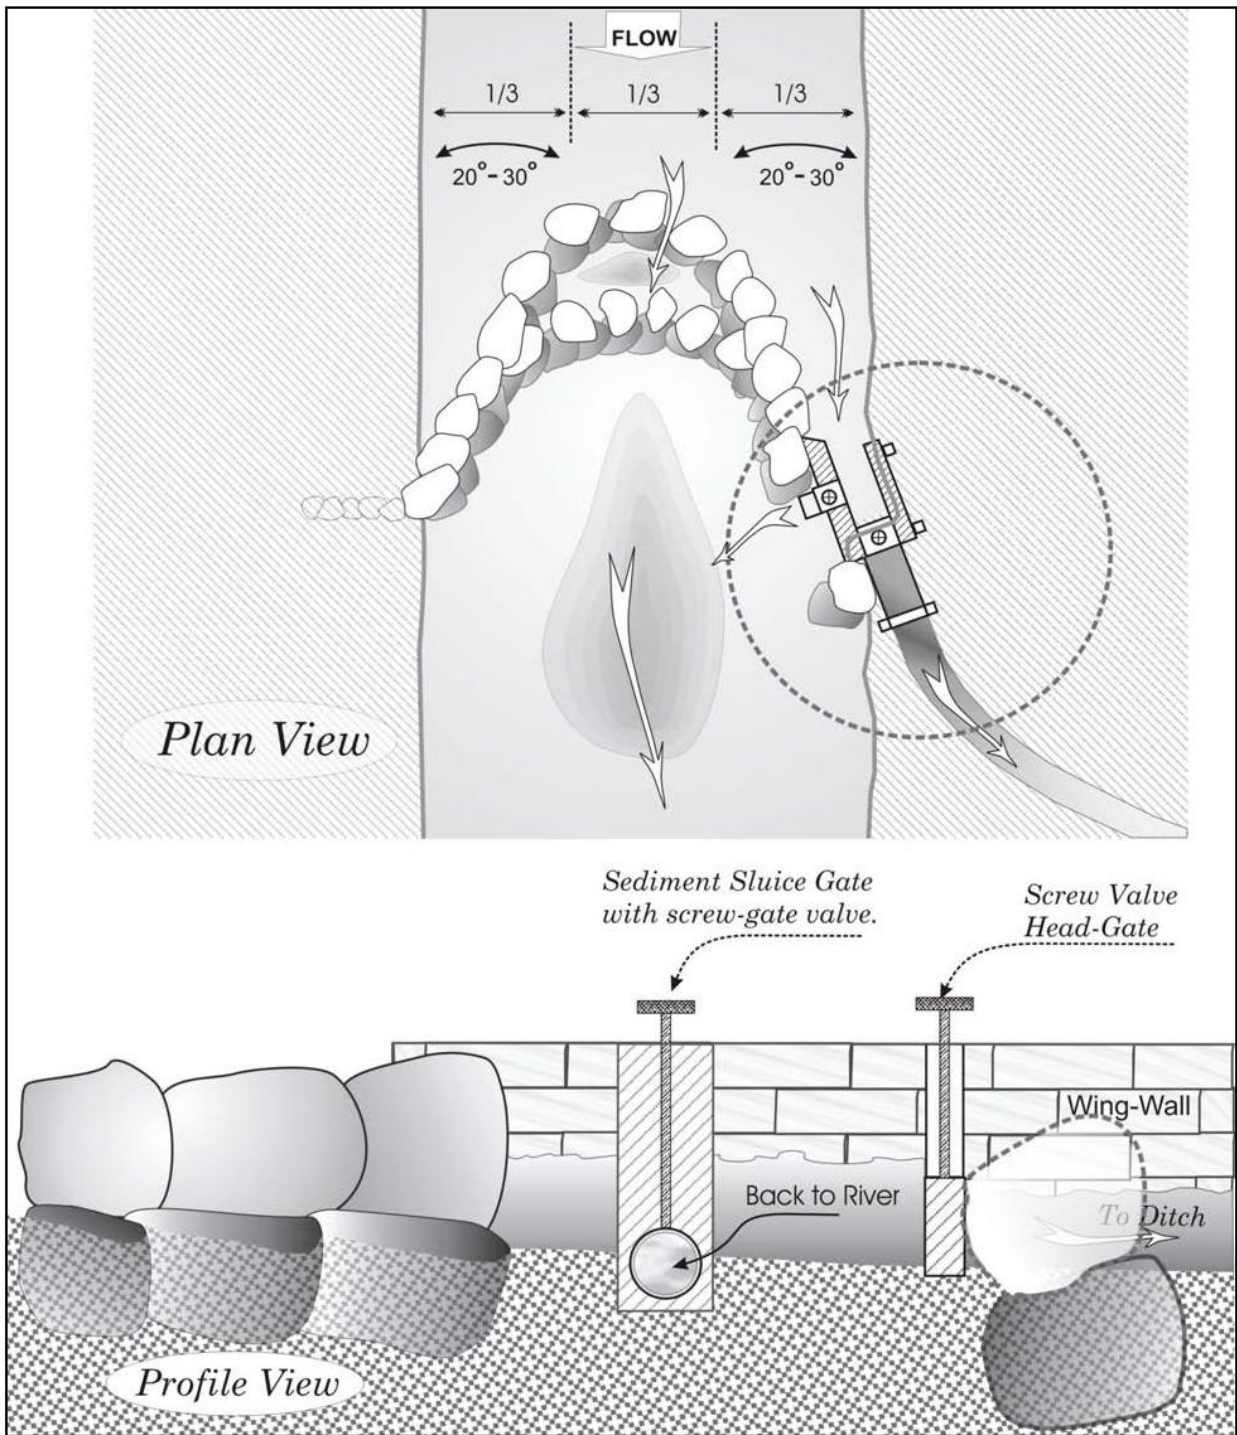
**Figure 5.** Conceptual example of a cross-vane diversion structure with irrigation head gate and sediment sluice (Rosgen, 2006).

These permitting and funding issues may have prevented ditch companies from considering alternative diversion designs recommended by the CWCB and CPW, such as the cross-vane diversion structure (Figure 5). These structures have not been widely used in the Colorado Front Range, but have been successfully and broadly applied in western Colorado to divert water and provide grade control while accommodating the passage of sediment, fish, and boats. Furthermore, these structures are often cheaper to build and repair than the traditional low-head concrete dam. These alternative structures may not have qualified for the agricultural exemption from the ACOE because they departed from the "character, scope, or size" of the original design under the maintenance exemption. However, the cross-vane structure is included under the Regional General Permit No. 12, which could expedite the permitting process for these structures in Colorado. We recommend that state and federal agencies work with the ACOE to identify permitting options for incorporating alternative diversion designs into emergency flood response.

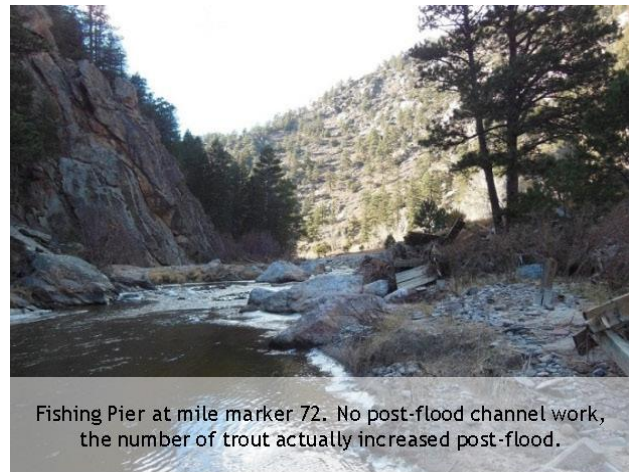
Fishing Pier at mile marker 72. No post-flood channel work, the number of trout actually increased post-flood.

**Figure 6.** Post-flood photos of fish monitoring sites along the Big Thompson River showing the effects of channelization.

Channelization and armoring of the Big Thompson River reduced trout abundance by 90-100% at most locations surveyed (Table 2). For example, a section of the Big Thompson River at Drake contained 3,206 trout per river mile when surveyed in September 2012. No fish were found at this same location in November 2013 following channelization work (Figure 6). Farther upstream, near the Waltonia Bridge, trout abundance was reduced from 5,895 fish per mile in September 2012 to 130 fish per mile in October 2013. Sections of the Big Thompson River that were not artificially channelized fared much better in terms of trout abundance. The handicap fishing pier access site located near Highway 34 mile marker 72 yielded 3,769 trout per mile in October 2011. Following the 2013 flood, this same section contained 4,368 trout per mile, a 16% increase. Relatively little restoration work is needed for sections of the Big Thompson River where post-flood landscapes were not altered or channelized during post-flood reconstruction activities.

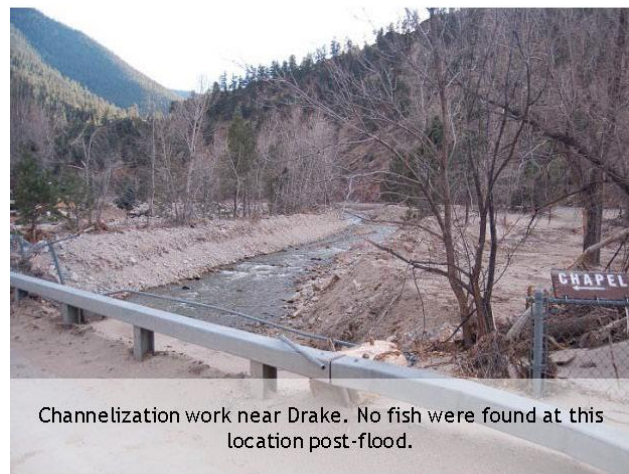
Channelization work near Drake. No fish were found at this location post-flood.

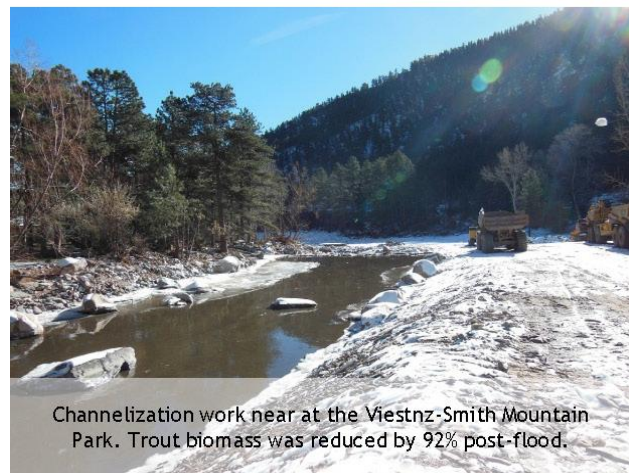
Channelization work near at the Viestnz-Smith Mountain Park. Trout biomass was reduced by 92% post-flood.

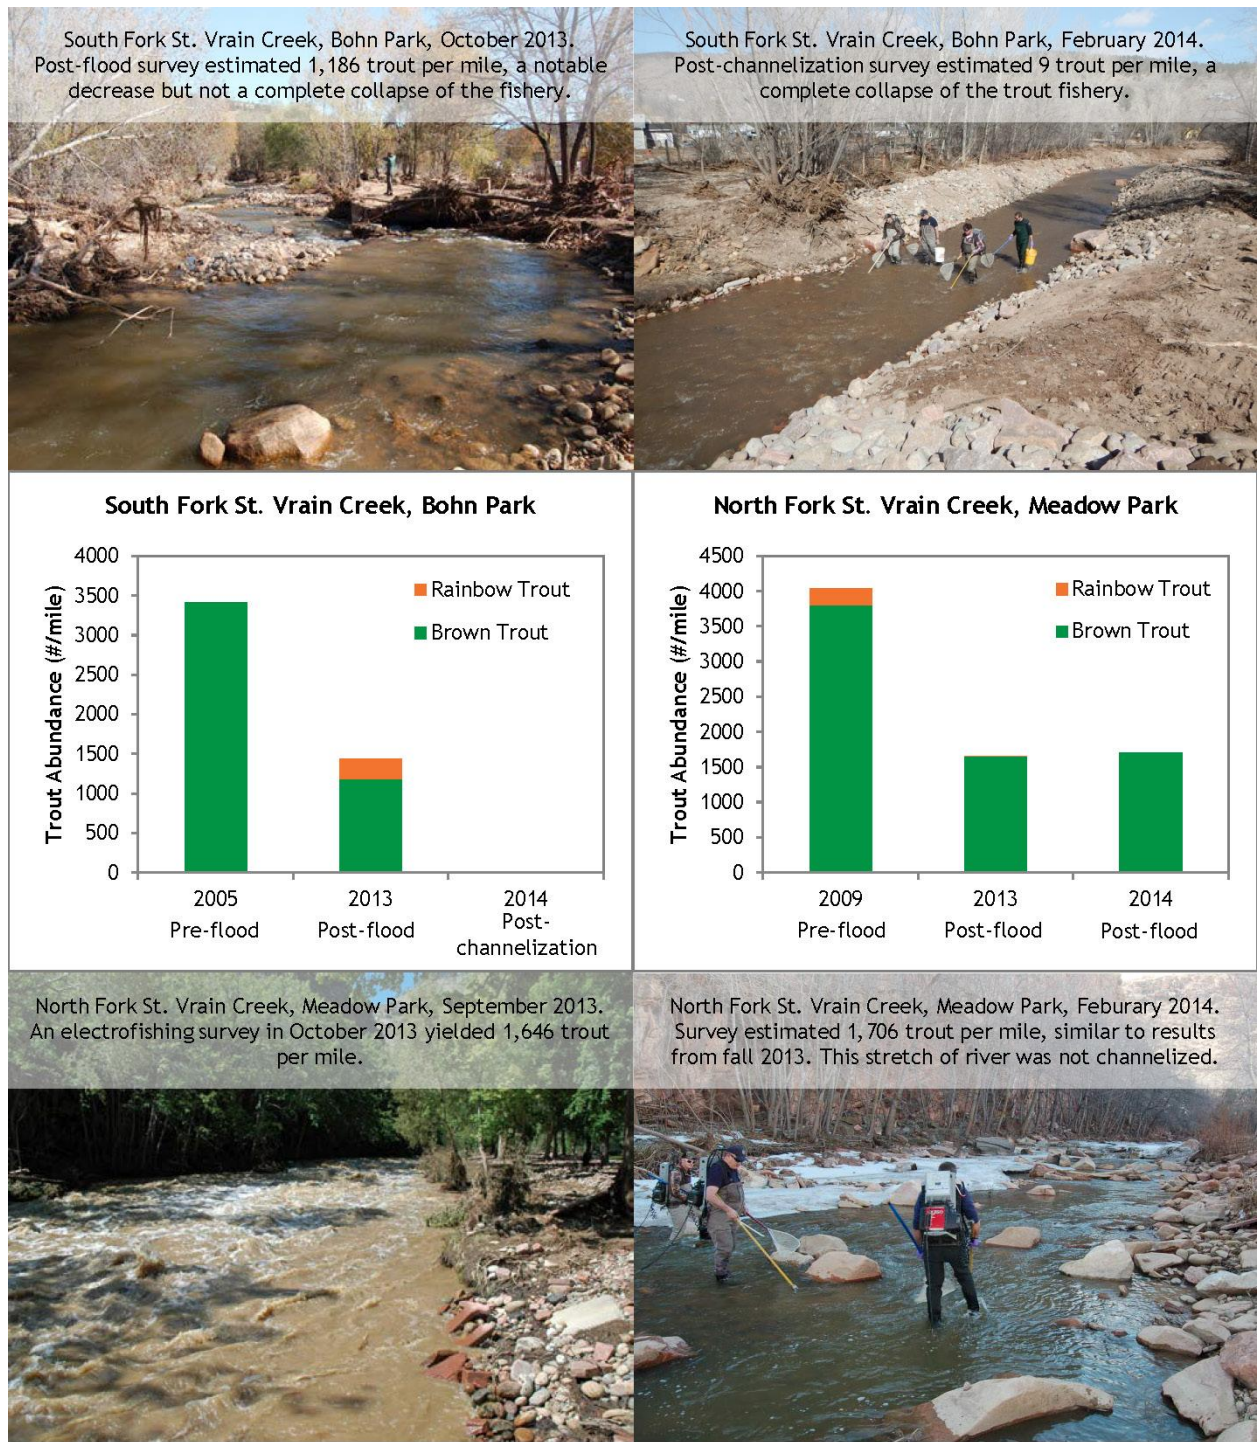
**Figure 7.** Changes in total trout abundance at Bohn Park, South Fork St. Vrain Creek, following the flood and subsequent channelization compared to Meadow Park, North Fork St. Vrain Creek, which was not channelized.

Decreased trout abundance was observed at both St. Vrain sites following the flood (Figure 7). Trout abundance at Bohn Park was previously estimated at 3,417 trout per mile in October 2005. Following the flood, trout abundance had decreased to 1,442 trout per mile in October 2013, representing a 58% decline for the previous estimate. Following post-flood channelization work, the electrofishing survey at Bohn Park yielded a single trout, or roughly nine trout per mile, representing a 99% decline in trout abundance between the post-flood and post-channelization surveys. Unlike Bohn Park, the historical survey site at Meadow Park on the North Fork St. Vrain was not channelized and remained relatively unaltered following the September 2013 flood. At this site, trout abundance decreased from 4,033 trout per mile in September 2009 to 1,659 trout per mile in October 2013, representing a 59% decline in the fishery due to the flood. However, survey results indicate that the fishery remained stable after the flood as 1,706 trout per mile were observed in February 2014. Although high flows observed during the flood impacted fisheries, these results suggest that drastic channel alterations during post-flood reconstruction further degraded fisheries in the Colorado Front Range. CPW will continue monitoring efforts to further evaluate the effects of both the 2013 floods and post-flood reconstruction on fishery resources in flood-impacted rivers.

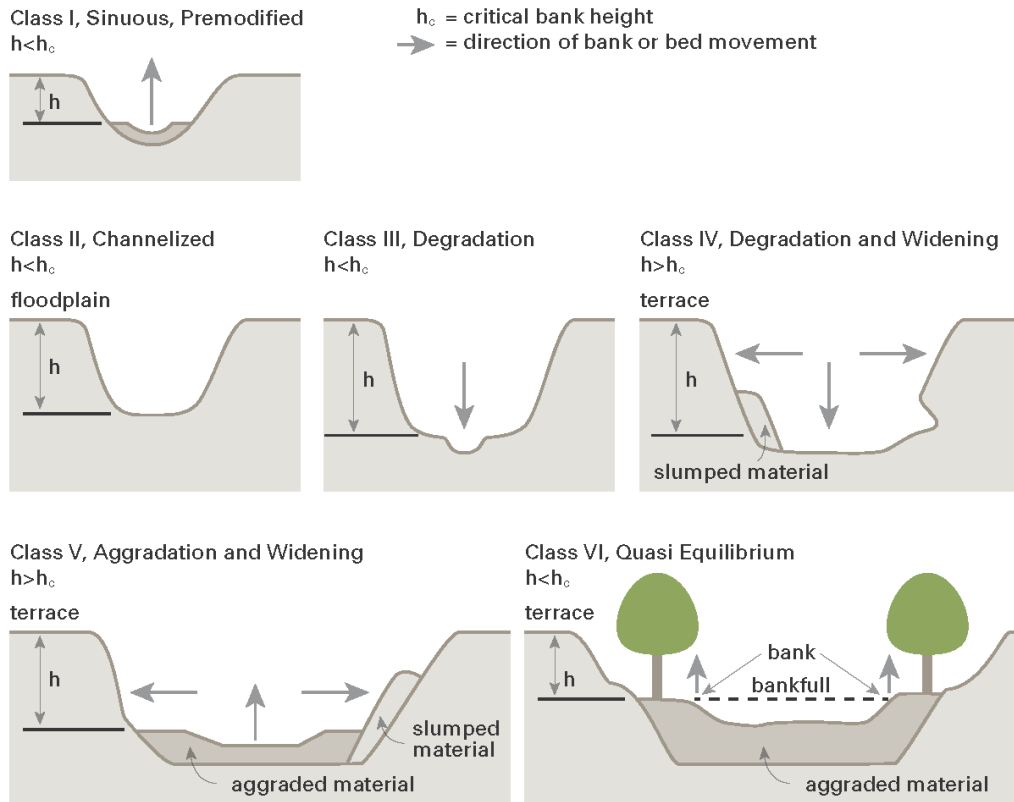
**Figure 8.** The Simon channel evolution model (Harman et al., 2012).

Channel evolution models demonstrate that channelized rivers are not stable and that channelization will lead to degradation and widening followed by aggradation and further widening (Figure 8). Rip-rap is commonly used in an attempt to prevent the natural evolution of channel morphology, but rip-rap can become mobilized or undermined during floods, as observed during the 2013 floods. We hope that bank stabilization measures can be utilized in a manner that supports stream functions, while both creating quality habitat and reducing debris accumulation at bridges. There are many stream restoration techniques, such as toe-wood or log-vanes, that utilize LWD to stabilize banks and create

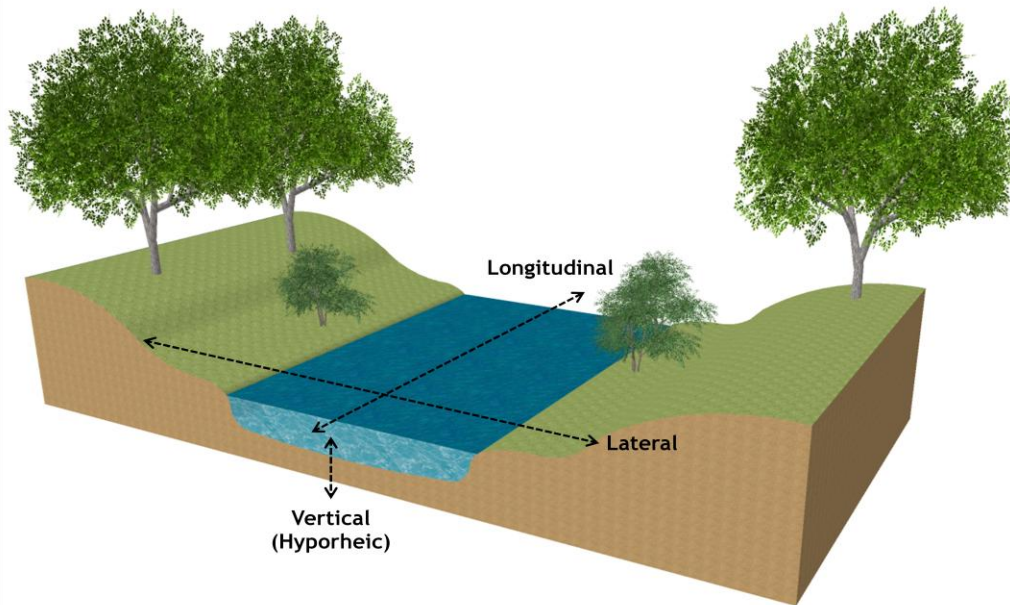
Figure 9. The three dimensions of habitat connectivity in a functioning river system.

Habitat connectivity is vital component of a functioning river or stream. There are three dimensions of habitat connectivity: longitudinal, lateral, and vertical (Figure 9). Longitudinal connectivity relates to connectivity between upstream and downstream reaches, lateral connectivity implies connectivity between the active channel and floodplain, and vertical connectivity pertains to connectivity between the active channel and hyporheic zone. Despite aforementioned issues with fish passage, re-connecting upstream and downstream reaches should remain an important goal for stream restoration along the Colorado Front Range. Longitudinal connectivity allows fish and other organisms to migrate upstream or downstream. Migration is a vital component of many species life cycle. Over a typical life cycle, fish seek out a variety of habitat conditions depending on their life stage, season, and environmental variability, among other factors. Should their local habitat patch become degraded from land use, point-source pollution, or climate change, fish and other organisms require access to habitat conditions found upstream or downstream. Lateral connectivity is also important for fish, as many species utilize the low velocities found on inundated floodplains for both refuge and migration. Therefore, it is

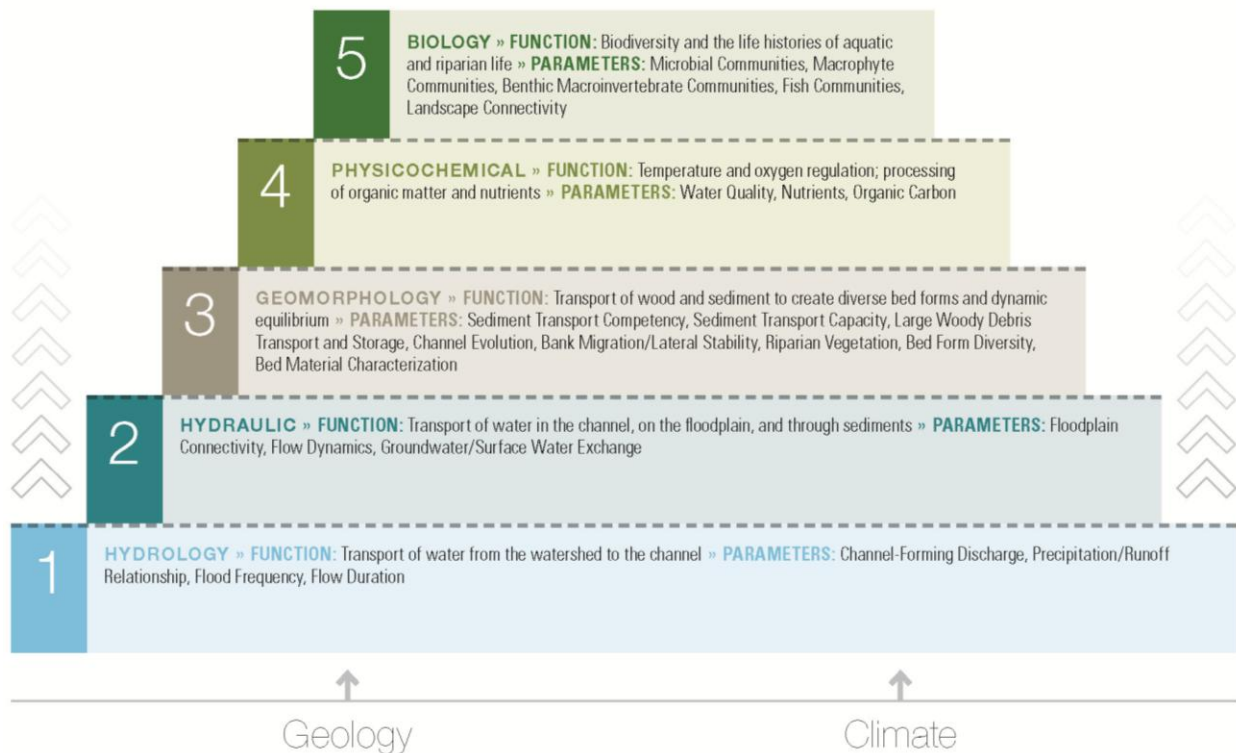
**Figure 10.** Functions and parameters associated with the each level of the Stream Functions Pyramid (Harman et al., 2012).

Guidelines for improving stream functions are detailed in the Stream Functions Pyramid (Figure 10; Harman et al., 2012). The Stream Functions Pyramid is a simple, conceptual framework based on the premise that all streams share common characteristics and functions. Hydrology and hydraulic processes provide the foundation for all stream functions, followed by geomorphologic, physiochemical, and biological functions. The pyramid captures the hierarchical nature of these functions and is a valuable tool for conducting stream assessments, developing project goals and objectives, and identifying approaches to restoration. We encourage state and federal agencies that are responsible for emergency reconstruction to consider the Stream Functions Pyramid when conducting exigent repairs after a major flood. By utilizing approaches to emergency flood response that support stream functions and ecological lift, we could not only improve the condition of our rivers, but also reduce costs associated with “permanent” stream restoration efforts following a major flood.

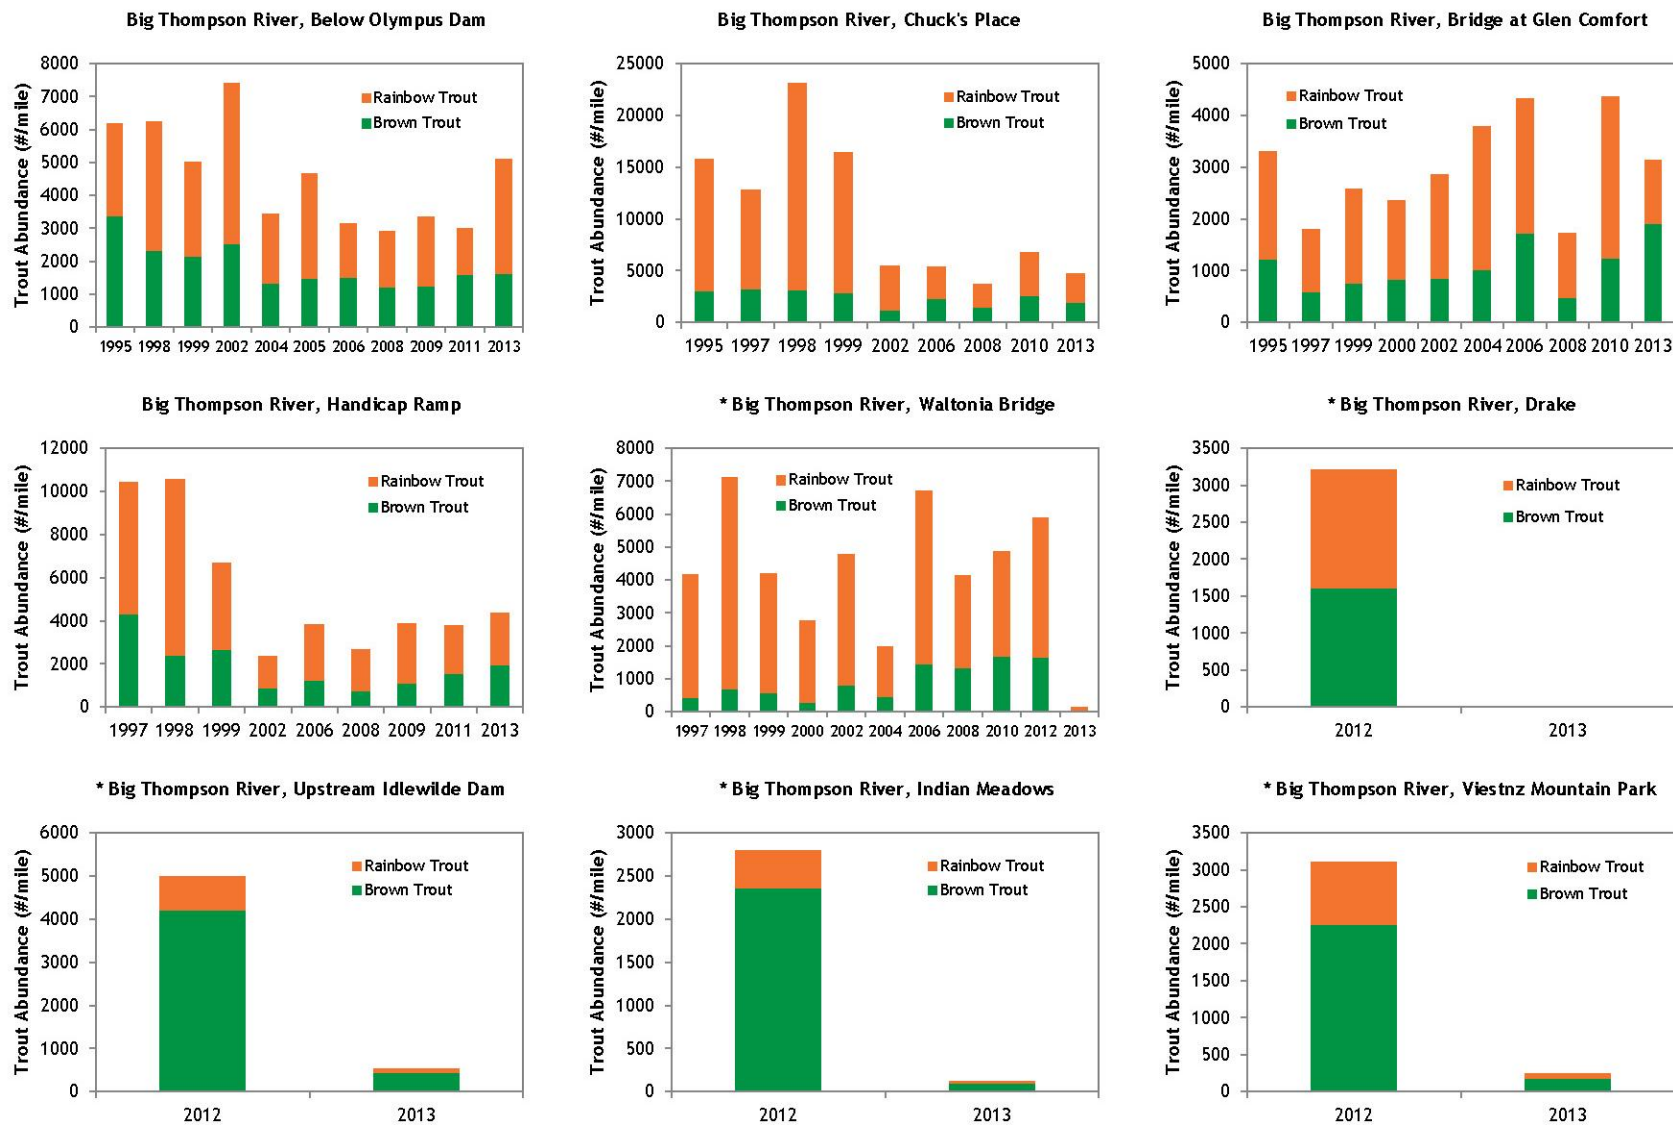
## Appendix B

Trout abundance data (#/mile) for monitoring sites along the Big Thompson River. Notes: \* denotes locations where post-flood channelization occurred in 2013; scale for abundance varies among sites.
