ELKHORN REACH

Estes Valley Watershed

2013 Colorado Flood Recovery

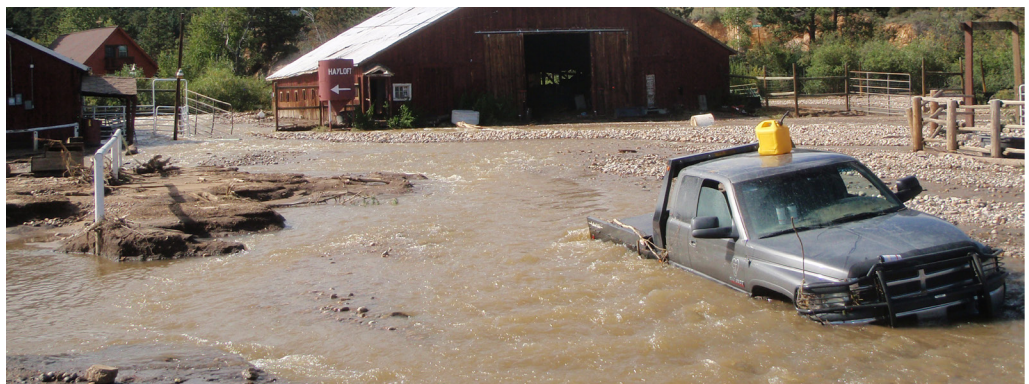
Flooding at the Elkhorn Ranch and Guest Lodge (September 13, 2013).

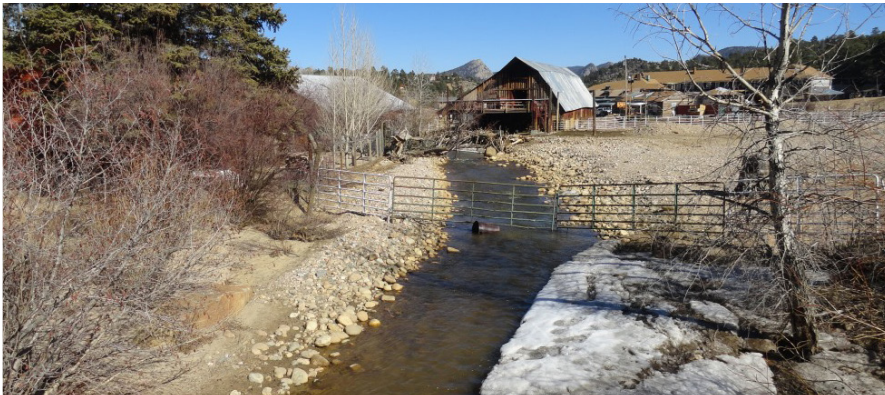
Above: Looking downstream from the Old Ranger Road Bridge after the flood (March 2014). Note two barns in the background.

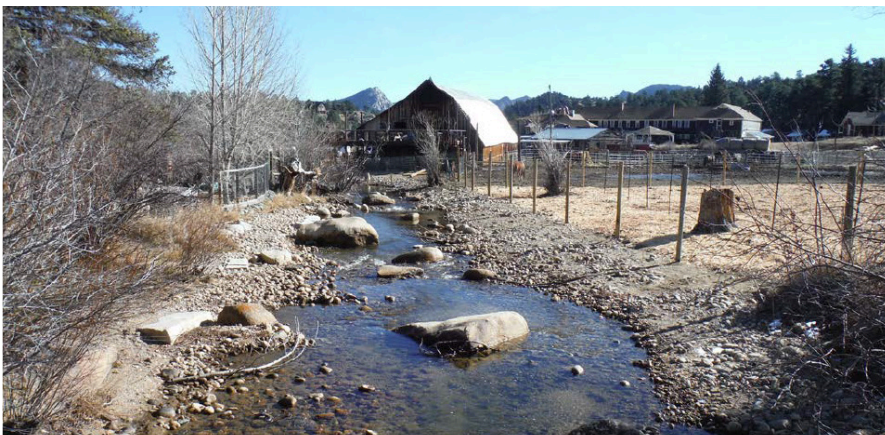
Below: Looking downstream from the Old Ranger Road Bridge after project construction (November 2017). Note the new fencing to exclude horses, removal of an old barn (left side of photo), boulder clusters, and riffle-pool sequencing.

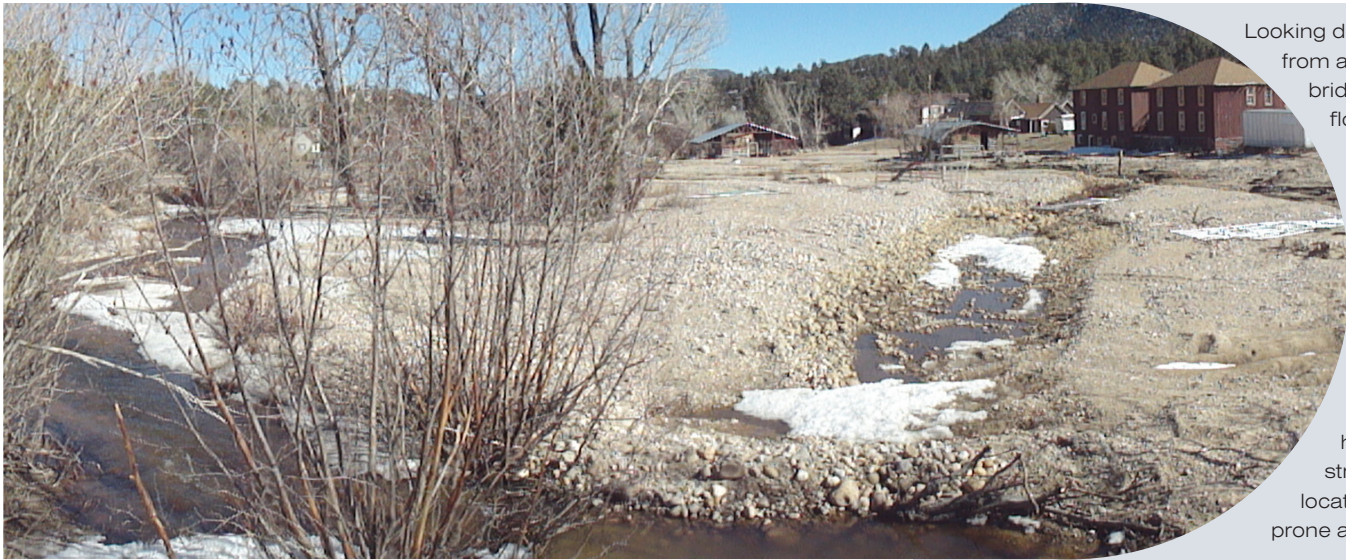
Before

During the flood, the Elkhorn reach of Fall River acted as a large depositional zone, and large volumes of unstable sediment accumulated along the channel and floodplain. As a result, the main stem channel avulsed during the flood, threatening infrastructure and degrading habitat. Site assessment results showed that the Elkhorn reach was overburdened with sediments, creating disconnected floodplains and a lack of both aquatic and riparian habitat.

Looking downstream from a private road bridge after the flood (March 2017). Massive amounts of sediment were deposited, the river split into two channels, and the ranch hay storage structure is located in a flood-prone area.
