GLEN HAVEN

Big Thompson Watershed

2013 Colorado Flood Recovery

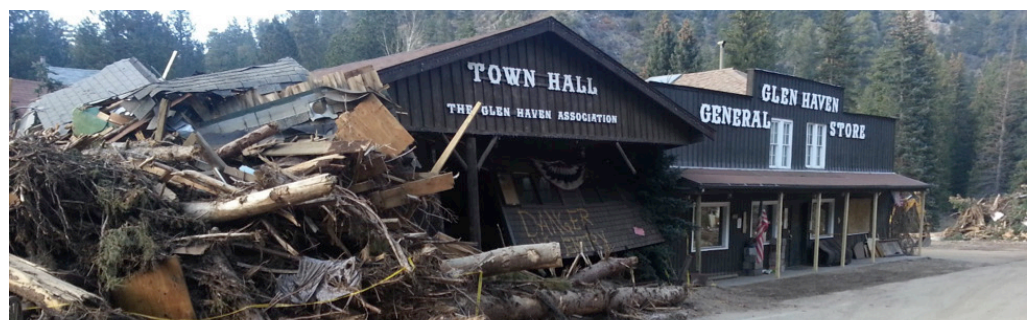
Destruction and debris at the Glen Haven Town Hall and General Store shortly after the flood.

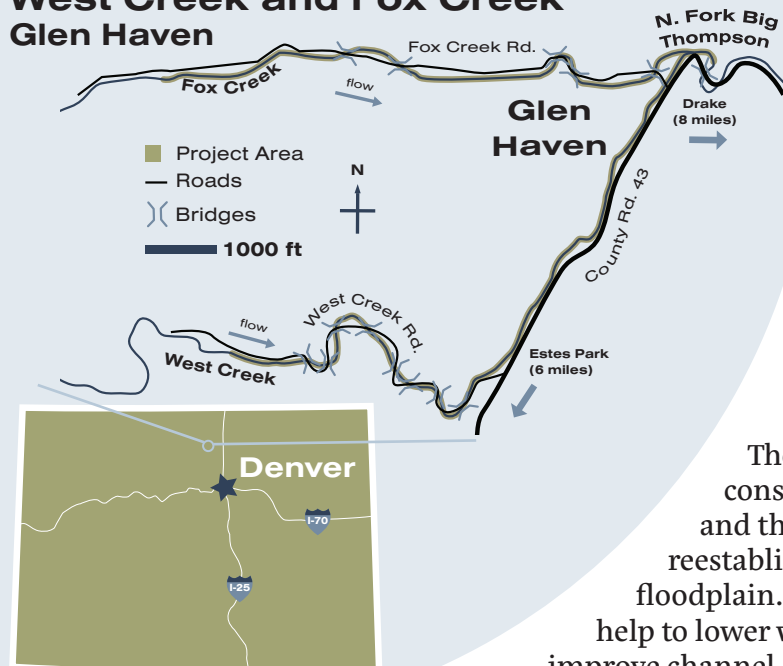
West Creek and Fox Creek Glen Haven

The main features of the Glen Haven project were designed to stabilize areas with excessive erosion close to structures, and remove sediment and debris in the floodplain to restore some of the channel and floodplain capacity that existed on West Creek and Fox Creek before the 2013 flood.

The majority of the stream restoration work consisted of the removal of large sediment deposits and the construction of floodplain benches to reestablish and reconnect the stream channel with the floodplain. In this scenario, a connected floodplain can help to lower water elevations near vulnerable structures, improve channel stability, and provide a place for future floods to deposit sediment and debris. The project treated excessively eroding streambanks through revegetation, bioengineering, and toe stabilization, as well as some rock riprap in high flood hazard locations.

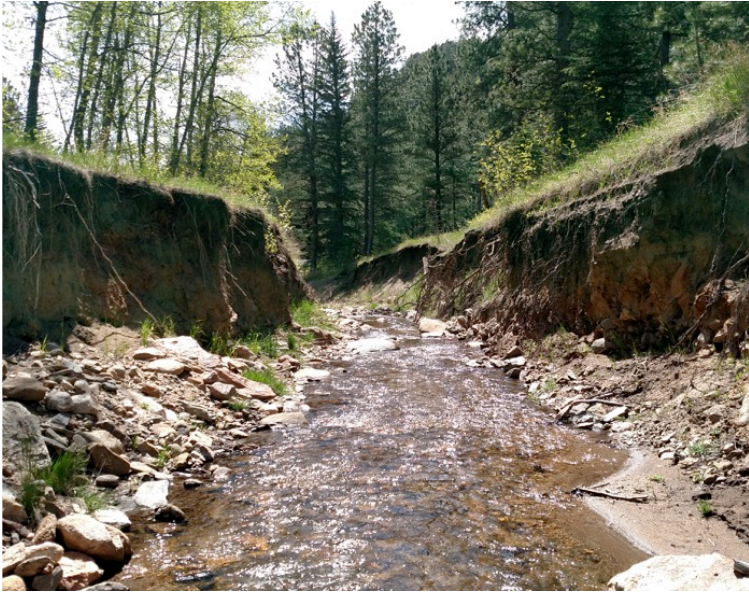
Before

A channel avulsion, where the main creek channel jumped across the floodplain to a different location, created the “Grand Canyon of Fox Creek.” Note the paucity of in-channel habitat and lack of floodplain to relieve flood energy.

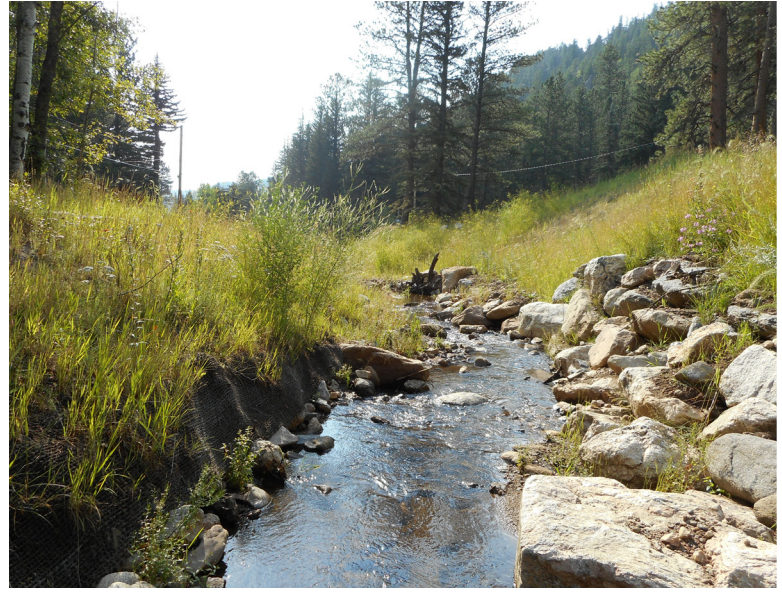
After

Banks were graded back and planted, reconnecting the channel with the floodplain and increasing the system’s overall discharge capacity. Habitat features and meanders were incorporated into the channel.

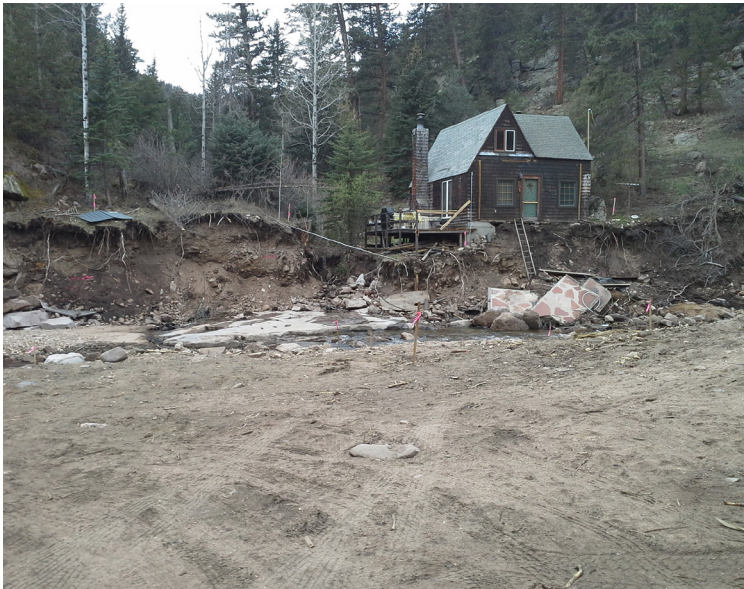
Severe bank erosion resulting from the flood undermined the house in this photo. Large volumes of sediment deposited by the flood were removed from the foreground of this photo following the flood, but debris and trash remain.

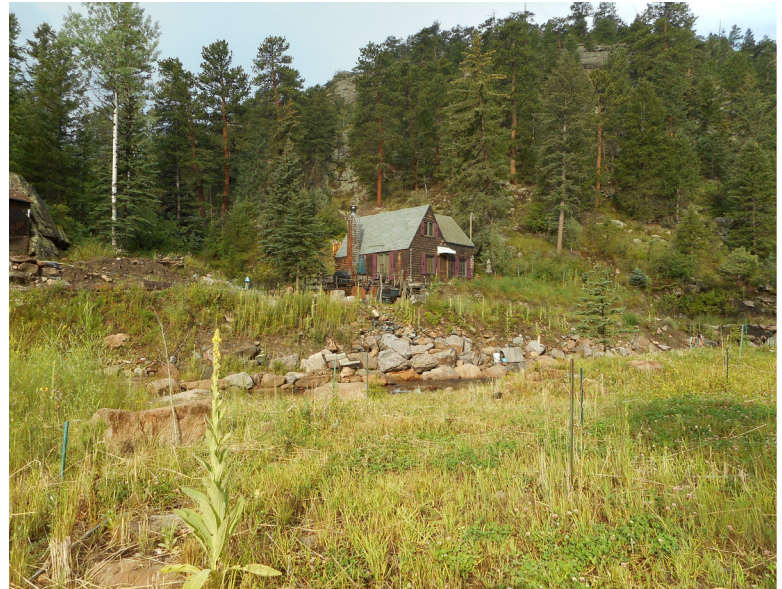
Sediment and debris were removed, establishing a floodplain to provide additional flow capacity. In-stream J-hooks (channel training structures) were added, the toe of the streambank was reinforced, and the site was planted with native vegetation. Active weed control is occurring while native plants establish.
