INGRAM GULCH PROJECT

Fourmile Creek Watershed

2013 Colorado Flood Recovery

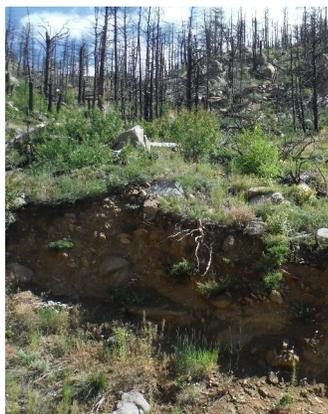
Left: Upstream portion of the project area before construction, with vertically eroded banks and burn scars on trees in background.

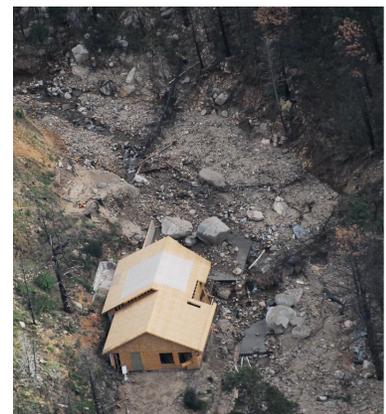
Right: Home in Ingram Gulch engulfed in sediment and other debris after the 2011 debris flow.

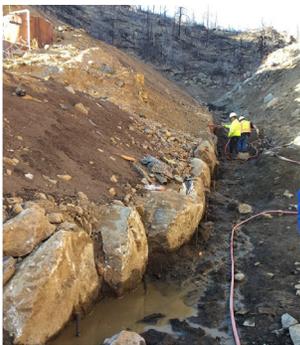
Left: Contractor installing steel rods, or “dwyidags,” into bedrock to ensure stabilization of large boulders set in a bedrock cradle.

Bottom Left: Contractor staking erosion blankets on steep slopes.

Bottom Right: Completed vegetated soil wraps as bank protection on the left, a seeded and mulched floodplain bench with floodplain roughness logs incorporated on the right, and a tank with drip lines for watering planted vegetation.

Despite its limitations, several innovative techniques were employed on the Ingram Gulch project. In the upper channel, highly unstable and steep slopes support a potable water system for the landowner. Due to the tenuous nature of this setup, the bank stabilization boulders below it were reinforced by drilling metal rods (dwyidags) into the bedrock upon which they were placed. A seeded “biolog” was installed along the boulder toe to encourage vegetation growth, assist in stabilization, guide the low-flow channel away from the boulders, and cover the dwyidags. Steep, vertically cut slopes were backfilled, seeded, and covered with erosion control blankets. The grade was so steep on these slopes that the erosion matting had to be staked using ladders.

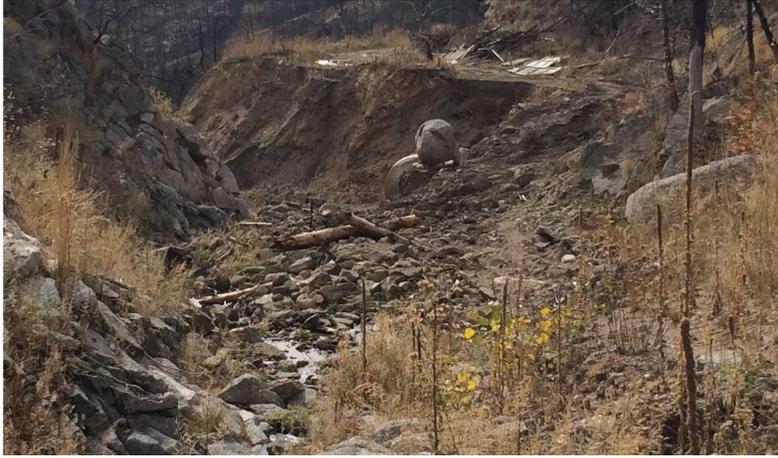
Before

Upstream end of the project reach showing extensive erosion and evidence of debris flows and sediment deposition.

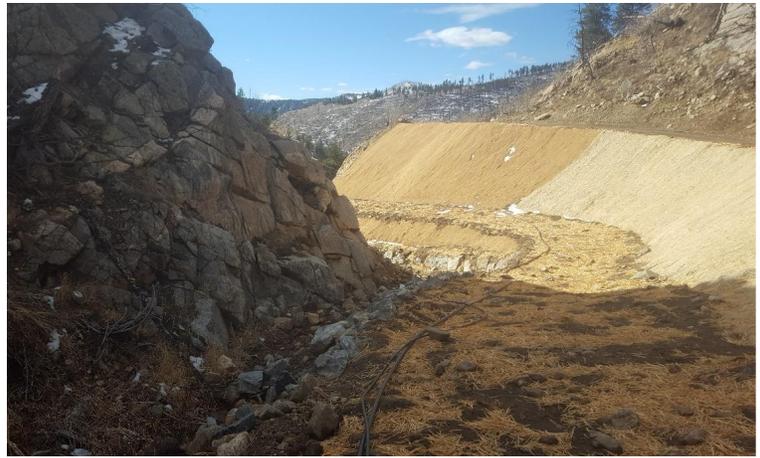
After

Stabilized section at the upstream end of the project reach showing grading of a landowner access route, steep erosion control blanket installation, and irrigation lines for watering.

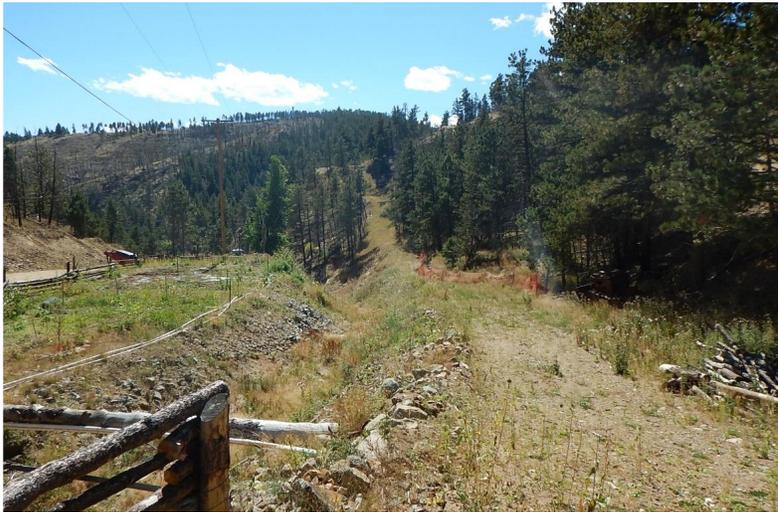
Looking downstream at the lower portion of the project. Note steep banks, lack of floodplain, and extensive deposition.

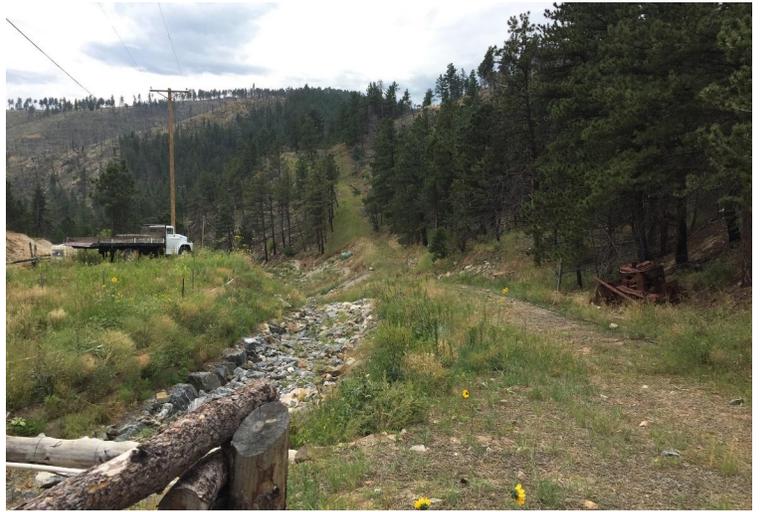
Lower portion of the project showing graded banks for flood conveyance, stabilized channel bed with in-stream grade control structures, banks protected with toe boulders and willows, and native revegetation throughout the reach.
