# JASPER LAKE REACH

Big Thompson Watershed

# 2013 Colorado Flood Recovery

# River Corridor Rehabilitation

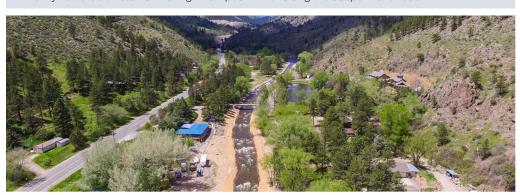
A newly-restored stretch of the Big Thompson River along the Jasper Lake reach.

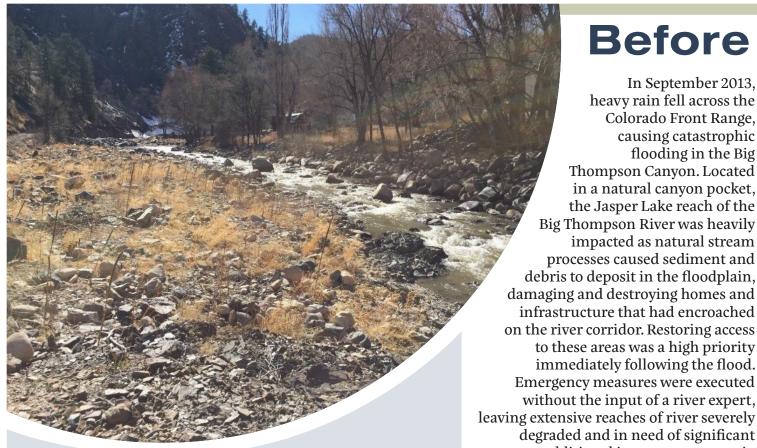
Looking upstream from the

downstream portion of the Jasper Lake project reach prior to restoration.

**After** Design and construction of the Jasper Lake project successfully accomplished the objectives identified for this area in the Master Plan. The in-stream structures installed are intended to provide grade control and bank protection by shifting higher velocity flow paths away from infrastructure and sensitive banks, and to reestablish a stable bedform while improving aquatic habitat. Since completion of

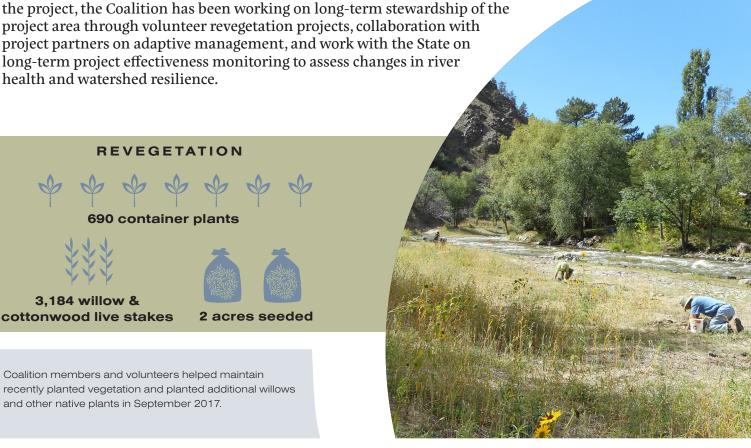
**Before**

Thompson Canyon. Located in a natural canyon pocket, the Jasper Lake reach of the Big Thompson River was heavily impacted as natural stream processes caused sediment and debris to deposit in the floodplain,

infrastructure that had encroached

to these areas was a high priority immediately following the flood. Emergency measures were executed without the input of a river expert,

degraded and in need of significant additional investment to repair.
