FOOTHILLS REACHES

Left Hand Creek Watershed

2013 Colorado Flood Recovery

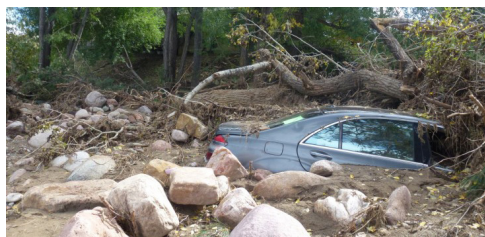
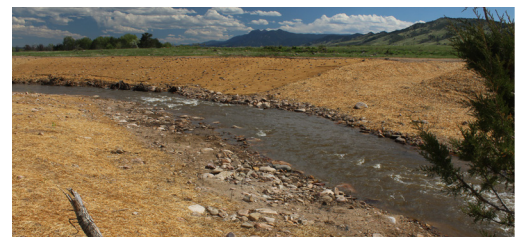
Left: Flood sediment and debris nearly burying a vehicle in the Streamcrest neighborhood (photo credit: Teri Morelli); Right: Post-construction photo of the Ranch reach, where eroded cut banks were graded back, revegetated, and covered with biodegradable erosion control fabric and WoodStaw mulch to protect bare soils until vegetation is established.

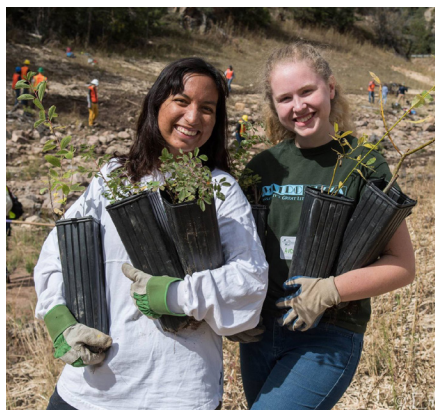
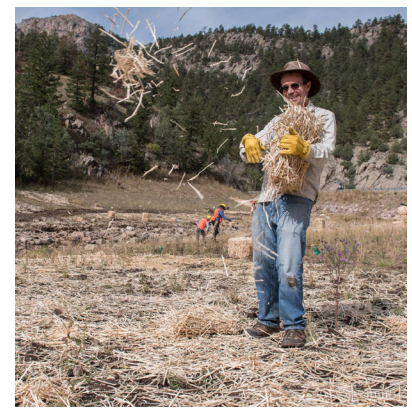
Construction was followed by revegetation, including seeding with native seed mix, staking live willow and cottonwood material, and planting trees and shrubs.

Wildlands Restoration Volunteers hosted volunteer events at Foothills Reaches to help with revegetation efforts. This effectively engaged the community in the project and extended the project budget.

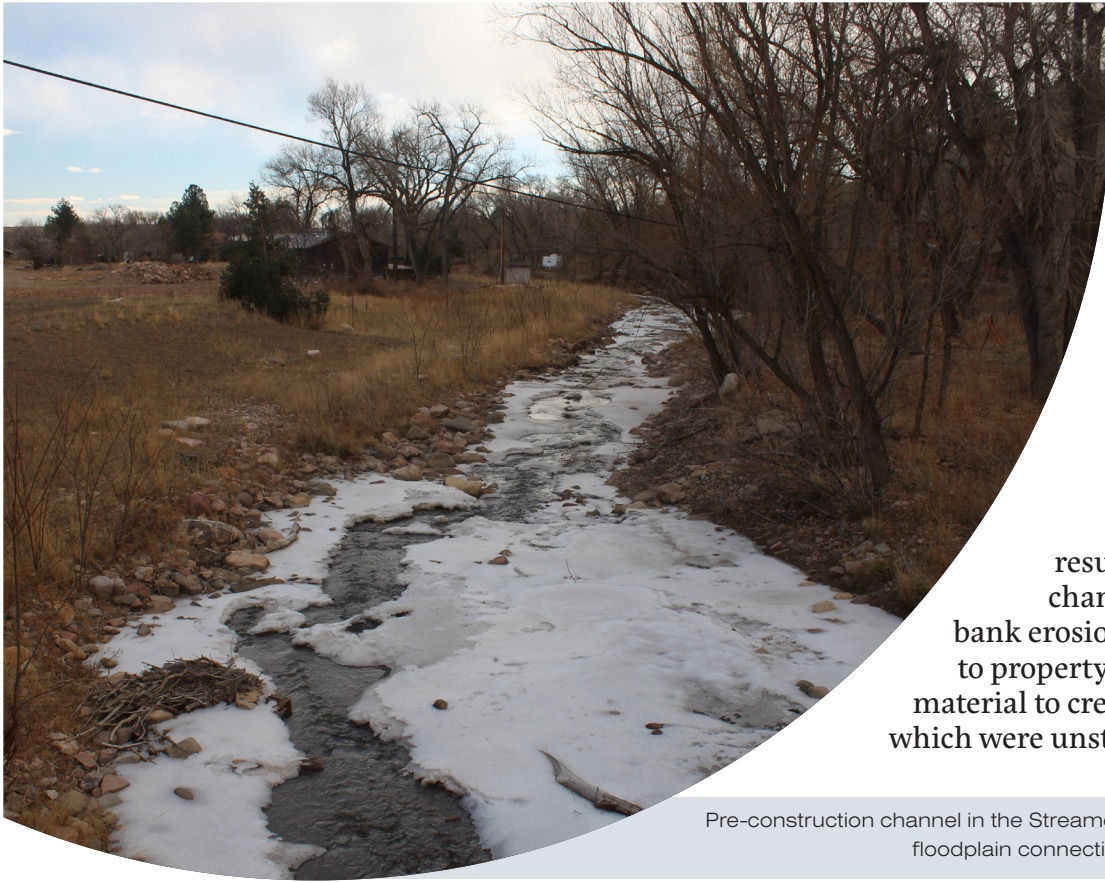
Before

Flooding, accompanied by its sediment and debris delivery out of the mountain canyons, caused the creek to migrate and experience deposition, erosion, and loss of riparian vegetation. The high sediment load naturally transported from the upper watershed quickly plugged undersized private crossings, resulting in sediment deposition, channel avulsion, and substantial bank erosion. To prevent further damage to property, residents used the deposited material to create makeshift levees, many of which were unstable, exacerbating the hazard for future flooding.

Pre-construction channel in the Streamcrest neighborhood lacking complexity, floodplain connection, stabilizing vegetation, and sinuosity.

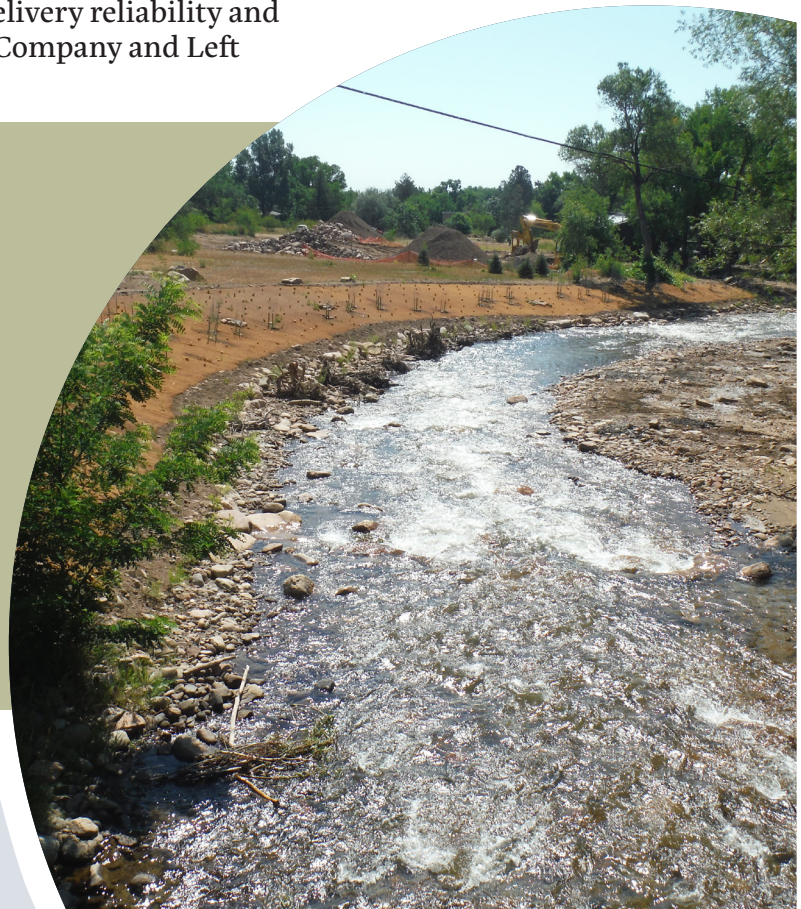
After

Post-construction channel with pool-riffle sequences, large wood structures to stabilize banks and increase roughness, a graded point bar on the inside of the meander bend, and planted native riparian vegetation.

The completed project directly improves the ecology, safety, and quality of life for private landowners within the project areas, including improved home protection, landowner access, reduction of hazards, and enhanced riparian and aquatic habitat.
