NORTH 83RD STREET

Little Thompson Watershed

2013 Colorado Flood Recovery

River Corridor Rehabilitation

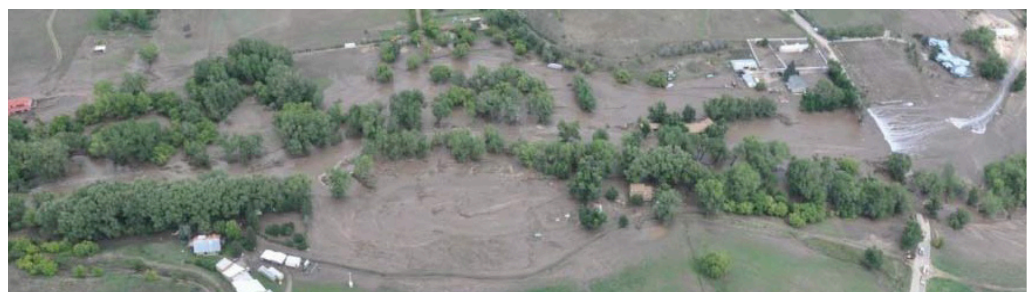
Immediate post-flood conditions (North 83rd Street is the road on the right side of the photo).

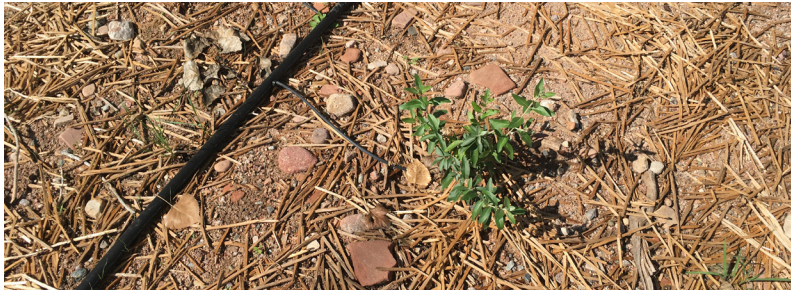
Right: Newly planted seedlings on temporary drip system.

Below: Laying out fiber blankets for erosion control.

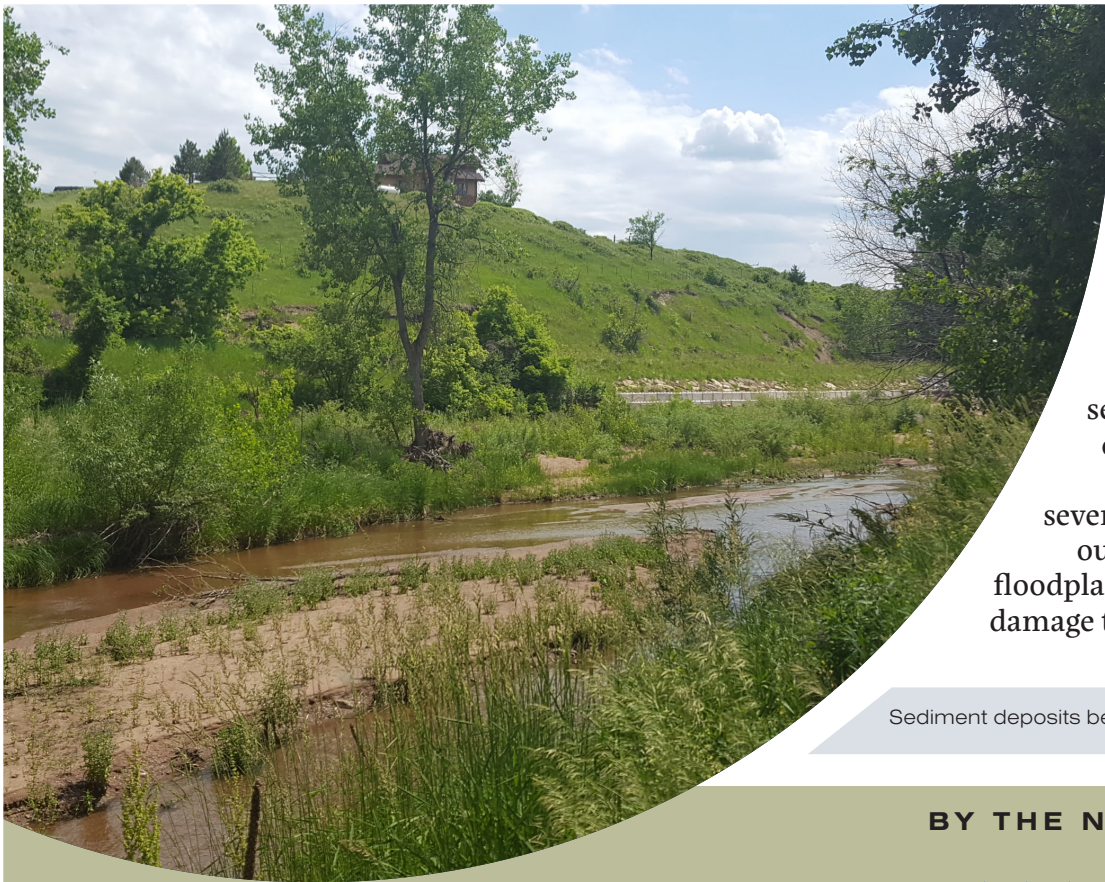
Before

The plugging of the undersized culverts at the North 83rd Street crossing caused the 2013 floodwaters to overtop the road and deposit an enormous amount of sediment upstream. As a result of the deposition, floodwaters migrated north and damaged several residences both inside and outside of the mapped 100-year floodplain. The sediment wedge made damage to these residents from future floods very likely.

Sediment deposits before construction.

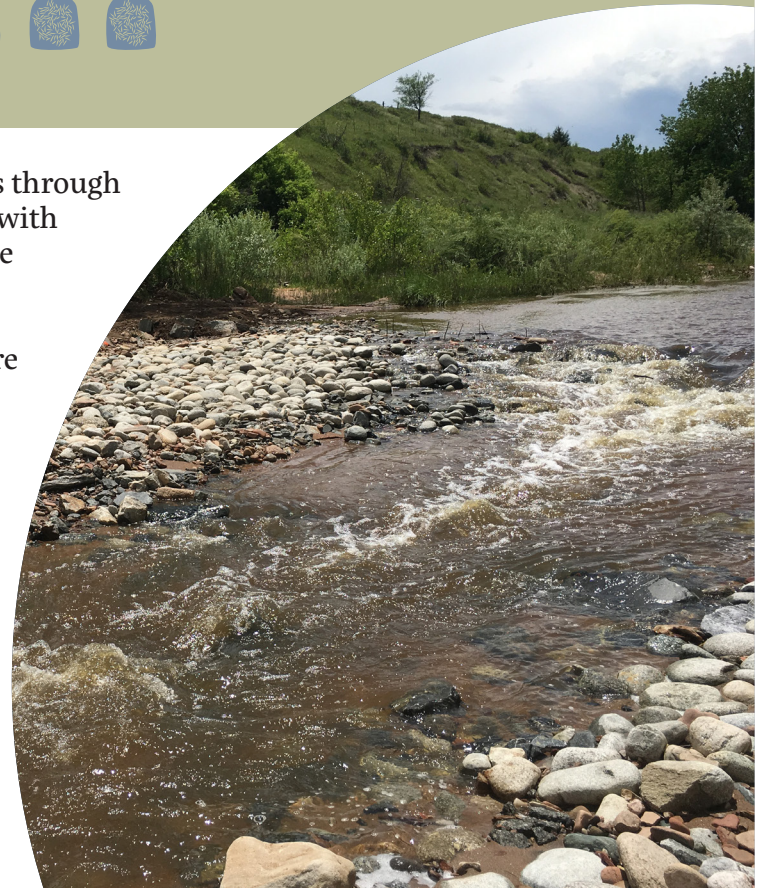
After

Today, a restored channel meanders through the central portion of the river bed with slopes gradually leading up from the water's edge. Bank stabilization features installed in certain locations on the outer banks, as well as the riffle structures, will reduce erosion and protect infrastructure in an environment of naturally shifting sediments. In spring of 2017 and 2018, the new channel successfully conveyed the high waters during runoff with limited new erosion or sediment deposition.

Riffle-pool sequences are now providing habitat, water quality benefits, and improved sediment transport after construction.

Three riffle-pool structures were added to the river reach to manage the transport of sediment, prevent downstream bank erosion from progressing upstream, control the grade of the river, and improve aquatic habitat. Willows, cottonwoods, and other container plants were strategically placed to help stabilize the floodplain and banks while also reducing out-of-bank water velocity and providing habitat.

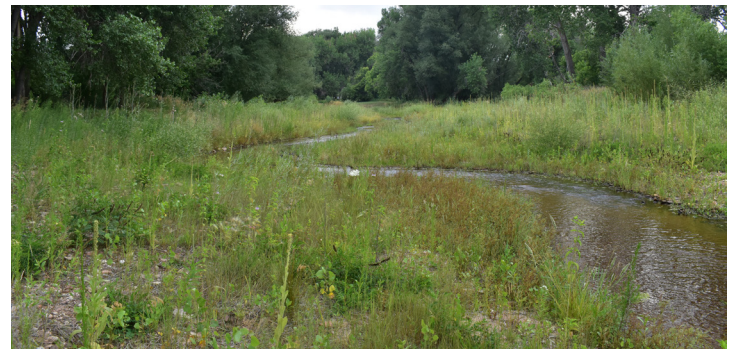
Vegetation returning to the North 83rd Street project site (July 2018).
