# STATE HIGHWAY 60

## 2013 Colorado Flood Recovery

## South Platte River State Highway 60

# River Corridor Rehabilitation

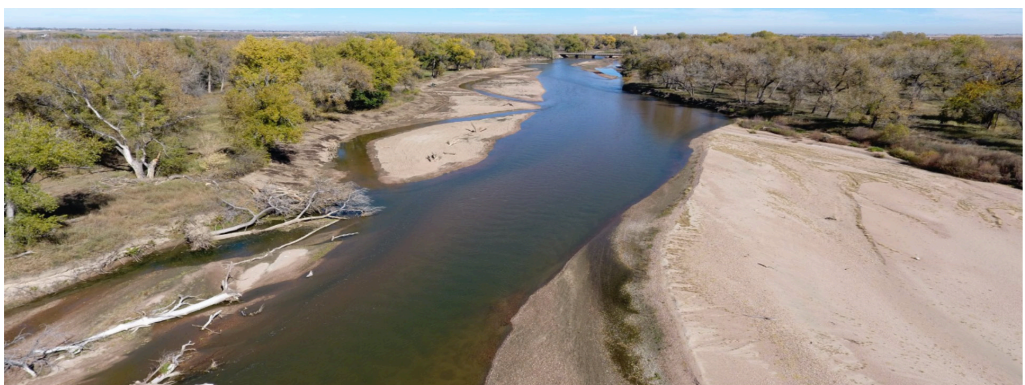
Post-construction photo looking east toward the SH 60 bridge, capturing the entire project area.

The SH 60 project sought to guide the channel alignment of the South Platte River to protect the SH 60 bridge, a critical emergency access route. Four bendway weirs were designed to redirect flows and sediments through the bridge. Native vegetation was installed to improve long-term bank stability, protect water quality, and enhance riparian and riverine habitat.

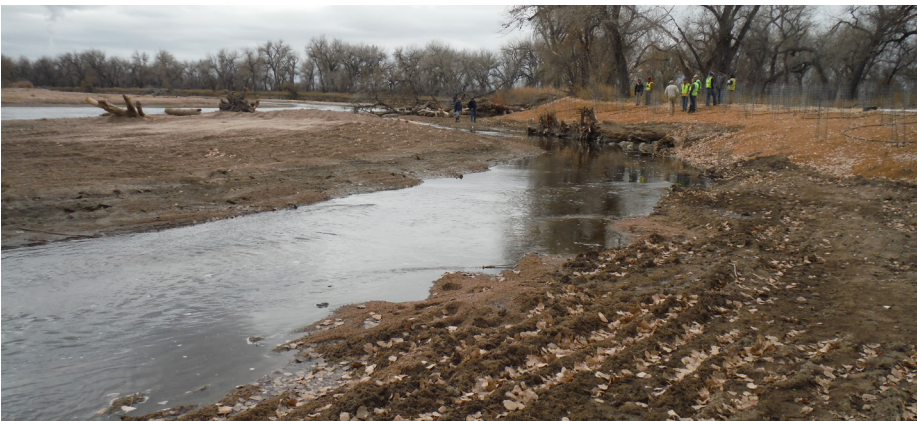
Woody habitat refuge at upstream end of project, log revetment on left bank (right side of photo), and sand bar with woody snags.

Mimicking natural habitat critical in a sand bed river system, an engineered revetment structure made of salvaged trees was installed at the upstream end of the project to stabilize the bank while providing aquatic habitat benefits. Small woody material found onsite was repurposed to create a wood habitat structure to enhance avian and riparian habitat. Finally, sand bars with woody snags were re-established through the project site to resemble existing natural features on the South Platte River and provide additional habitat.

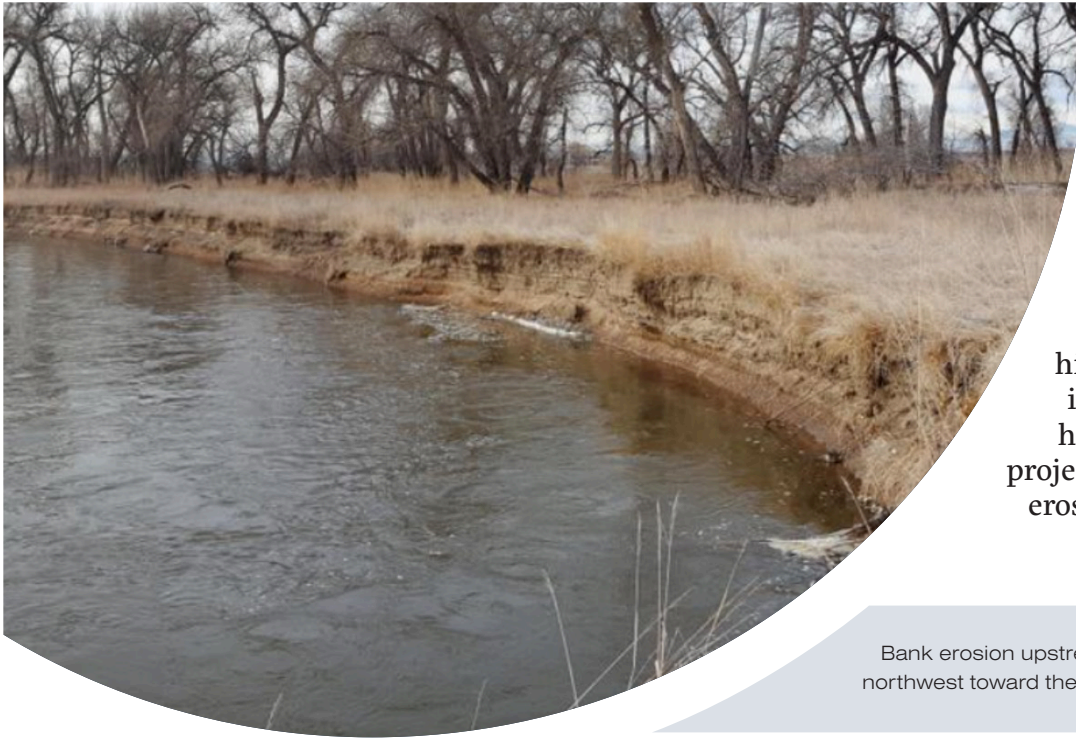
# Before

A detailed sediment transport study indicated that the altered hydrology (from urbanization of the watershed and numerous diversions), combined with historic channelization prevalent in the Middle South Platte River, has exacerbated instability in the project area over time. The result was erosion of land and a threat to state highway infrastructure.

Bank erosion upstream of the SH 60 bridge, looking northwest toward the future location of Weir 1.

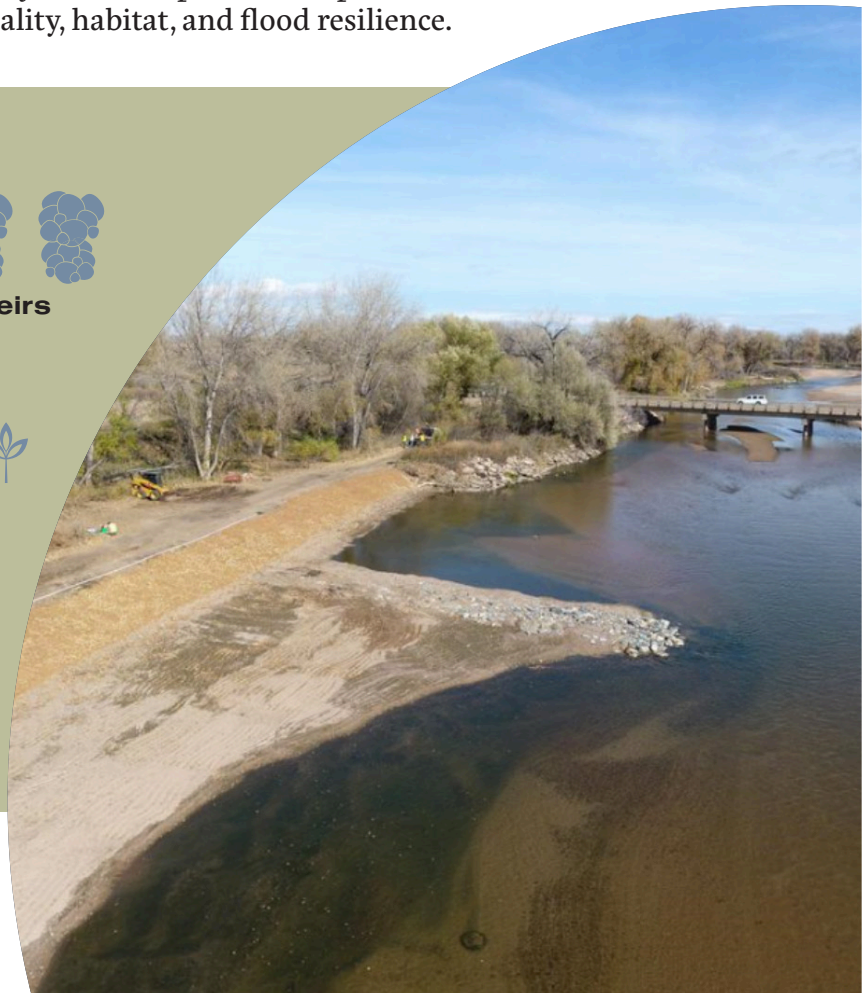
Post-construction aerial view of Weir 1 and the SH 60 bridge looking east.

Four bendway weirs were installed to redirect flows towards the center of the channel as a way to minimize erosion and encourage sediment transport. These were constructed out of rock material of various sizes and extend approximately 50 feet into the river. Unlike traditional riprap, these use less rock, are designed to have minimal visual impact, provide better long-term access for landowners to the channel, and create improved in-channel habitat.

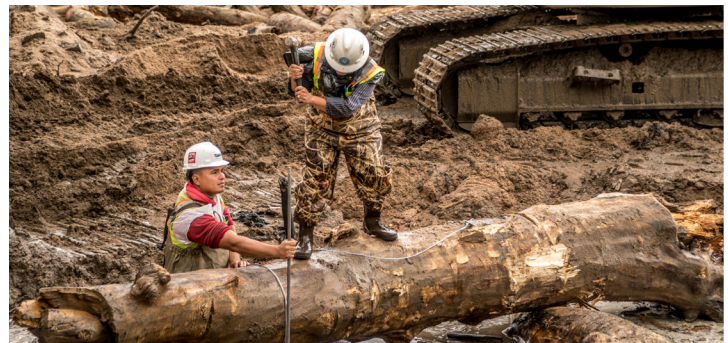
Installing woody material to provide aquatic habitat.
