- Big Thompson River -

WALTONIA & MOUNTAIN SHADOWS REACHES

2013 Colorado Flood Recovery

River Corridor Rehabilitation

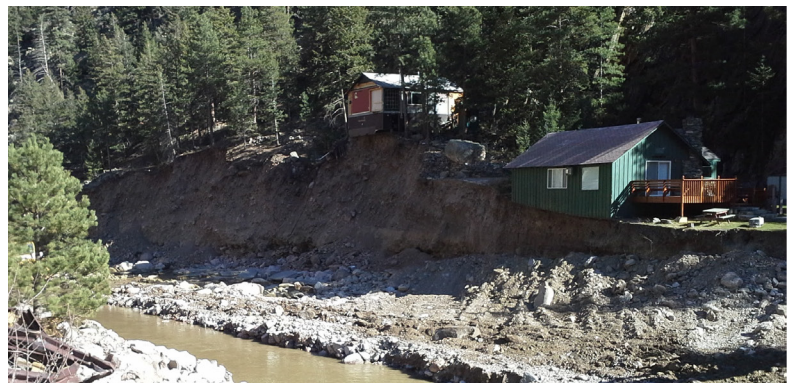
Erosion damage undermining residences in the downstream section of the Waltonia reach, November 2013.
Photo: Bill Spitz

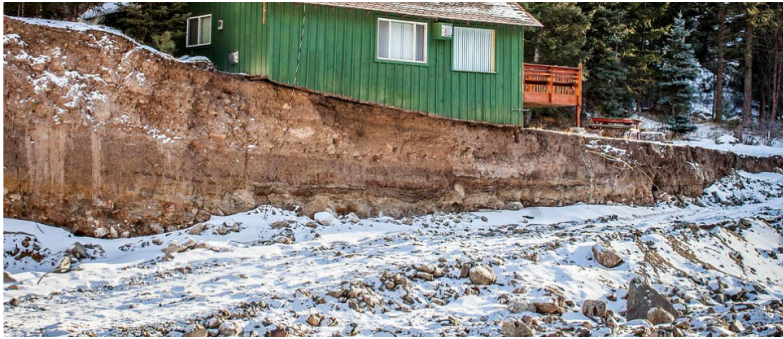
Before

Massively eroded bank at a cabin near the downstream extent of the Waltonia project, after the flood and emergency repair work, but before the W/MS/MS2 project.

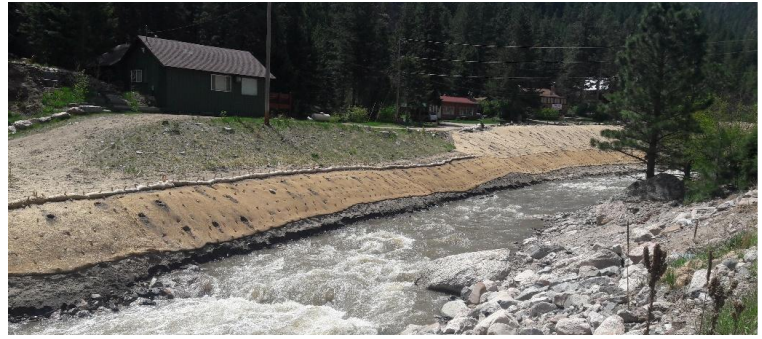
After

Rock bank protection is covered in topsoil, seeded, and planted. Erosion control blanket holds soil in place while vegetation establishes. A constructed boulder cascade and plunge-pool add complexity and help dissipate energy while creating cold-water refuge that is vital summer habitat for trout.

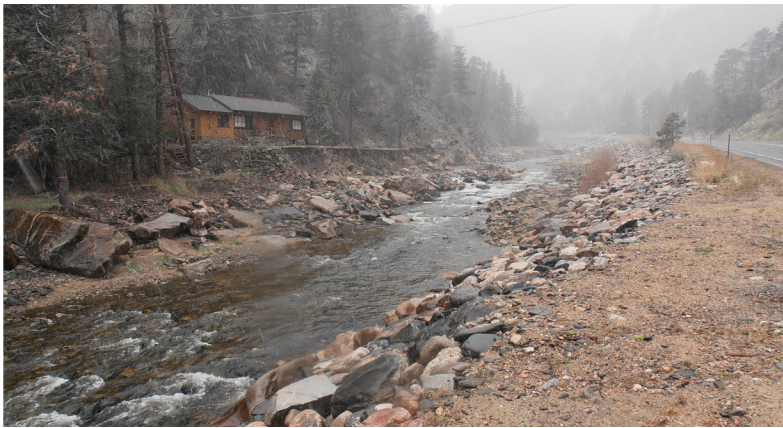
Post-flood photo of a house in the Mountain Shadows reach. The flood scoured banks and tore away vegetation, and severe erosion threatened to undermine the home.

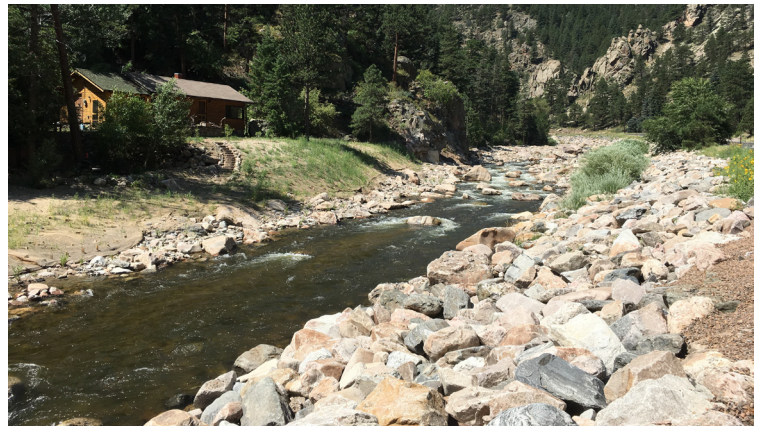
After the project, the banks are graded back and protected with buried rock, erosion control matting, and native vegetation. Existing vegetation is preserved to the extent possible.

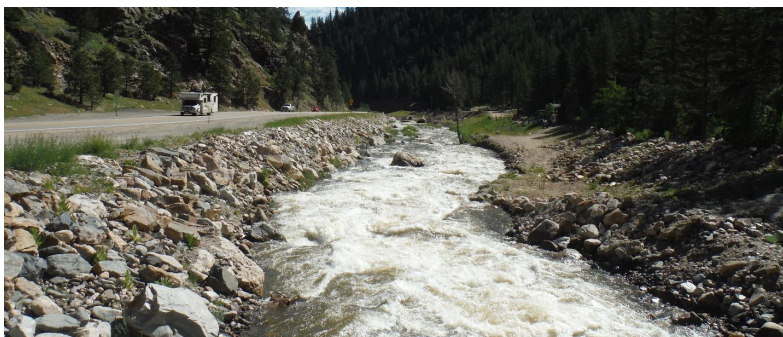
Looking downstream from the Waltonia Bridge, after the flood and emergency repair but prior to the W/MS/MS2 project. Trees remain on top of the banks, but the river is disconnected from floodplain and the floodplain is devoid of vegetation. Though this is one of the river's widest spots in the canyon, there is little floodplain to provide relief in high water events. While difficult to discern at this high flow, the channel is relatively homogeneous.

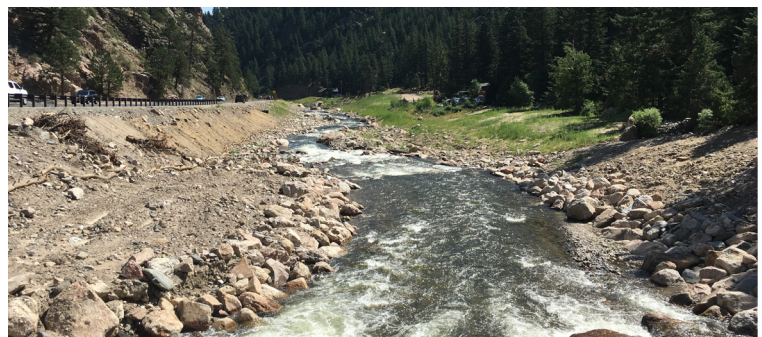
Floodplain relief on the left side of the river (photo shows some unfinished work and exposed rock in the foreground due to new bridge construction) and improved connectivity on the right. Banks are protected with rock, covered in topsoil, and revegetated with native plants. Constructed riffles and pools provide a complex channel that can better absorb velocity at high flows and provide aquatic habitat. The channel was realigned to better protect infrastructure and increase sinuosity at low flows.
