CEDAR COVE REACH

Big Thompson Watershed

2013 Colorado Flood Recovery

River Corridor Rehabilitation

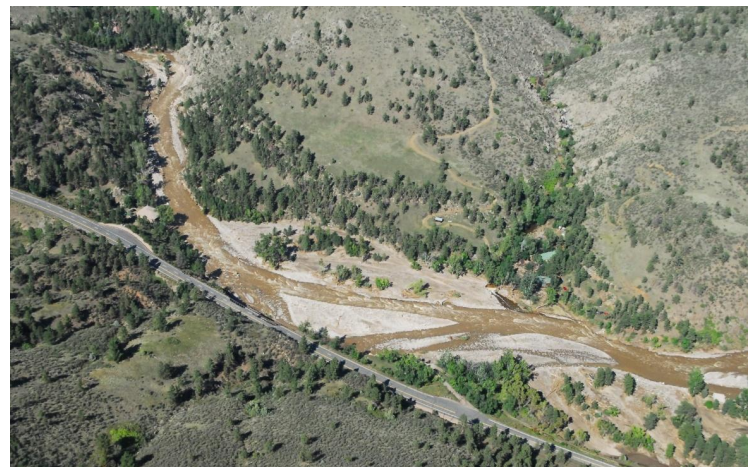
Upper portion of the Cedar Cove reach immediately after the flood. The channel quickly bypassed the undersized Cedar Cove bridge, accessing historic river channels to the south and undermining the US Highway 34 embankment. Photo courtesy of Bill Spitz.

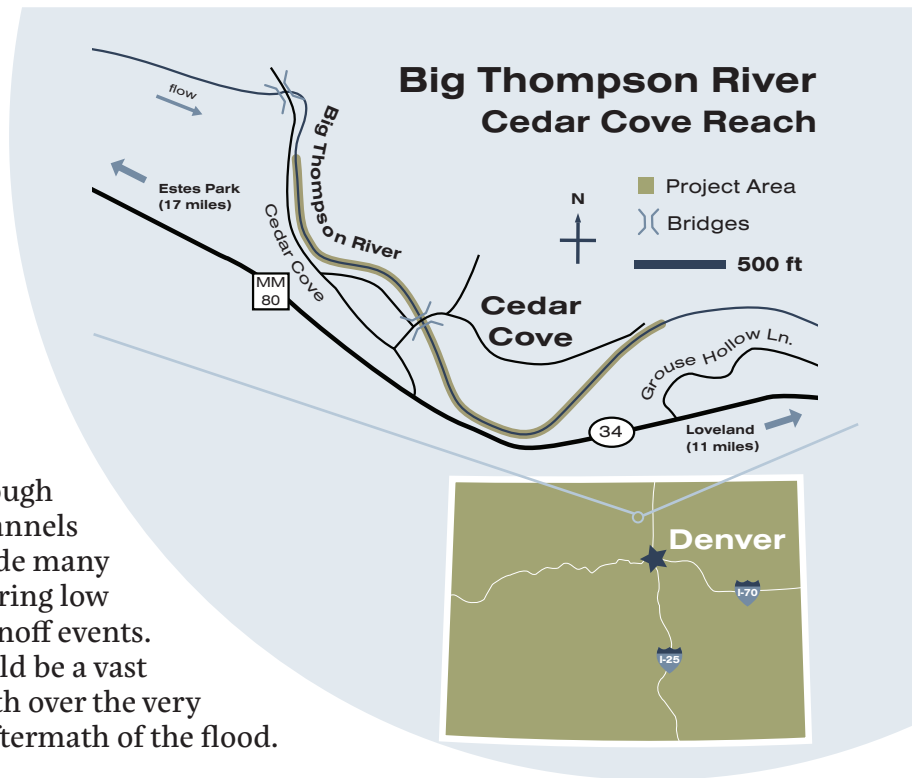
In-channel features, including rock grade control and stabilization structures, boulder toe, woody debris toe protection, and soil lift bank protection, were installed to stabilize the channel bed and banks. These structures reduce potential bank erosion and channel down-cutting that could impact stream function and threaten infrastructure. In addition, these features help maintain the appropriate riffle/pool morphology and improve habitat complexity.

Following construction, the Cedar Cove project area was revegetated with native seed mixes, live stakes and brush-layered willows, container plants, and bare-root trees and shrubs. Successful native vegetation establishment will provide further stabilization for the channel banks and floodplain areas, and improve riparian habitat and water quality through the reach.

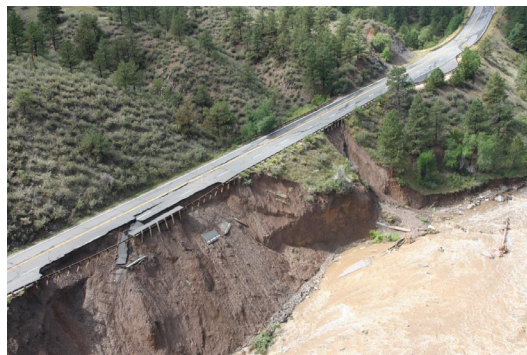
Top: Energized once again in 2013, the Big Thompson River accessed its native corridor, this time undermining the hillslope upon which the US Highway 34 roadway sits. Photo courtesy of Bill Spitz.

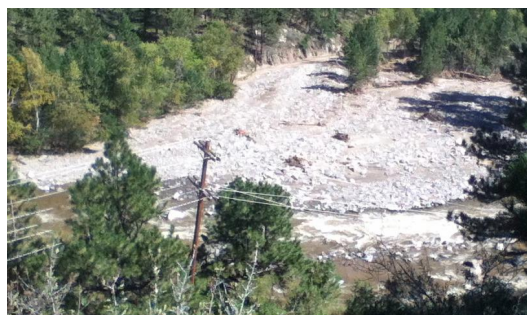
Bottom: Massive sediment deposition in the Cedar Cove reach one week after the flood. Photograph courtesy of Shar and Gary Wamsley.

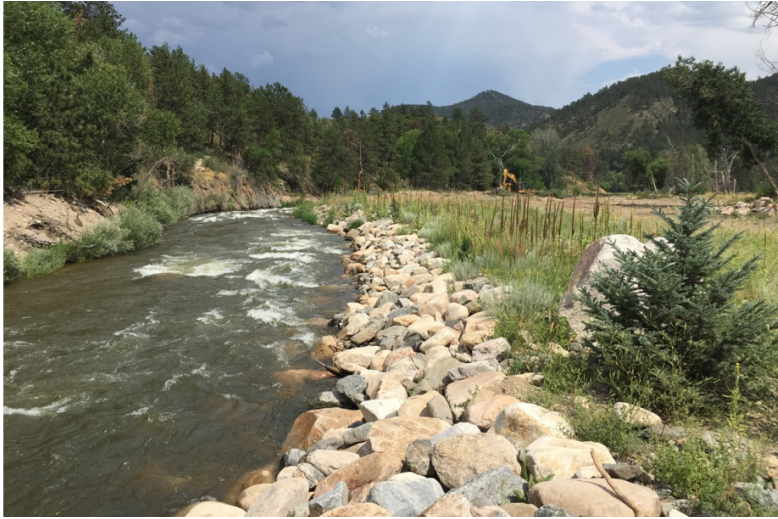
Before

Uniform and homogeneous channel lacking access to the floodplain on either side. Riprap was placed as an emergency measure shortly after the flood.

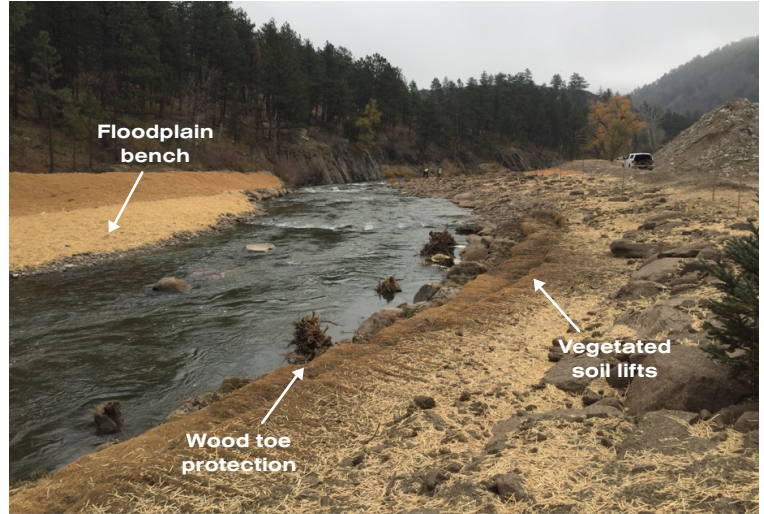
After

The project realigned the channel to create a floodplain bench on the left side of the photo. On the right side, banks were protected using vegetated soil lifts on a wood toe protection structure. The entire project area was seeded and mulched.

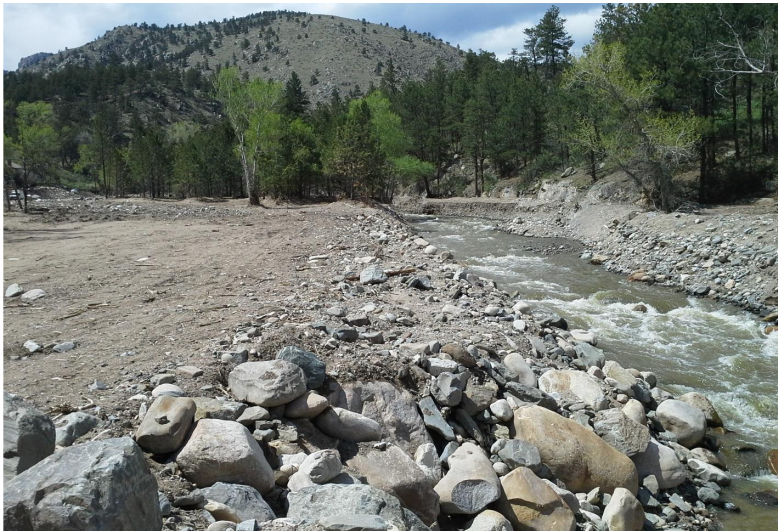
Emergency repairs at Cedar Cove homogenized the channel, lined it with rock, and kept it disconnected from the floodplain.
