NORTH FORK

Big Thompson Watershed

2013 Colorado Flood Recovery

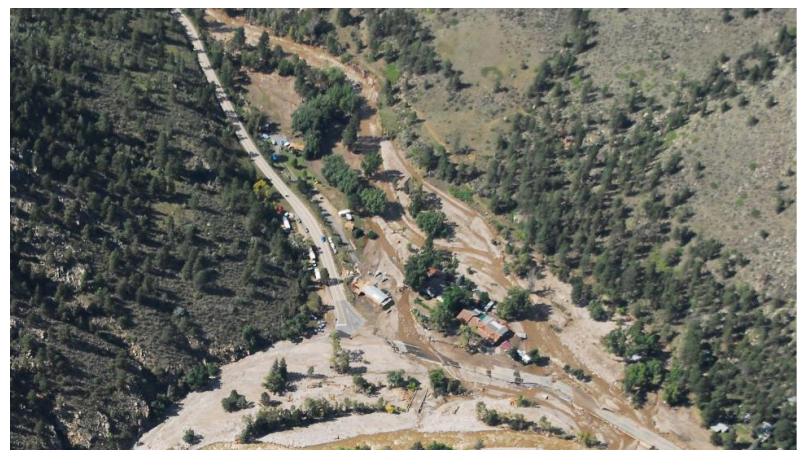
Confluence of the North Fork and Big Thompson River at Drake immediately following the flood.

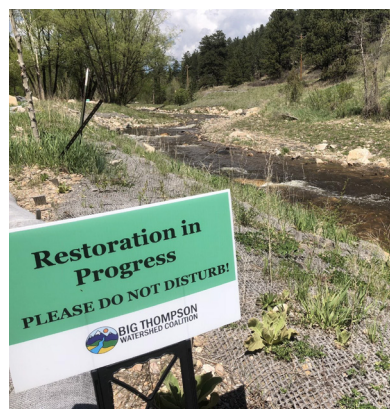
Right: Spring 2018 at the North Fork site as revegetation efforts begin to take root.

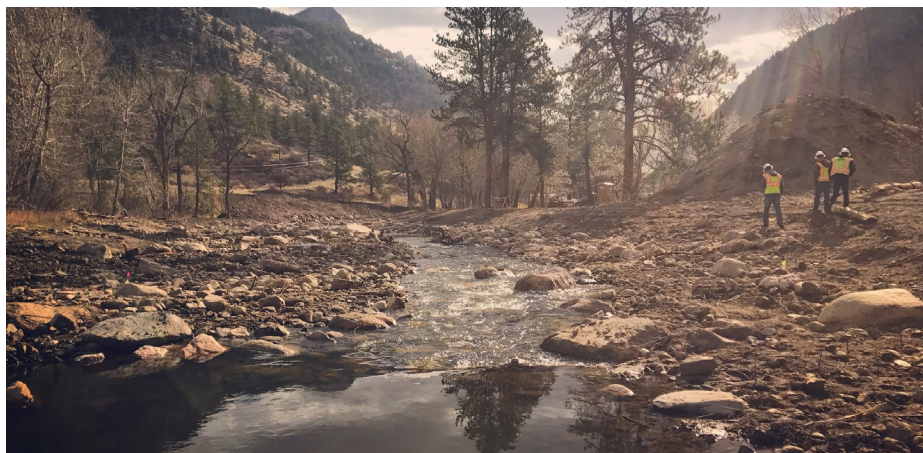
Above: Low-flow pool and riffle features, combined with a roughened floodplain and buried rock structures, work in concert to improve aquatic habitat while providing relative stability to the river channel. Engineered structures were built by incorporating available native material and plants into the features to promote natural ecosystem function.

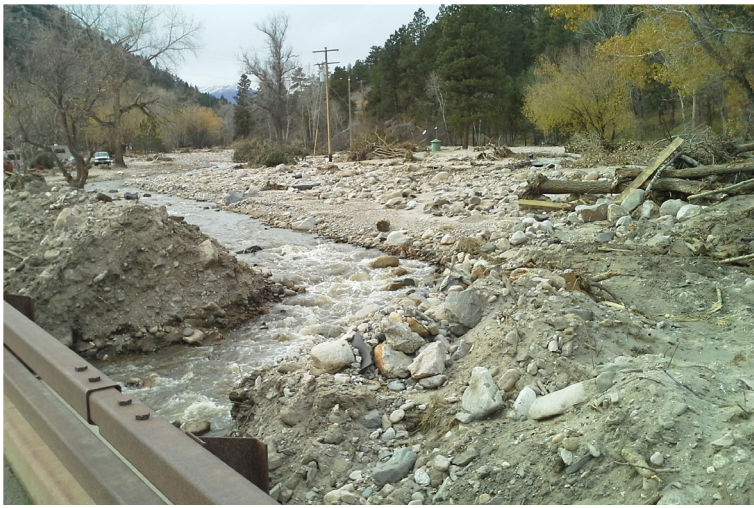
Post-Flood

Looking upstream at the North Fork of the Big Thompson River from the US 34 bridge 2 months after the flood (November 2013). The flood altered the channel alignment from its pre-flood location and deposited massive amounts of sediment and debris. Development in the channel's native corridor led to widespread damages. Photo: Bill Spitz

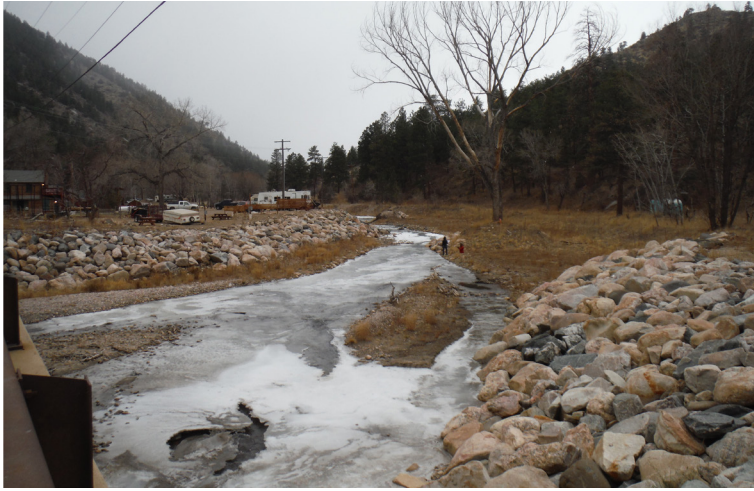
Post-Emergency Work

Looking upstream at the North Fork from the US 34 bridge after emergency work was completed (December 2016). Efforts undertaken in the months following the flood to quickly protect damaged structures from future floods resulted in a channelized ditch with riprap on both sides. The emergency repairs may have provided some emotional comfort but offered very little long-term relief and even less ecological benefit.

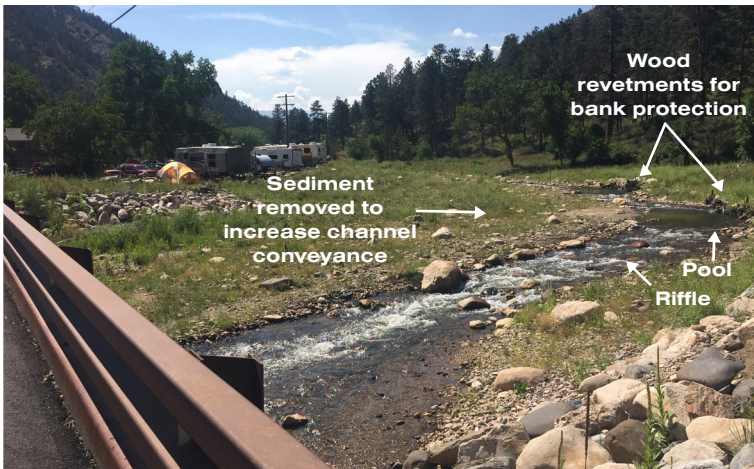
Post-Project

Looking upstream at the North Fork from the US 34 bridge after project construction (July 2018). The project removed sediment and debris to increase the river corridor's size. It also created riffle/pool habitat, planted the site with native vegetation, and realigned the channel for improved floodplain access and a better approach to the bridge. The structures installed are intended to provide bank protection and grade control while allowing for natural shifting of the low-flow channel.

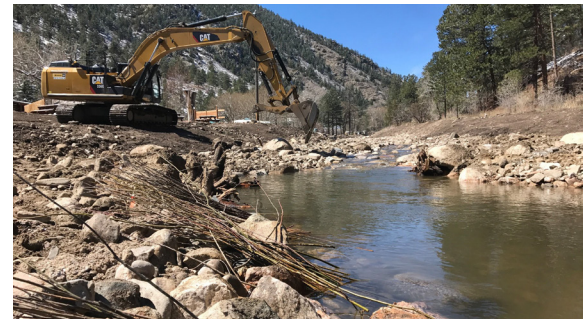
Willow cuttings soaking in preparation for installation during construction of the North Fork project.
