ROCK CREEK PROJECT

Fountain Creek Watershed

2013 Colorado Flood Recovery

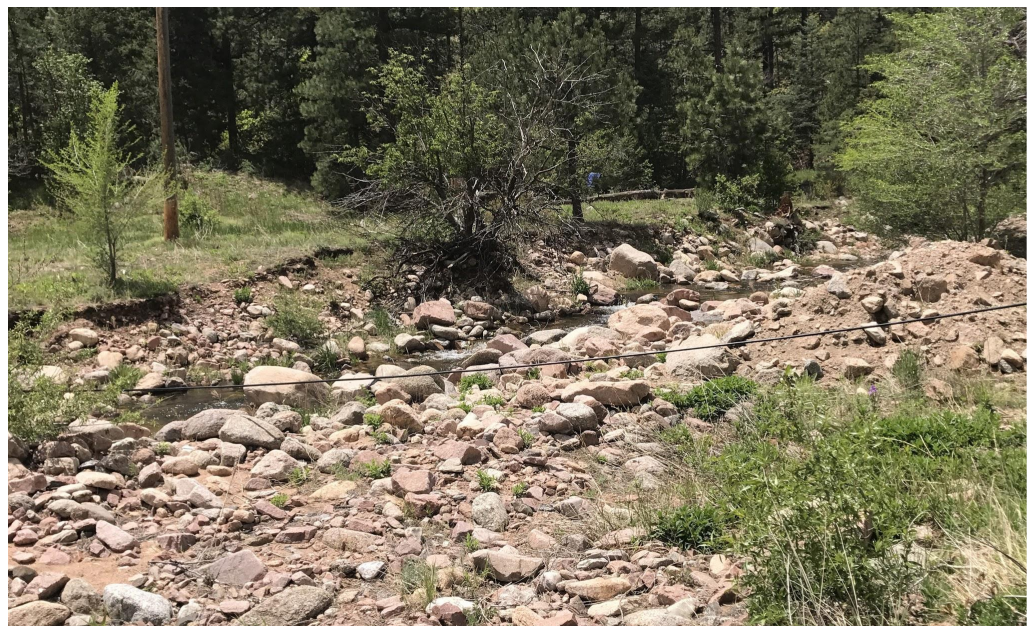
Rock Creek prior to project implementation (2017).

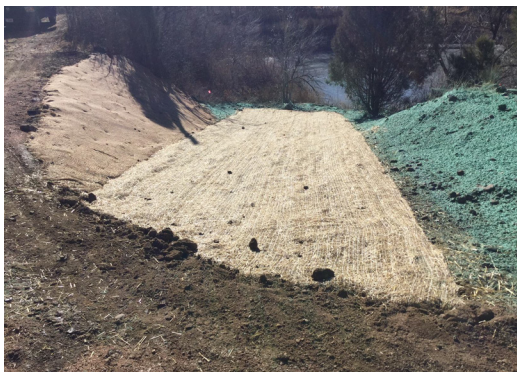
Left: A newly-constructed emergency spillway seeded and stabilized with erosion control fabric and hydromulch.

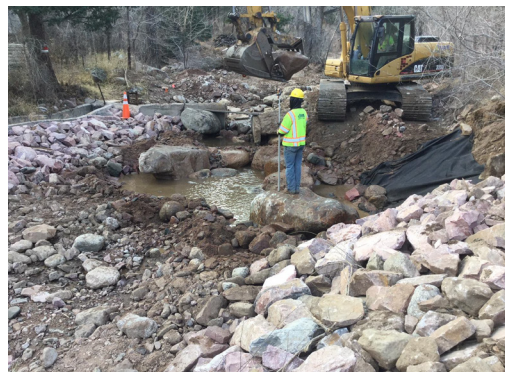
Right: Construction of a boulder cross-vane downstream of a diversion structure.

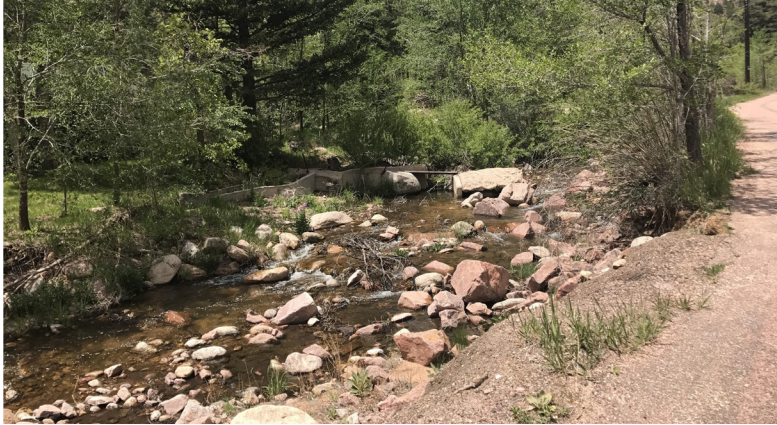
Before

Looking upstream at a diversion structure that was flanked during the flood. Road repairs are temporary.

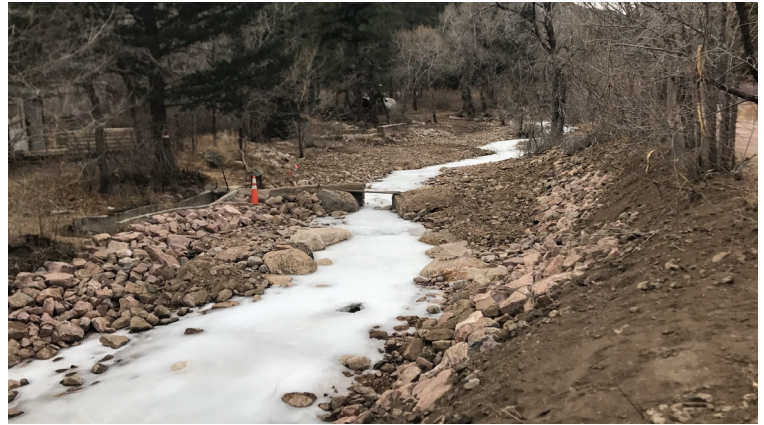
After

Looking upstream a repaired diversion structure and improved channel and floodplain capacity.

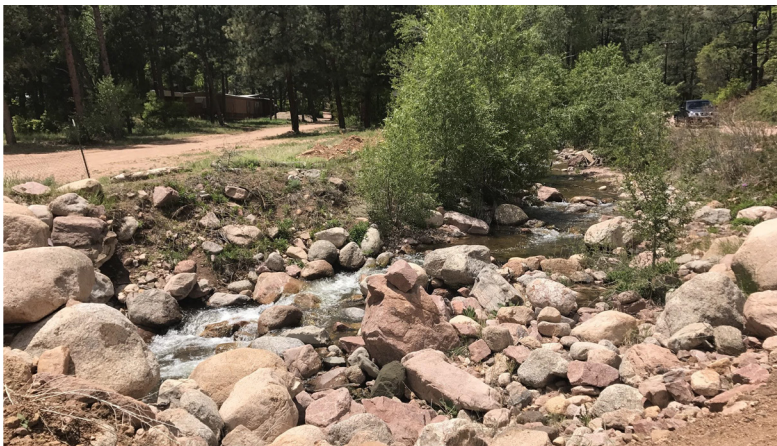
Looking upstream at channel in the vicinity of the May Museum parking lot.

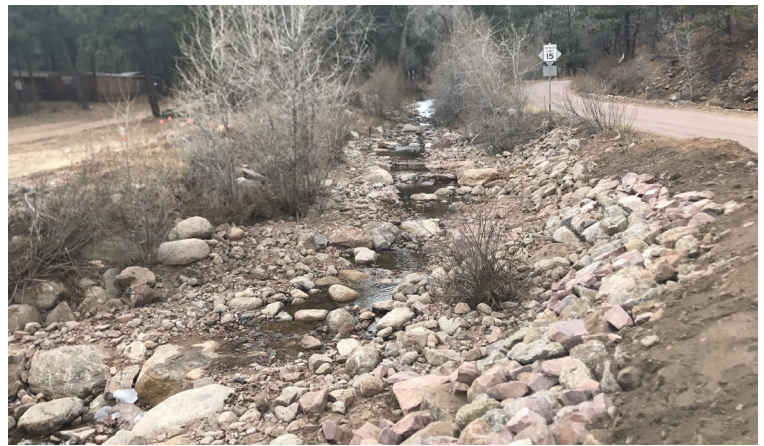
Looking upstream at reconstructed channel in the vicinity of the May Museum parking lot. Note improved channel capacity, grade control structures, and roadway embankment protection.

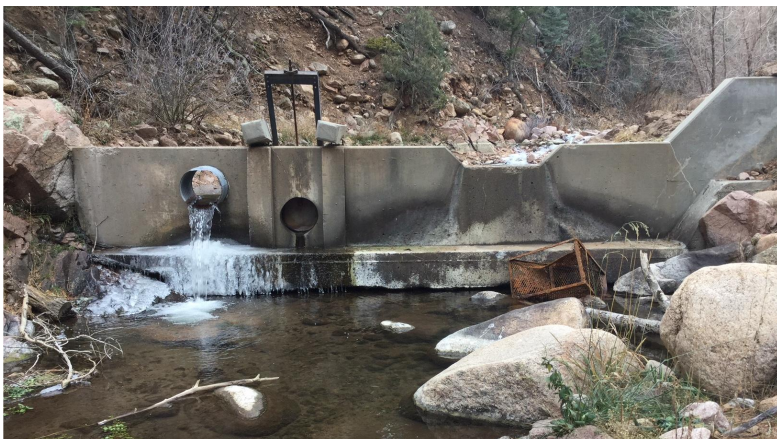
Excessive bed scour on the downstream side of the Gale diversion structure left it vulnerable to washout during the next flood.

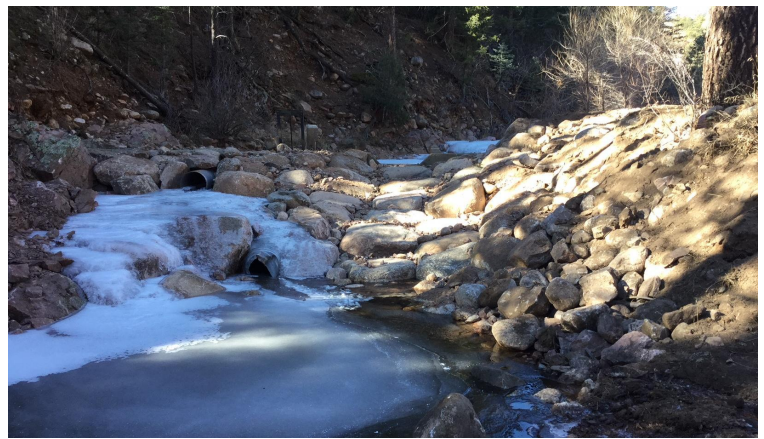
A new rock ramp has improved the long-term stability of the Gale diversion structure and provided the opportunity for improved aquatic organism passage.

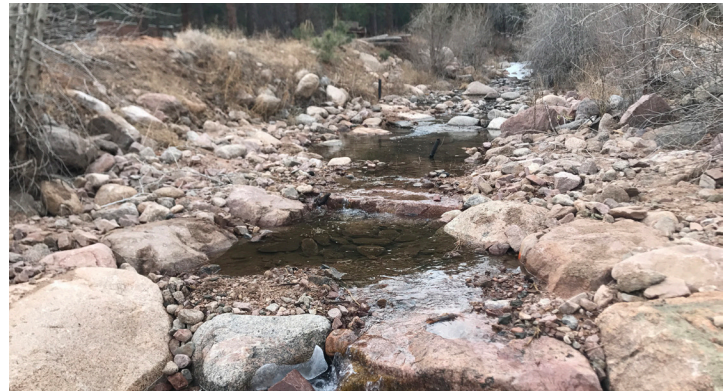
Energy-dissipating steps that incorporate native boulders give the project a natural "feel" while providing scour protection for nearby infrastructure.
