# BIG THOMPSON RIVER RESTORATION MASTER PLAN

May 2015

**AYRES**  
ASSOCIATES

Ayres Project No. 32-1791.02  
BIG-THOMPSON-M-PLAN-5-11-15.DOC

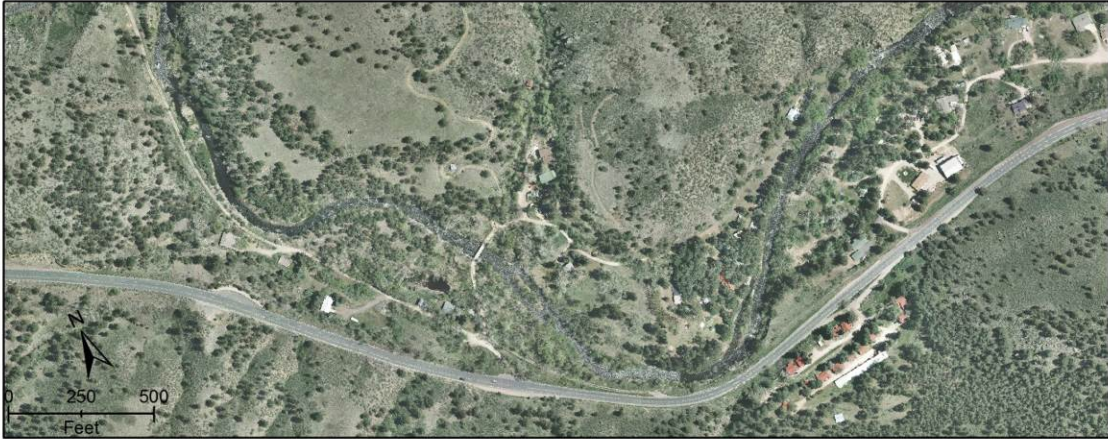
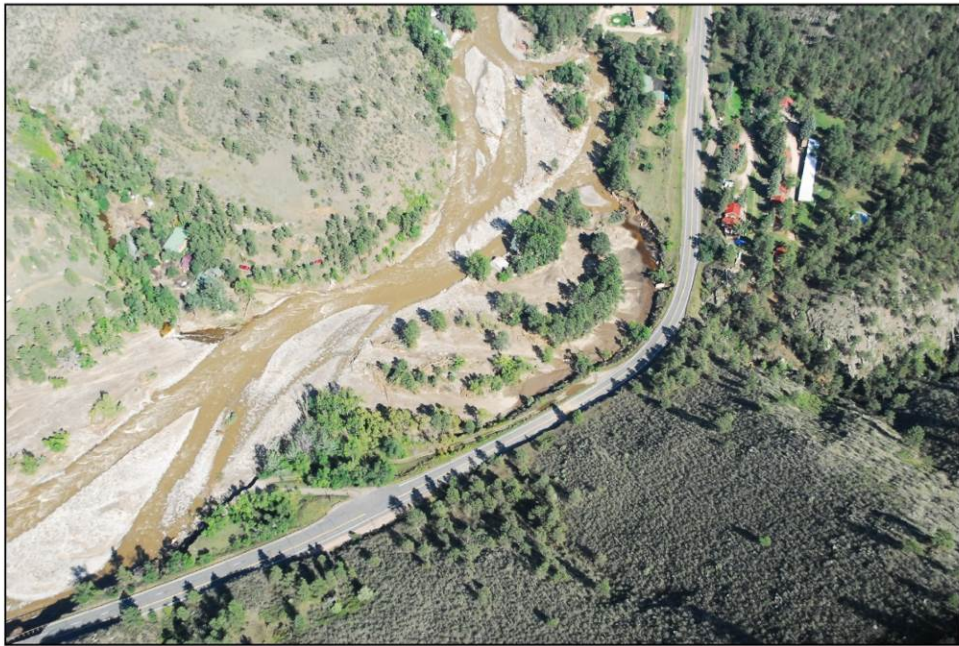
Figure 3.2. Example GR = 5 at Cedar Cove.

Example areas showing pre- and post-flood imagery of GR scores of 5, 3, and 1 are provided in **Figures 3.2, 3.3, and 3.4**, respectively. The example images for areas with a GR score of 5 include areas of deposition, channel migration, new split flow development, severely eroded embankments, and removal and transport of a large amount of sediment. The example images for areas with a GR score of 3 include areas of channel widening, moderate floodplain deposition, bank erosion, channel widening, headcuts developing in floodplain, and local areas of erosion. The example images for areas with a GR score of 1 show minor bank erosion along the channel and no channel movement.

Pre-Flood Image - 05-2013

Post-Flood Image - 10-2013

Civil Air Patrol (CAP) Photo - 9-22-2013

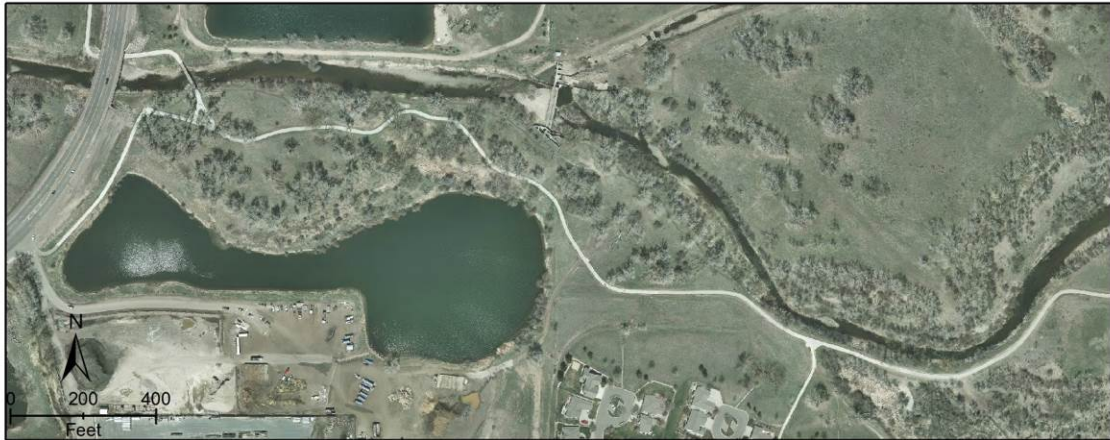
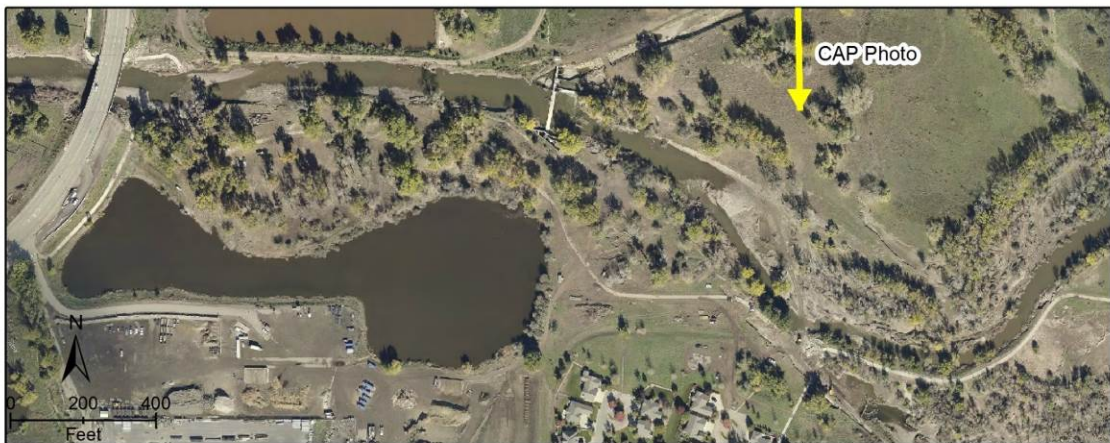
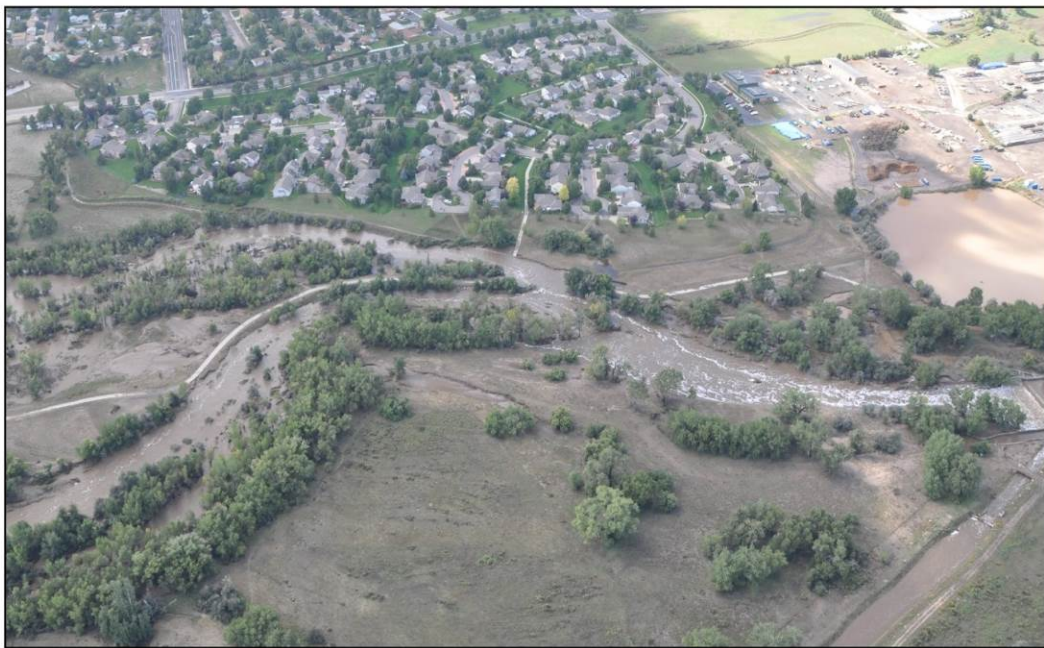
Figure 3.3. Example channel and floodplain GR = 3 downstream of Wilson Avenue in Loveland.

Pre-Flood Image - 05-2013

Post-Flood Image - 10-2013

Civil Air Patrol (CAP) Photo - 9-16-2013

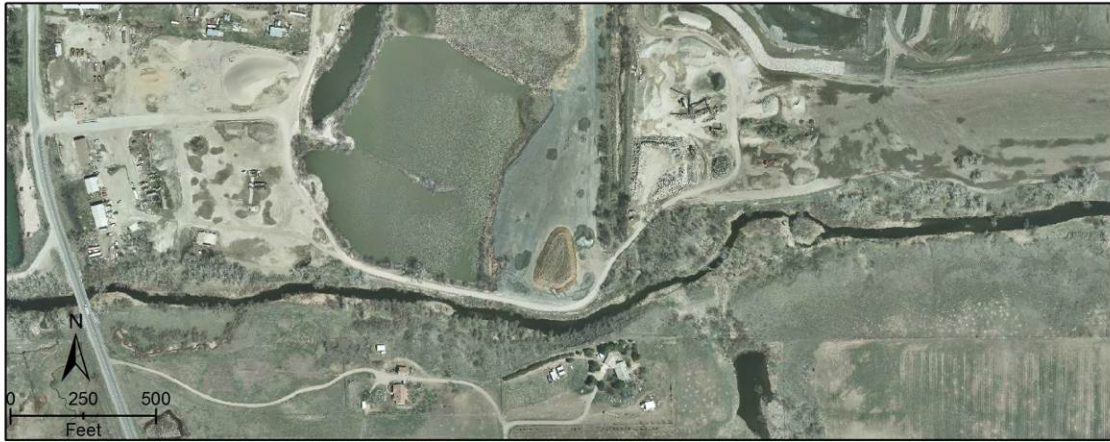
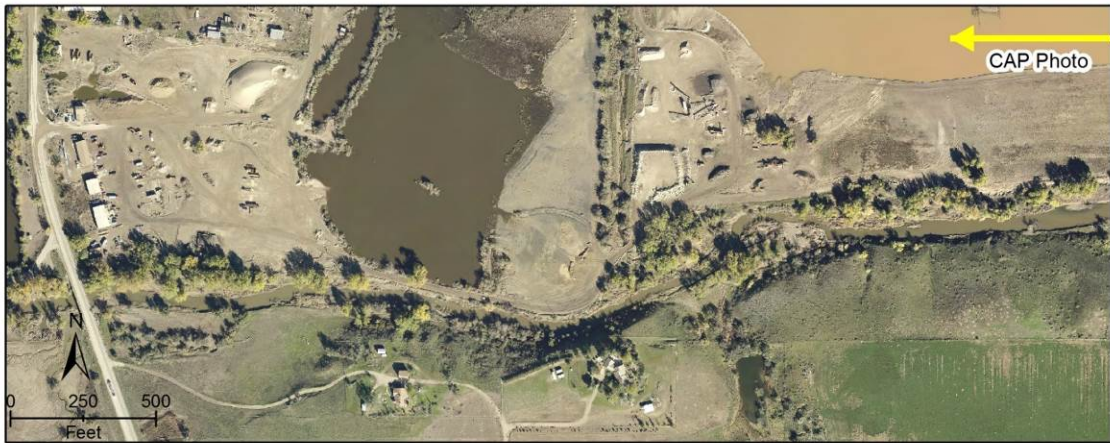
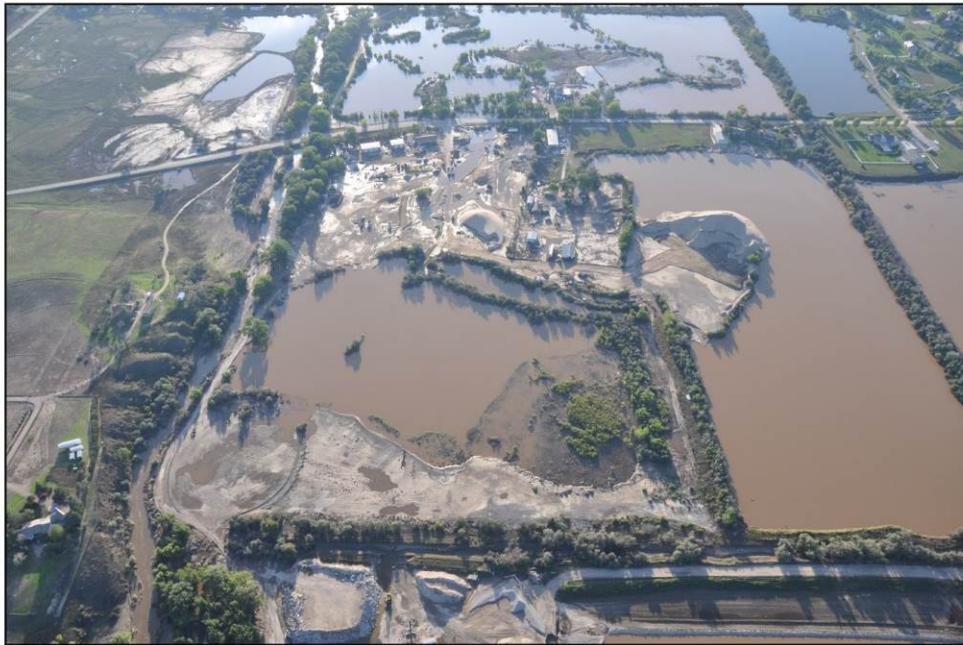
Figure 3.4. Example channel GR = 1 and floodplain GR = 3 downstream of County Road 9E in Loveland.

Pre-Flood Image - 05-2013

Post-Flood Image - 10-2013

Civil Air Patrol (CAP) Photo - 9-19-2013

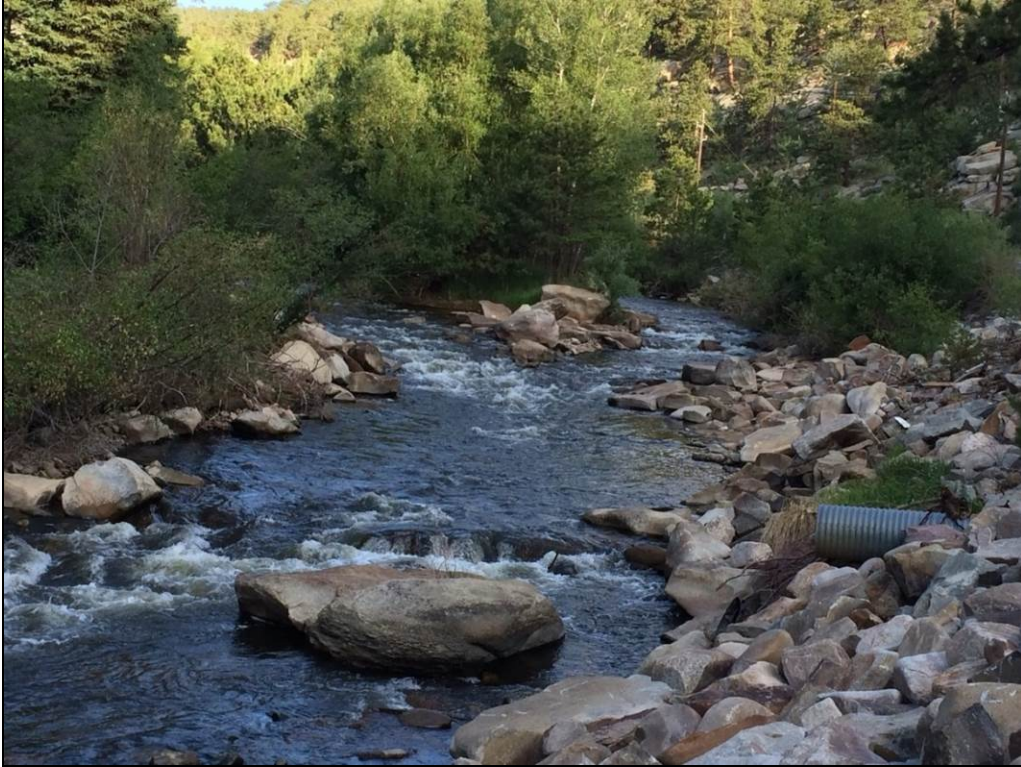
Figure 3.7. Big Thompson downstream of Olympus Dam, AHIP = 0.

**Upper Canyon.** The Big Thompson River from Olympus Dam downstream to the confluence with the North Fork had the most intact and relatively good post-flood aquatic habitat (**Figure 3.7**). The banks are generally vegetated and stable and have suitable in-channel habitat typical of a high gradient mountain river. Aquatic habitat in these sections includes cascades, high gradient riffles and plunge pools. The pools provide refuge habitat during low flows.

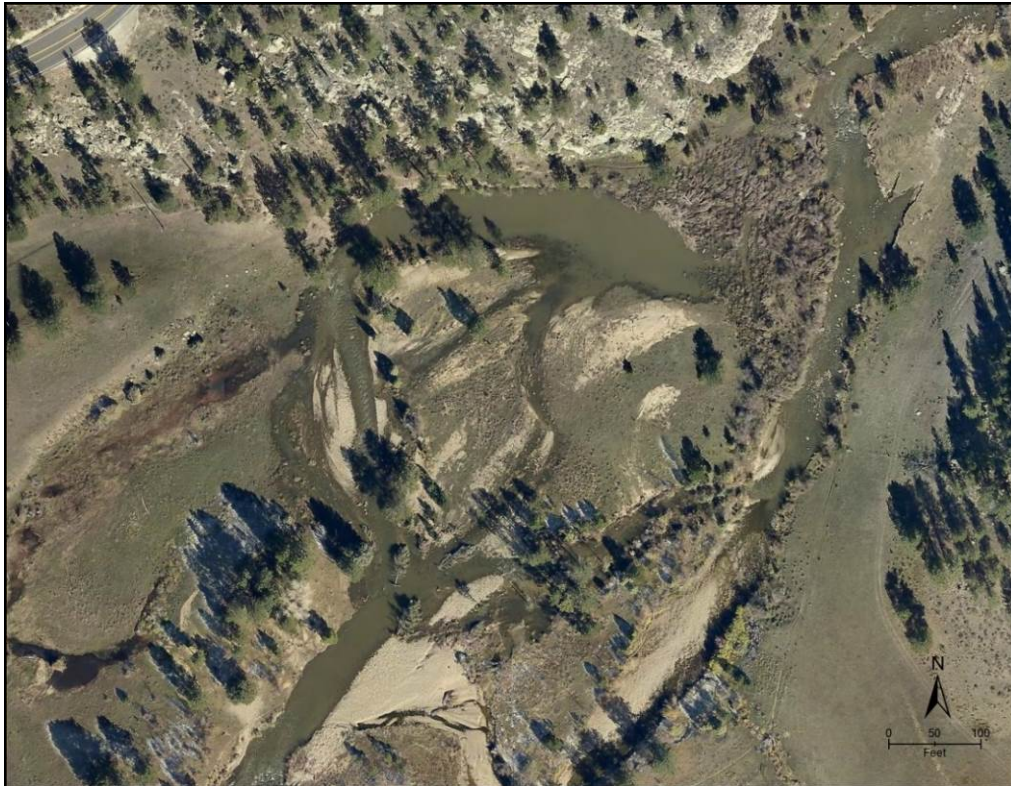
Figure 3.8. Big Thompson downstream of Olympus Dam, split flow, AHIP = 3.

There are several sites between the dam and the North Fork confluence with lower gradient where the channel is braided post-flood, which resulted in extremely shallow, wide habitats that may be passaged impediments or result in dry channels during low flow conditions. These areas would benefit from some restoration work (**Figure 3.8**). These sections received an AHIP score of 3. These areas would benefit by restoring the channel to a single thread with appropriate habitat diversity of riffle-pool sequence while maintaining connection to the floodplain to improve habitat during summer and winter flow conditions.

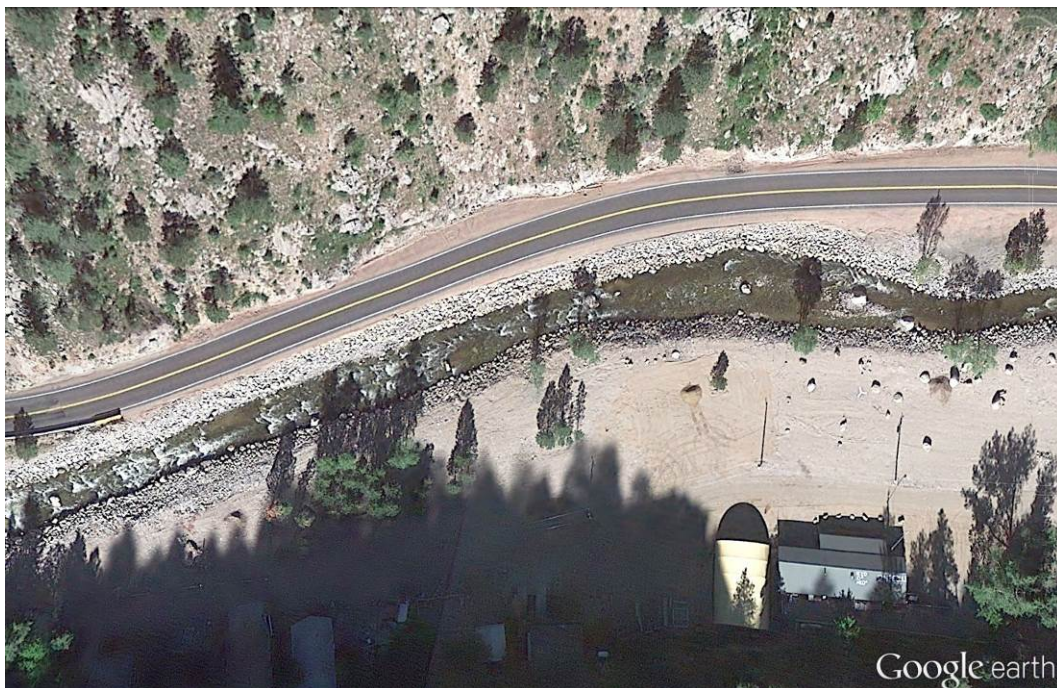
Figure 3.10. Example of post flood channel modification and bank stabilization, but with good in-channel features. (Drake).

The temporary road and channel work conducted by the CDOT and others has modified the post-flood channel conditions in some areas. Most of these sections have large boulder riprap placed along the channel banks to prevent channel movement and erosion. While the channel banks and overbank areas need restoration, the in-channel features in most of these areas do provide habitat typical of this high gradient river (**Figure 3.10**). The channel contains large boulders that create drops and pools similar to the habitat in the undisturbed areas. There is a lack of riparian vegetation in these areas which has a negative impact on the aquatic habitat.

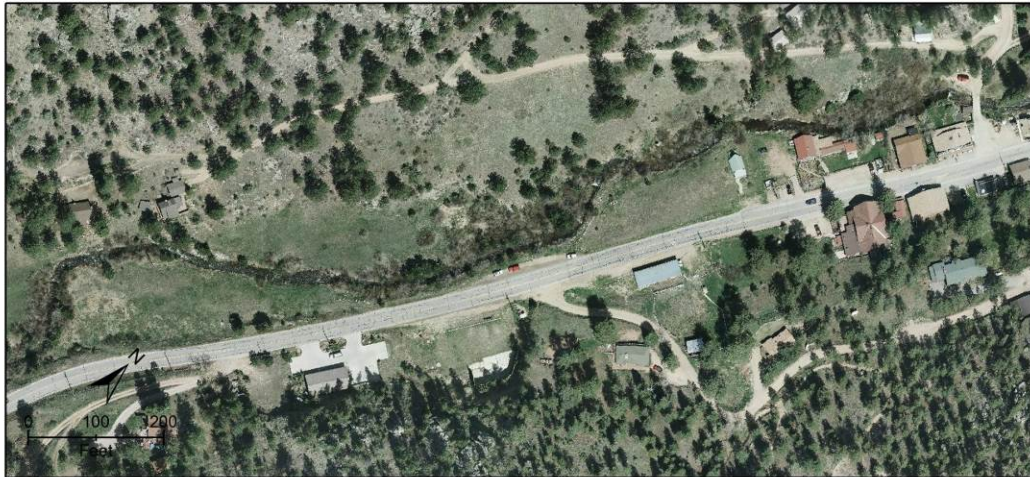
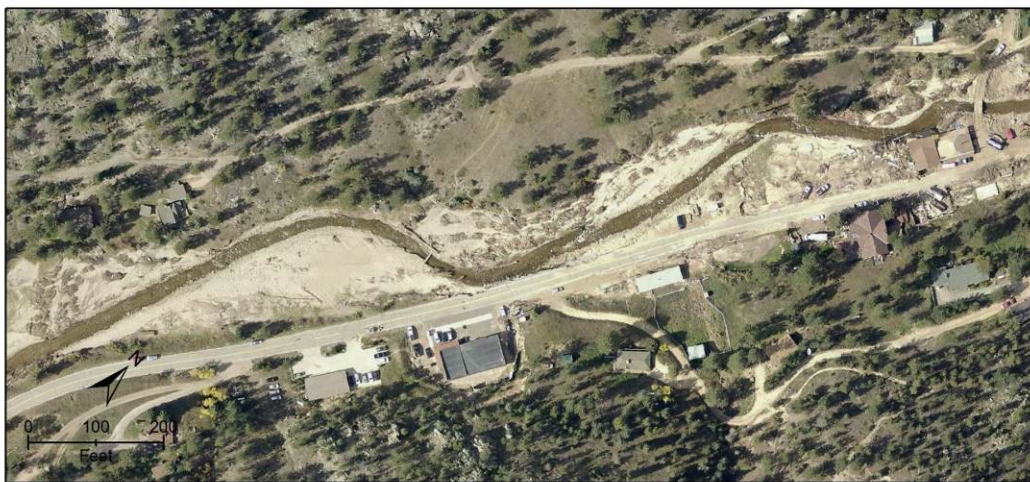
Figure 3.11. Section of West Creek that experienced degradation and aggradation, AHIP = 5.

**North Fork.** Upper reaches of the North Fork of Big Thompson River and tributaries show only minor localized areas where aquatic restoration is recommended. The most severe flood damage related to aquatic habitat is on West Creek and the main stem of the North Fork near Glen Haven (**Figure 3.11**). In contrast, middle and lower sections of North Fork, did sustain damage to aquatic habitat and fisheries; therefore, much of this reach and the main stem of the North Fork down to the confluence with Big Thompson received a score of 3 or 5.

Pre-Flood Image - 05-2013

Post-Flood Image - 10-2013

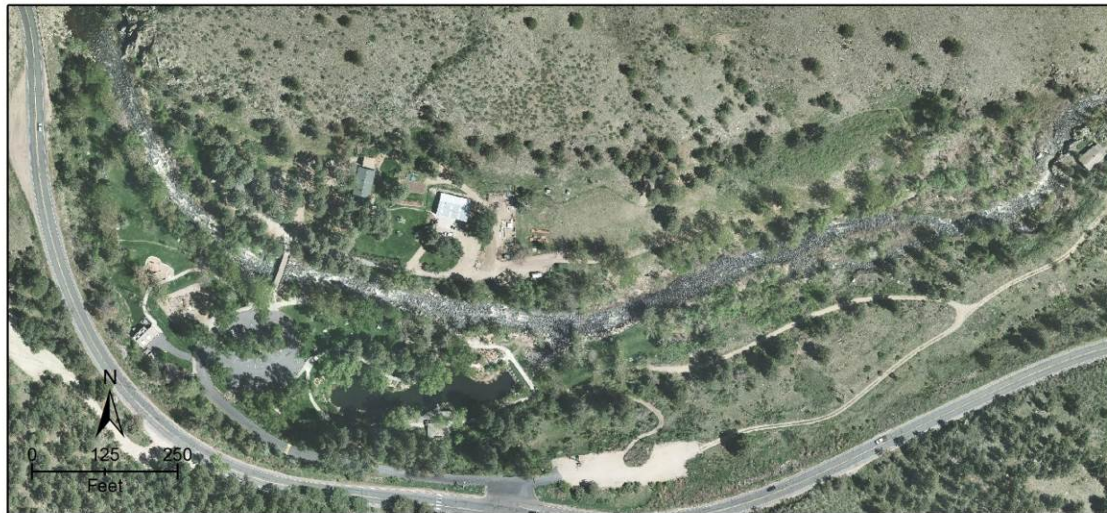
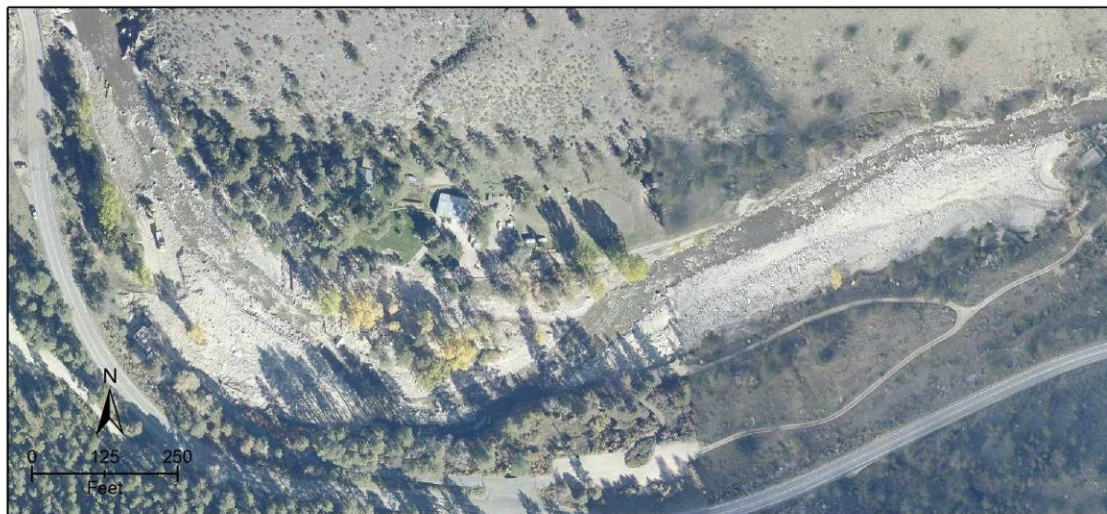
Figure 3.12. Example of sediment movement and channel change.

**Lower Canyon.** The lower canyon had the most severe flood damage of all segments evaluated. The increased flow in this section resulted in large areas of the channel with sediment degradation and/or aggradation. There are many areas that received an AHIP score of 3 and several with a score of 5. An example of the sediment movement and channel change is shown in **Figure 3.12**. This example at Viestenz-Smith Mountain Park was formerly vegetated with large trees, willows, and grasses. This segment is typical of the areas with an AHIP score of 3. The in-channel habitat is moderate to low with some features such as large boulders and high gradient riffles that provide some habitat. There are many areas similar to this location in the lower canyon.

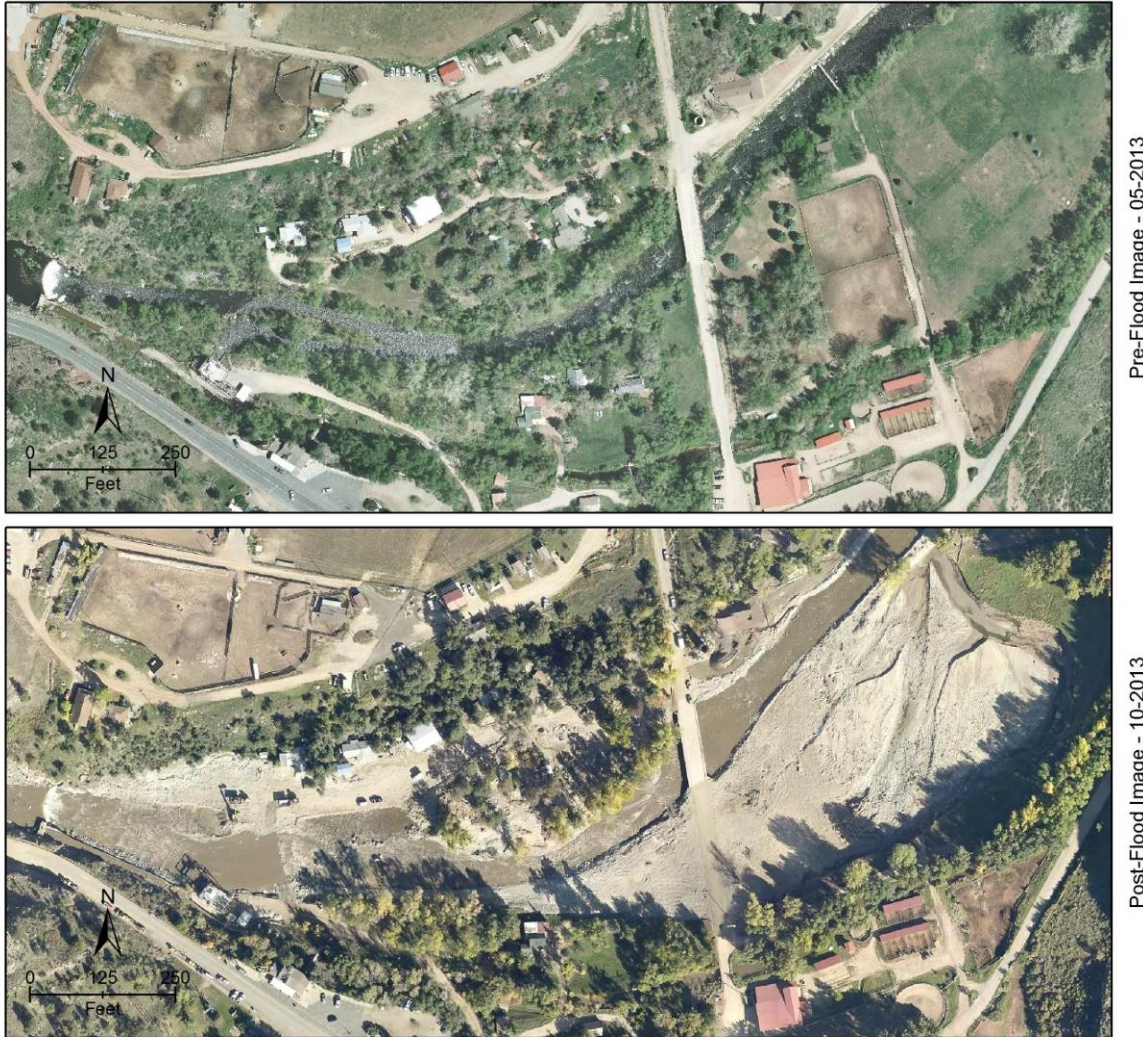
Figure 3.13. Areas east of the canyon mouth that experience degradation and aggradation, AHIP = 5.

The river channel from the mouth of the canyon downstream to Glade Road was also highly modified by the flood. Areas experienced both severe degradation and aggradation (**Figure 3.13**). Most of the upper portion of this reach received an AHIP score of 5. At the time of the field evaluation, some restoration activities were underway. The majority of the stream channel in the upper portion of this reach is riffle habitat with very little run or pool habitat. The downstream section of this reach is an unconstrained floodplain area where the flood flows occupied the overbank areas and deposited fine sediment.

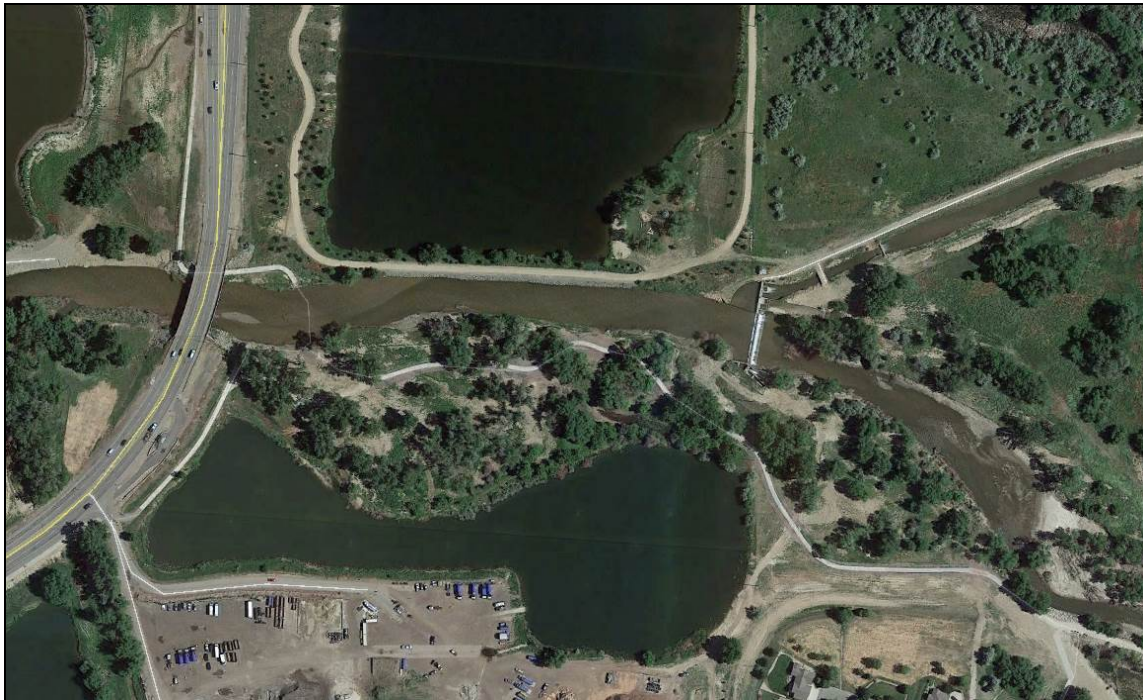
Figure 3.14. Example of post-flood stream channel at downstream of Wilson Avenue, AHIP = 1 - 3.

**Loveland.** The AHIP assessment relied on aerial imagery for the assessments downstream of Glade Road through Loveland. The reach from Glade Road downstream to I-25 has some need for restoration although it is less than the needs upstream of Glade Road. There are sections with some damage to in-channel habitat but they are smaller, localized sections. The channel is confined through much of this segment, and lacks access to the floodplain for low flood flows. The channel is also over widened at some locations due to flooding and/or post flood repairs (**Figure 3.14**).

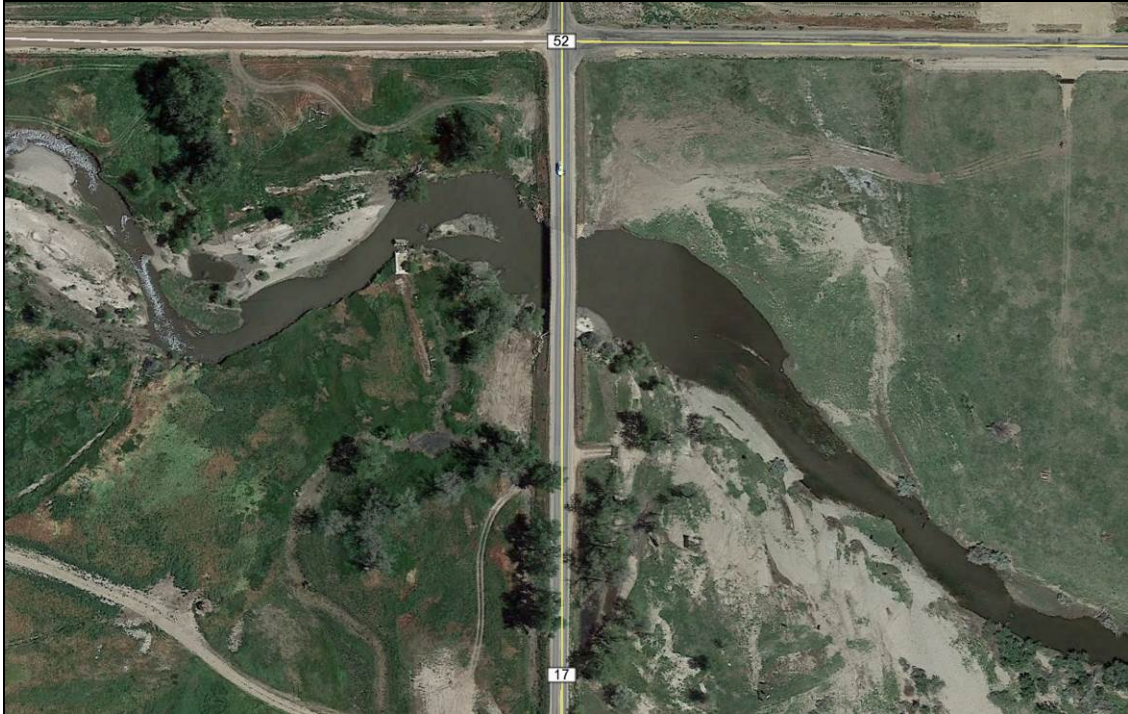
Figure 3.15. Example of post-flood stream channel at Weld County Rd 17, AHIP = 3.

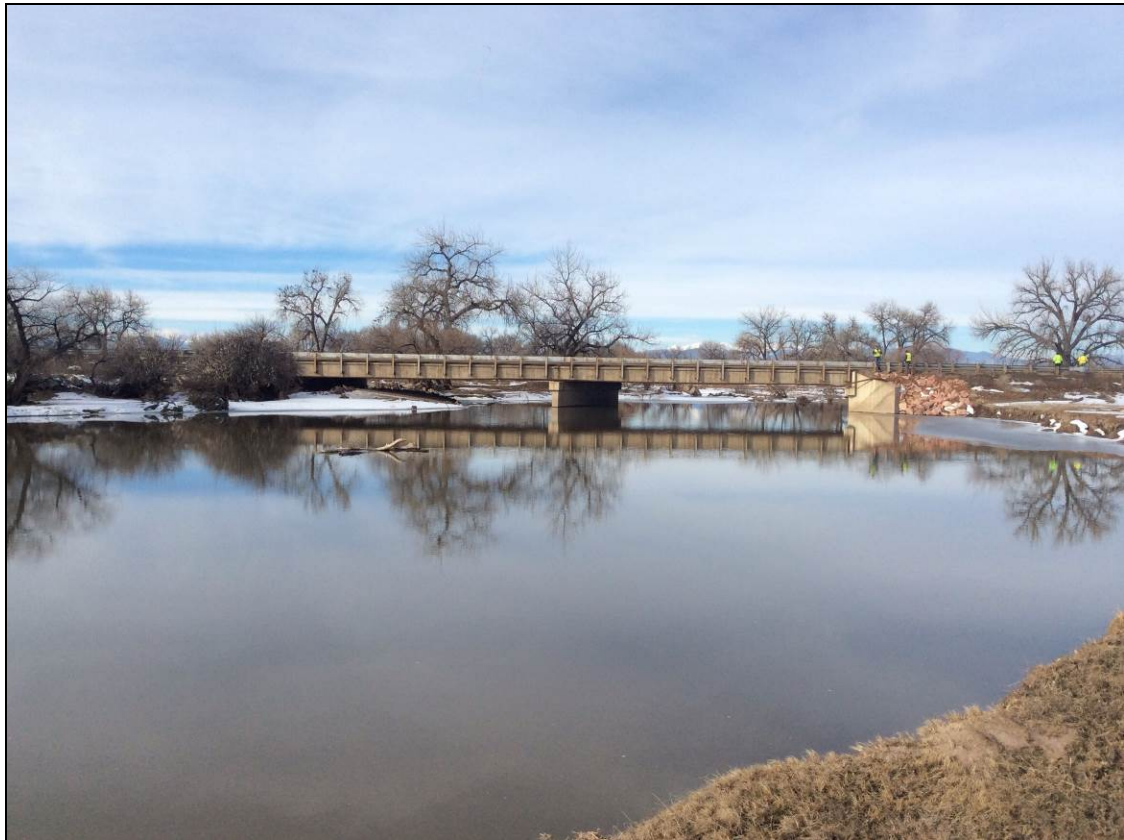
Figure 3.16. Example of post-flood stream channel at Weld County Rd 17, AHIP = 3.

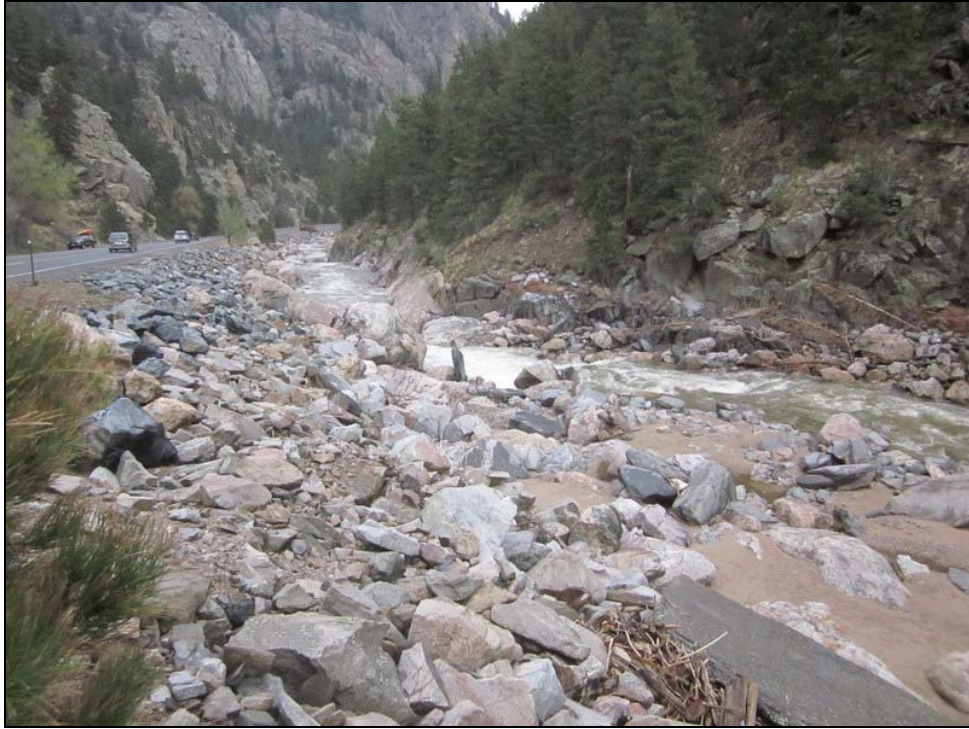
Figure 3.17. Upper Canyon, narrow rocky section with little to no floodplain, REIP = 1.

Field surveys were conducted for the western four segments of the BTRRMP corridor on May 5, 8, and 9, 2014 and the eastern two segments during January 2014. Most field surveys were performed in areas accessible by roads; various areas were walked to collect additional data on plant species present and severity of flood damage. Each assessment reach was given a score of 1 to 5, with 1 having low potential for restoration and 5 having high potential. Rating of river reaches for riparian vegetation restoration potential is based on many factors. **Table 3.5** summarizes these factors in the list of characteristics. Representative photographs for each rating are shown in **Figures 3.15 – 3.29**.

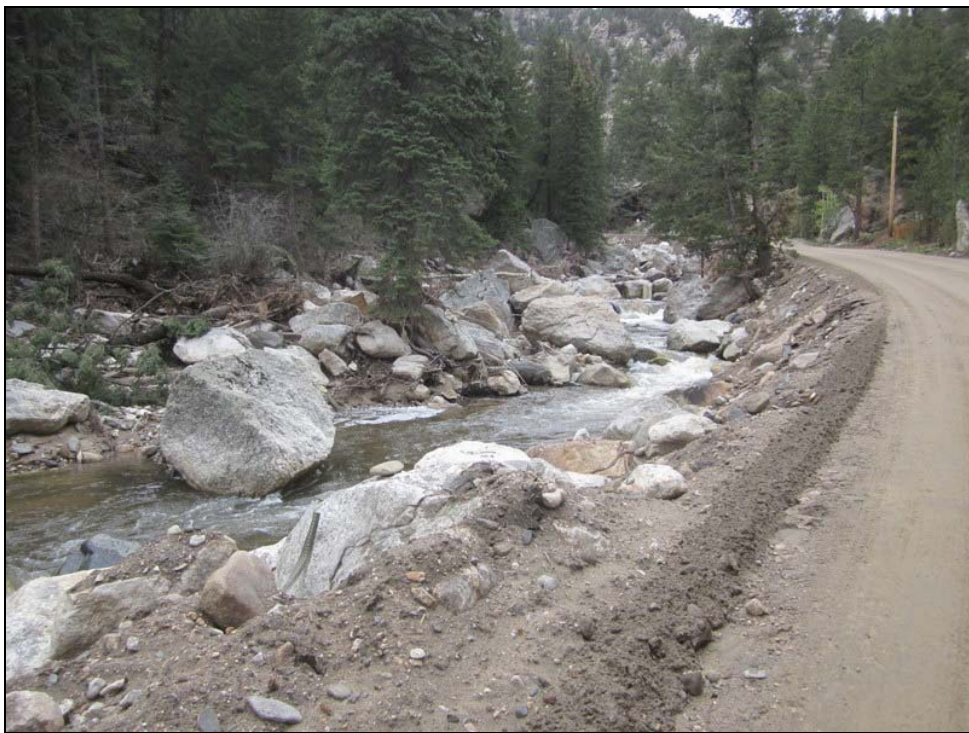
Figure 3.18. North Fork, narrow rocky section with little to no floodplain, REIP = 1.

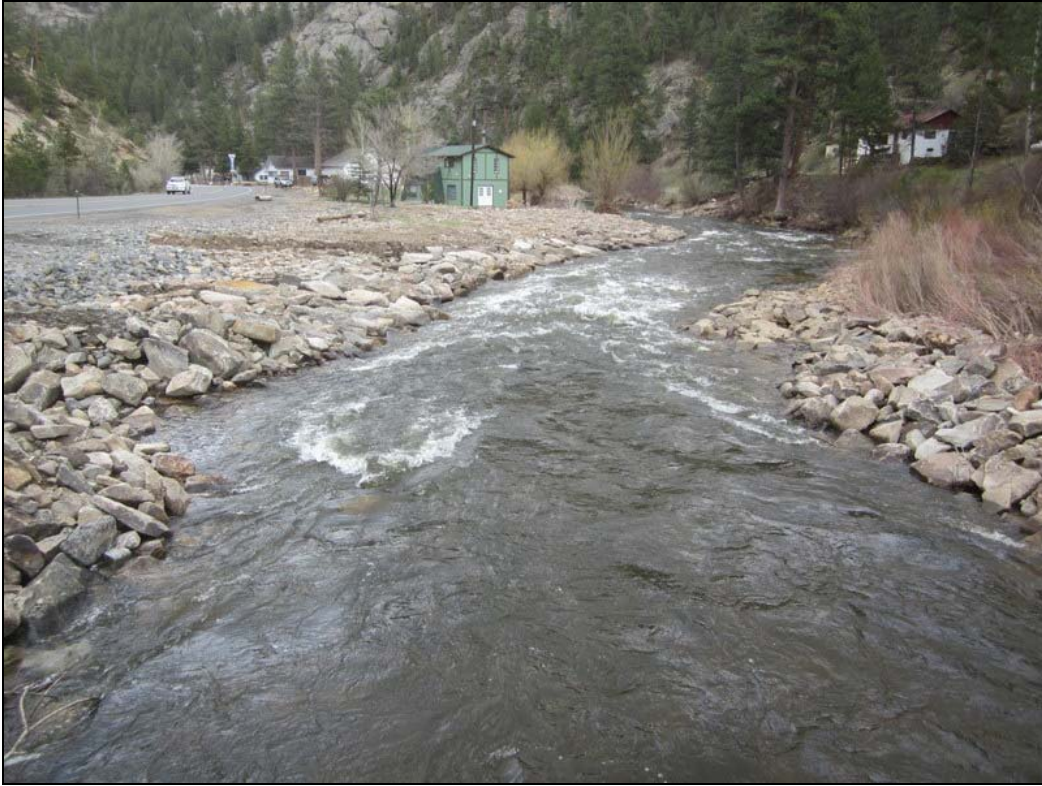
Figure 3.19. Upper Canyon, narrow floodplain area including road and structures, REIP = 2.

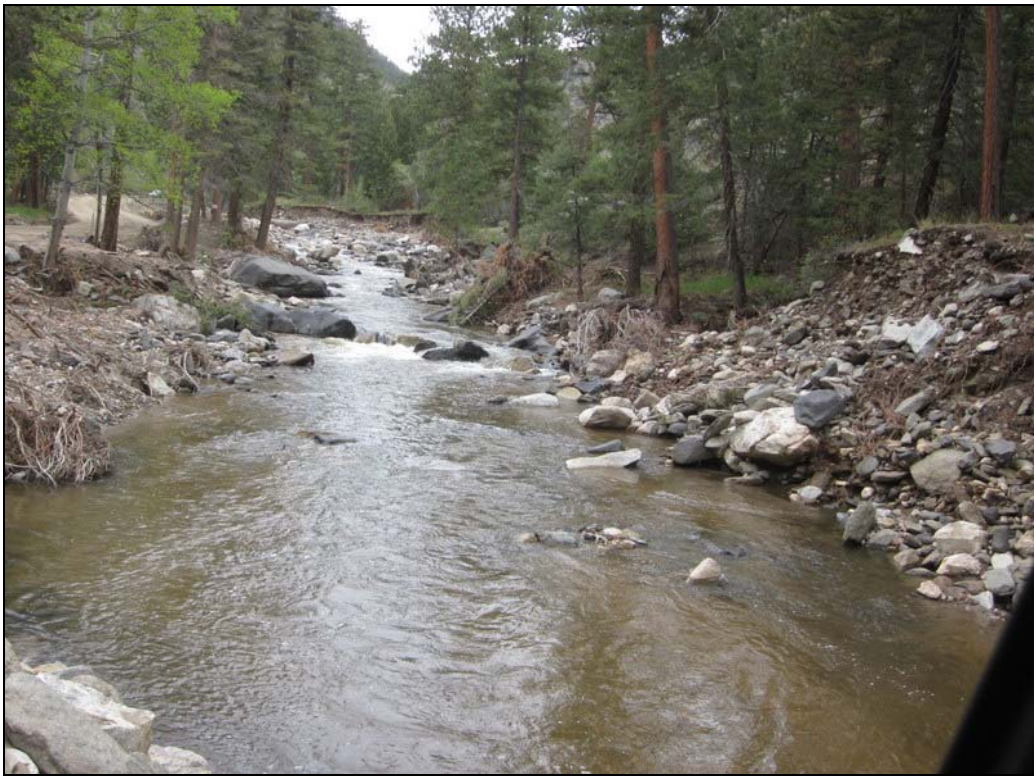
Figure 3.20. North Fork, narrow floodplain area, REIP = 2.

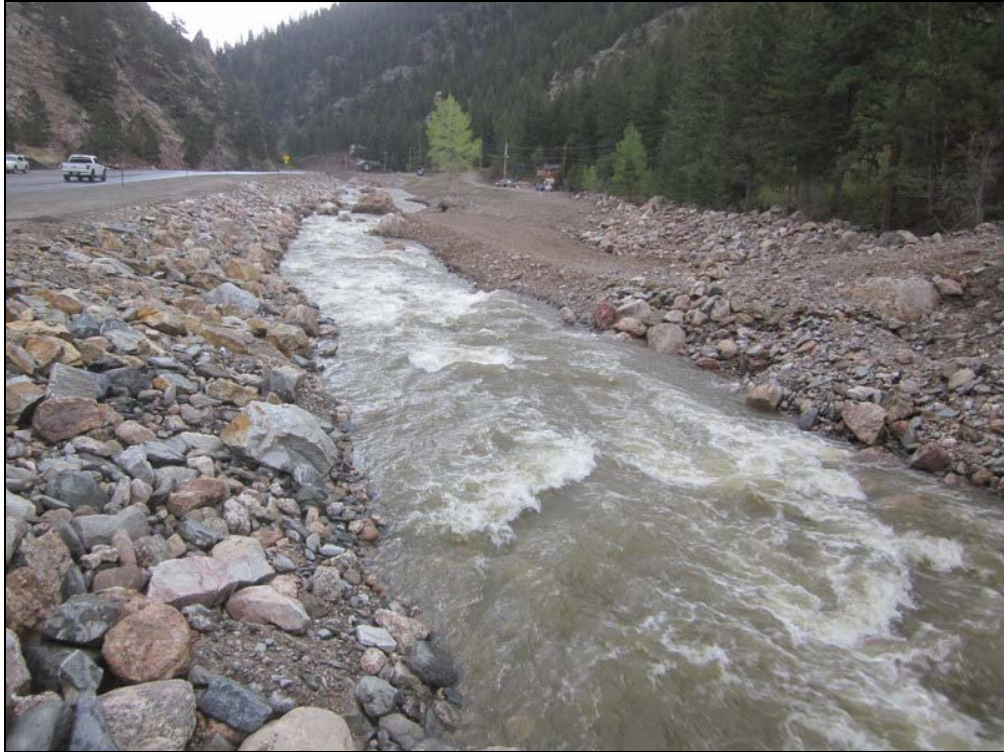
Figure 3.21. Upper Canyon (Waltonia), some undeveloped floodplain with little vegetation, REIP = 3.

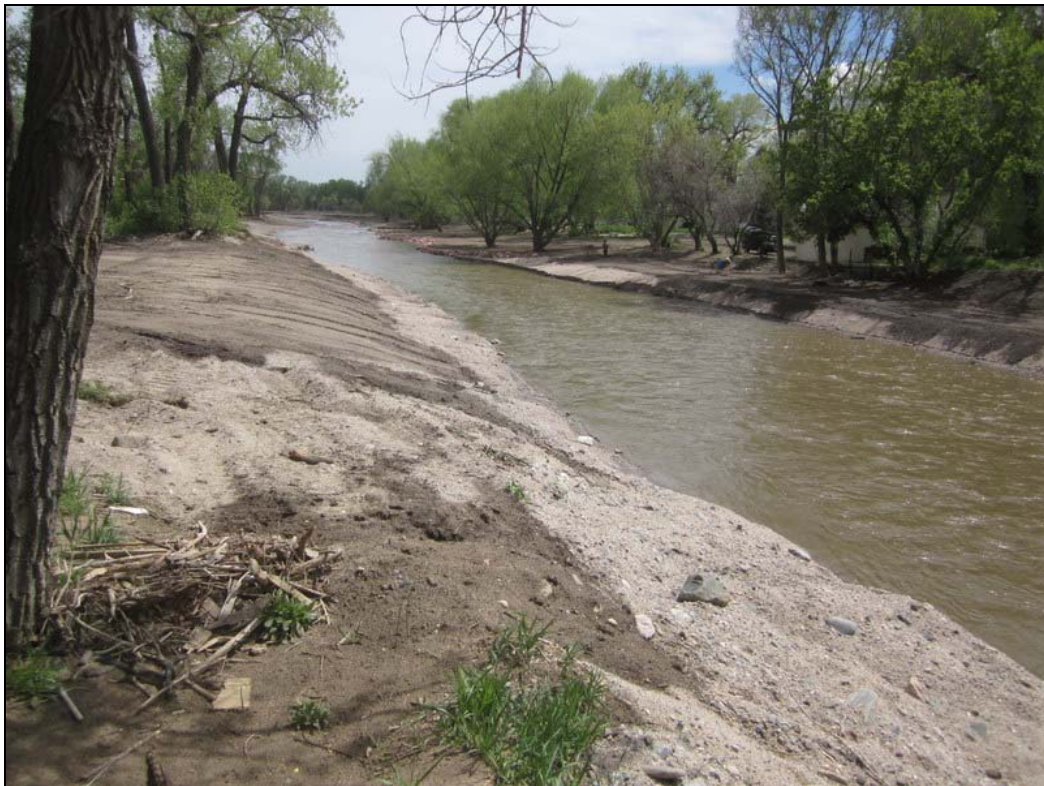
Figure 3.22. Loveland area, some undeveloped floodplain with little vegetation, REIP = 3.

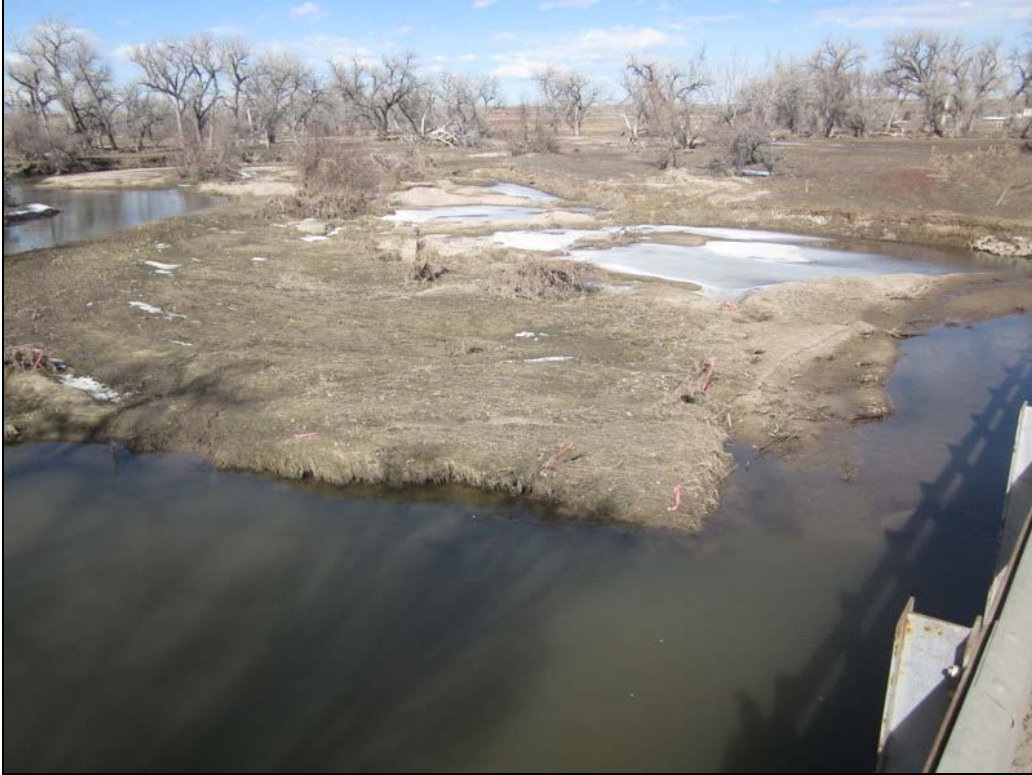
Figure 3.23. Eastern Plains, upstream of CR 27.5, REIP = 3.

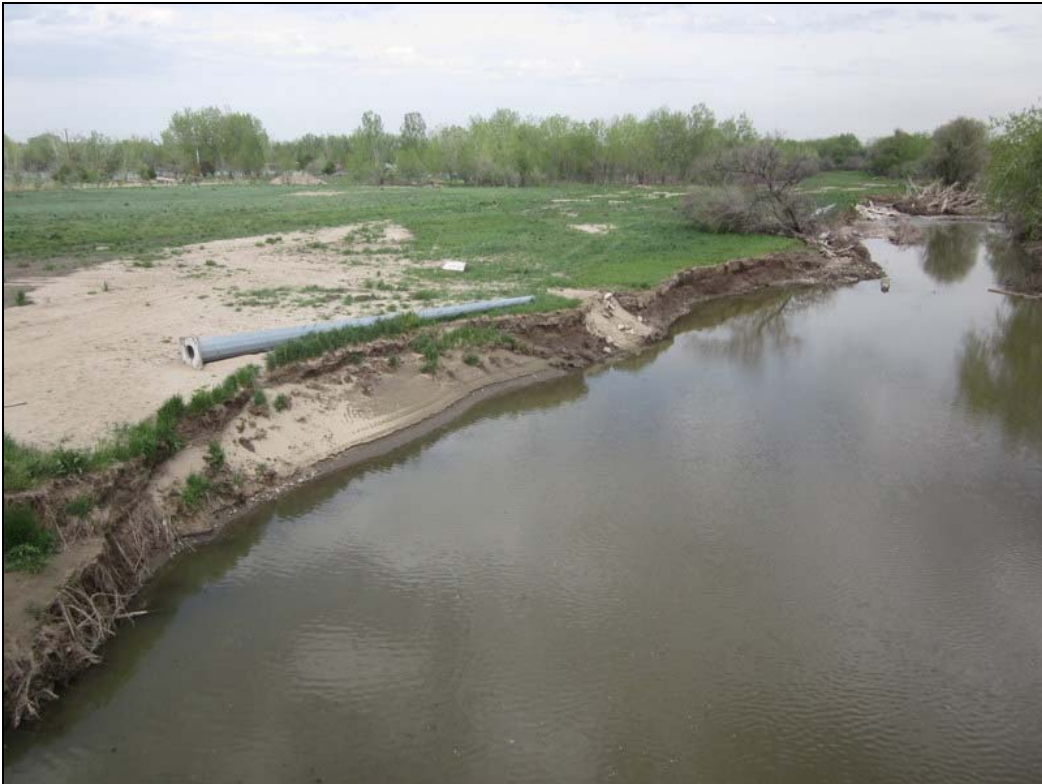
Figure 3.24. Loveland area, wide undeveloped floodplain, REIP = 4.

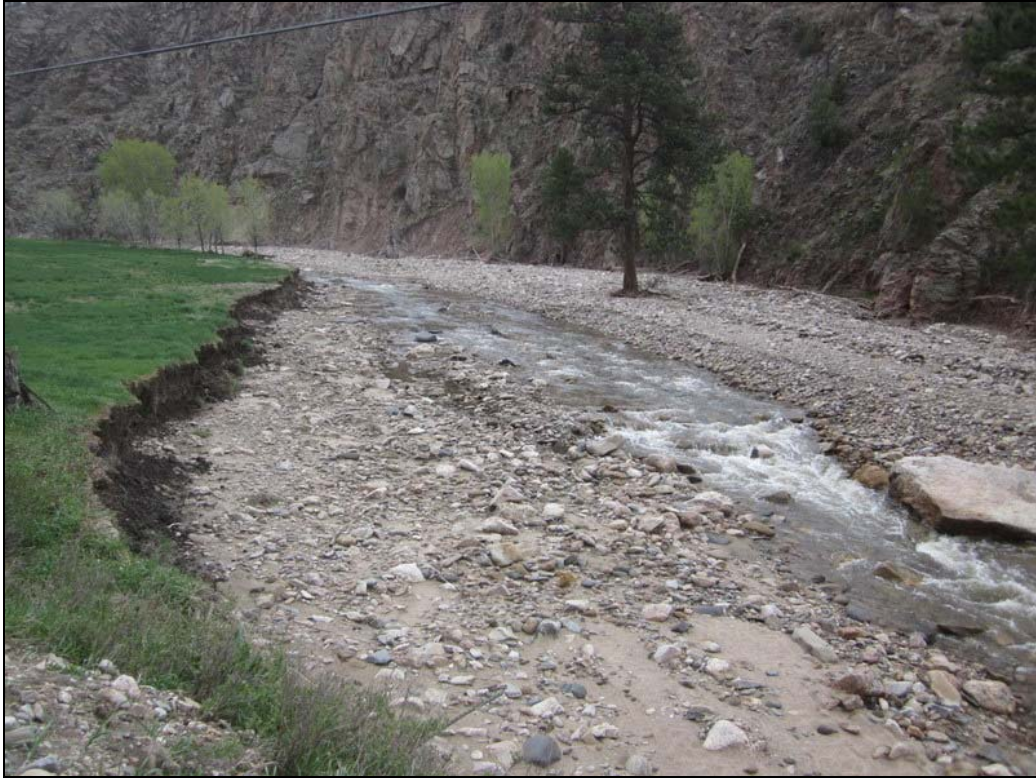
Figure 3.25. North Fork, wide undeveloped floodplain, REIP = 4.

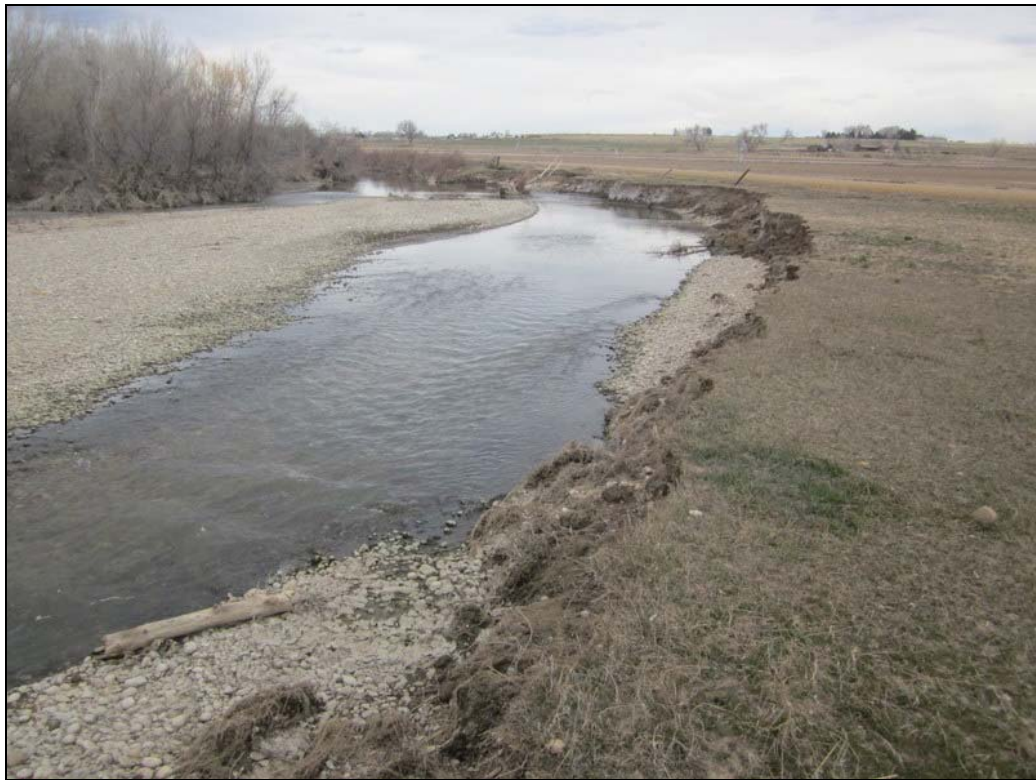
Figure 3.26. Eastern Plains, near CR 52, REIP = 4.
