# BIG THOMPSON RIVER RESTORATION MASTER PLAN

May 2015

**AYRES**  
ASSOCIATES

Ayres Project No. 32-1791.02  
BIG-THOMPSON-M-PLAN-5-11-15.DOC

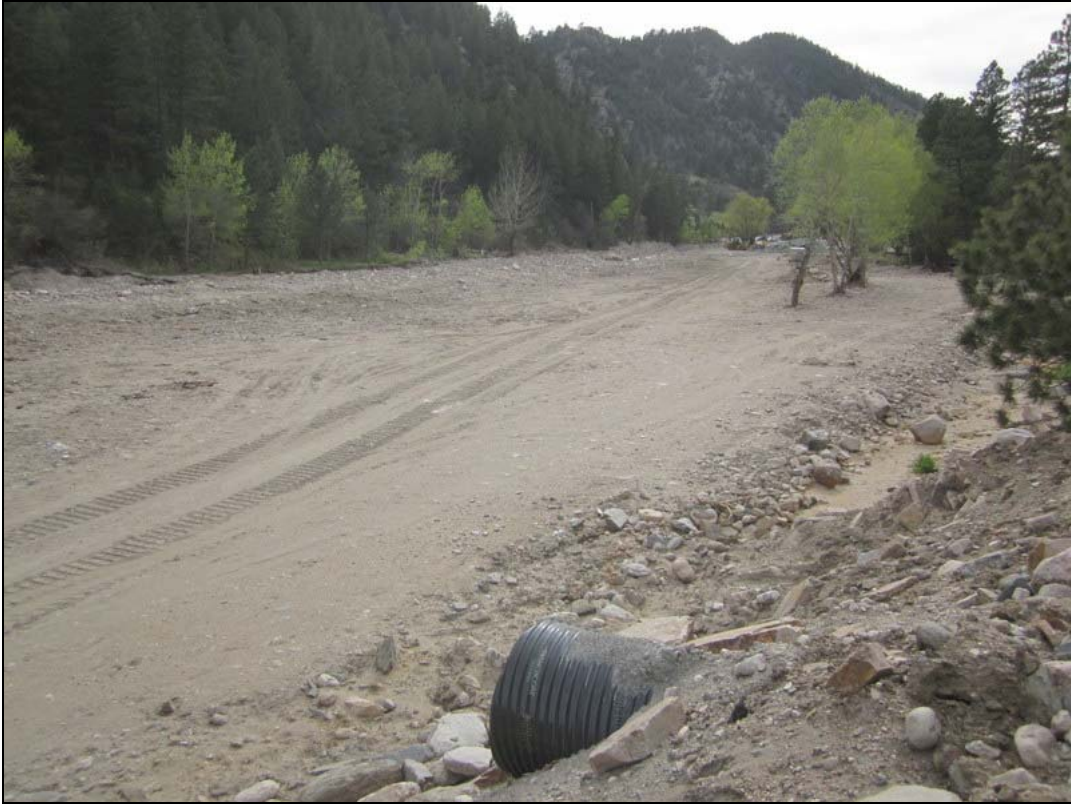
Figure 3.27. Lower Canyon, very large floodplain almost no vegetation, REIP = 5.

Field surveys were conducted for the western four segments of the BTRRMP corridor on May 5, 8, and 9, 2014 and the eastern two segments during January 2014. Most field surveys were performed in areas accessible by roads; various areas were walked to collect additional data on plant species present and severity of flood damage. Each assessment reach was given a score of 1 to 5, with 1 having low potential for restoration and 5 having high potential. Rating of river reaches for riparian vegetation restoration potential is based on many factors. **Table 3.5** summarizes these factors in the list of characteristics. Representative photographs for each rating are shown in **Figures 3.15 – 3.29**.

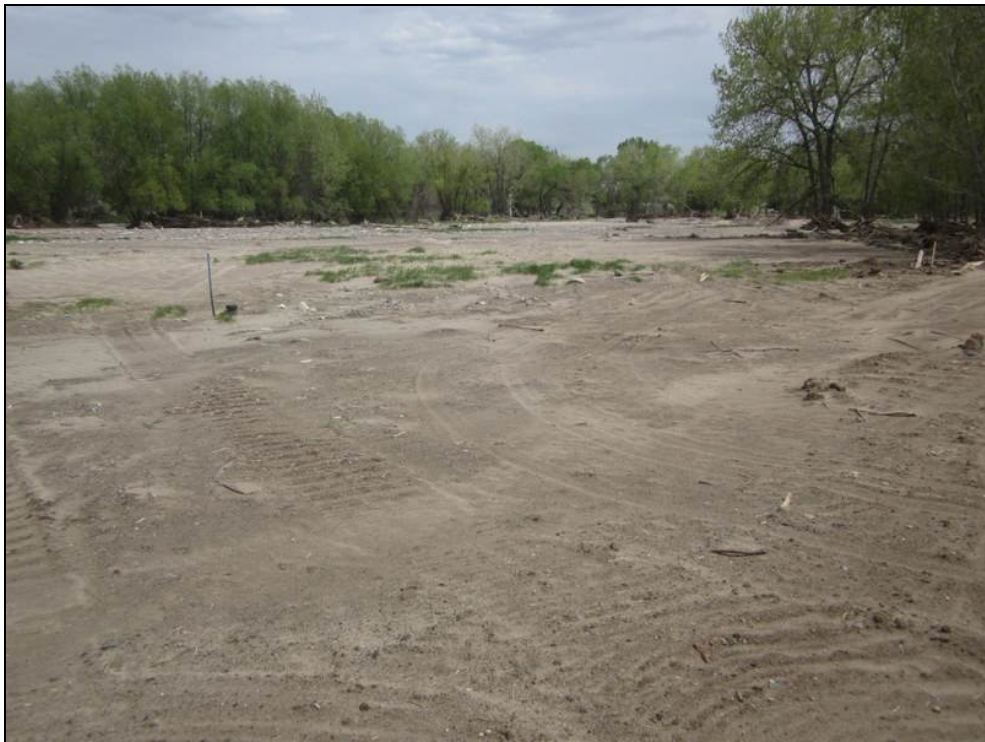
Figure 3.28. Loveland area, very large floodplain almost no vegetation, REIP = 5.

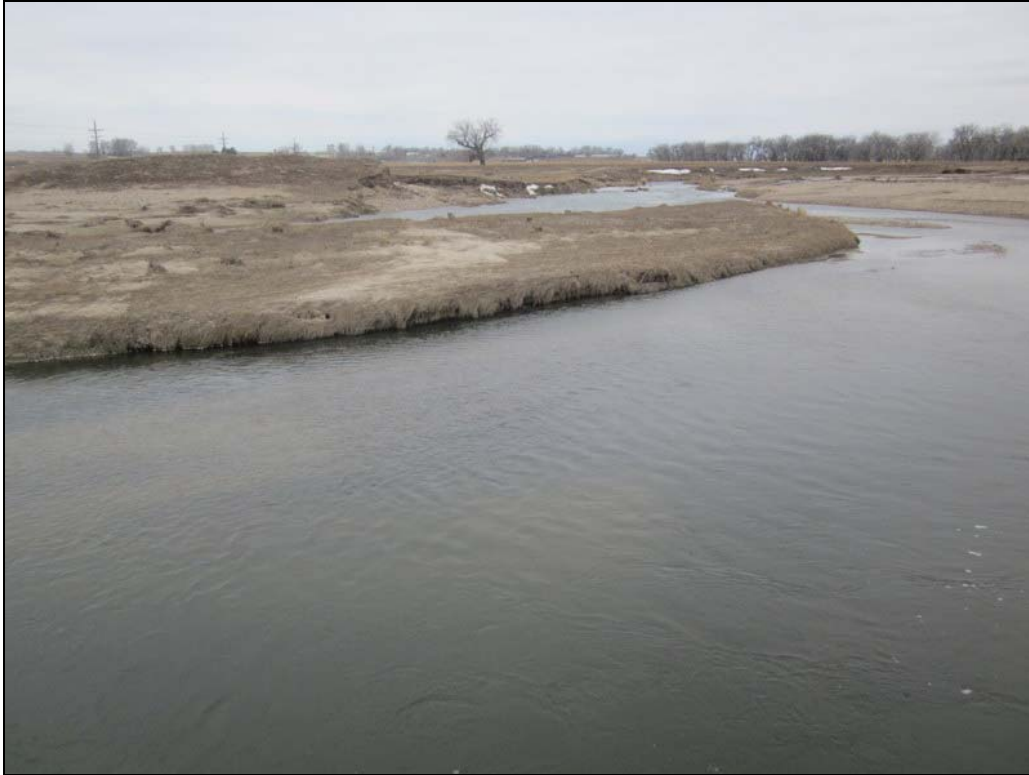
Figure 3.29. Eastern Plains, downstream of CR 54, REIP = 5.

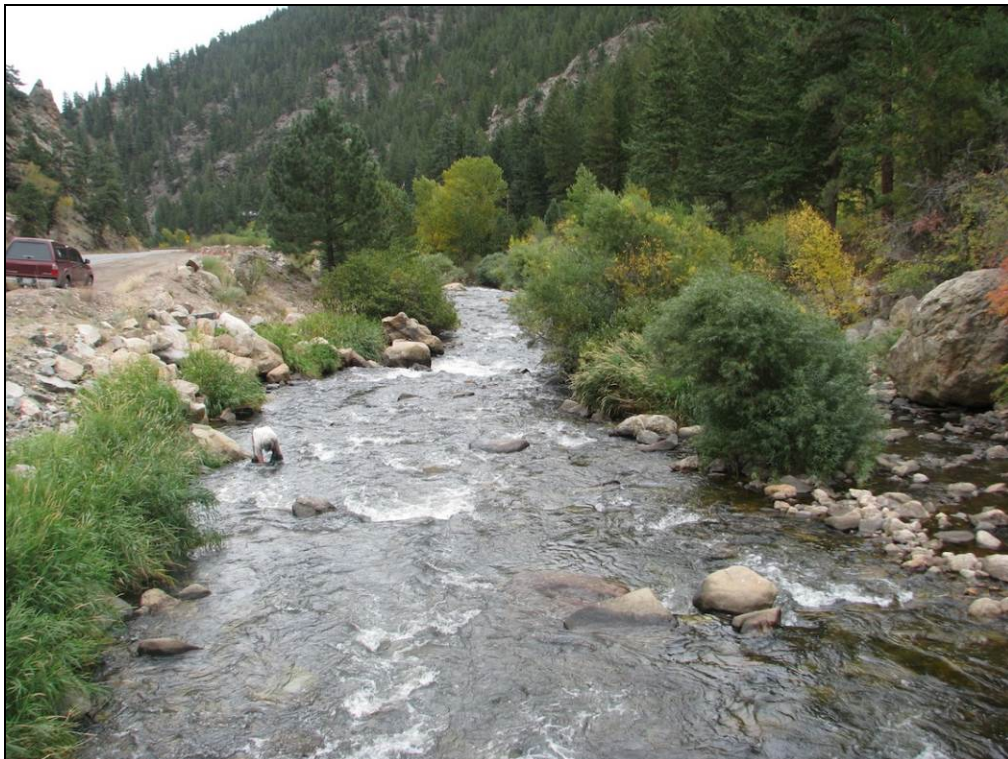
Figure 5.1. Big Thompson downstream of Waltonia Bridge, 9-24-2012.

The Big Thompson River in the upper and lower canyons prior to the flood of September 2013 supported a robust aquatic ecosystem. The aquatic habitat conditions in the canyons consisted of high-gradient riffles, low-gradient riffles, pocket water (small pools formed downstream of large boulders) and pools, as depicted in **Figures 5.1** and **5.2**. More than 50% of the pre-flood habitat was high gradient riffles and pocket water (Miller 1993). These photographs show the generally large substrate present in the higher gradient areas and the abundance of riparian vegetation along the channel. These are two characteristics needed for aquatic habitat restoration. Areas with typical lower-gradient riffles are shown in **Figures 5.3** and **5.4**, and consist of large cobble substrate. Low-gradient channel types are less frequent due to the overall steep, canyon-bound river channel.

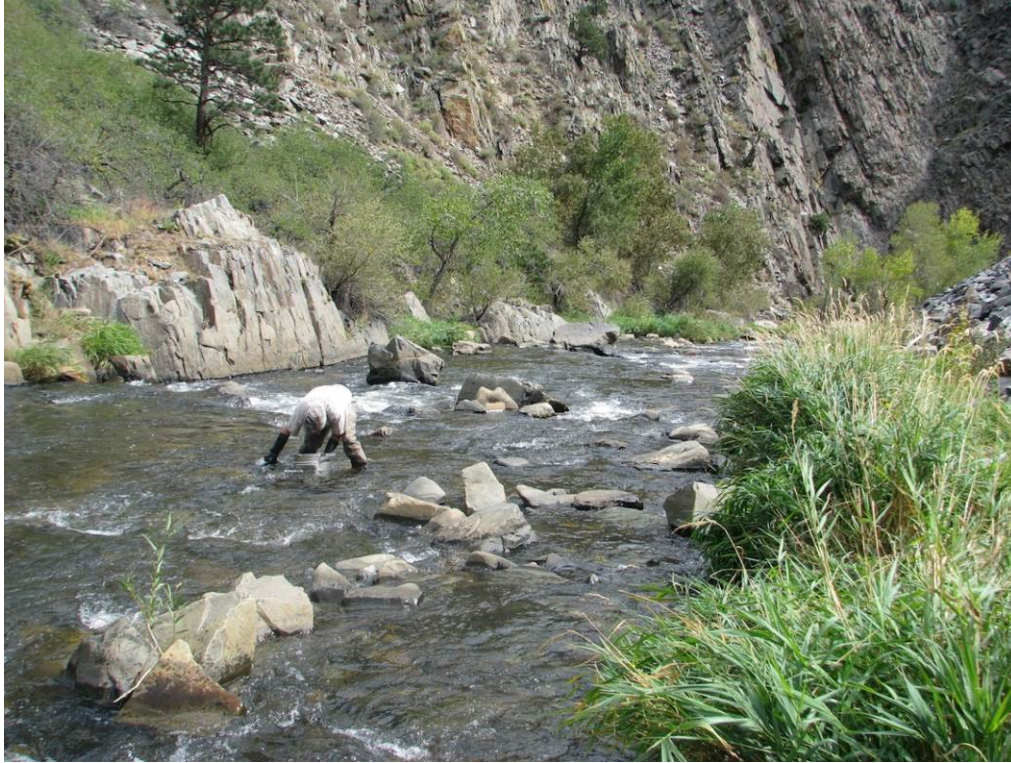
Figure 5.2. Big Thompson River approximately ½ mile upstream of the mouth of the canyon, 9-24-2012.

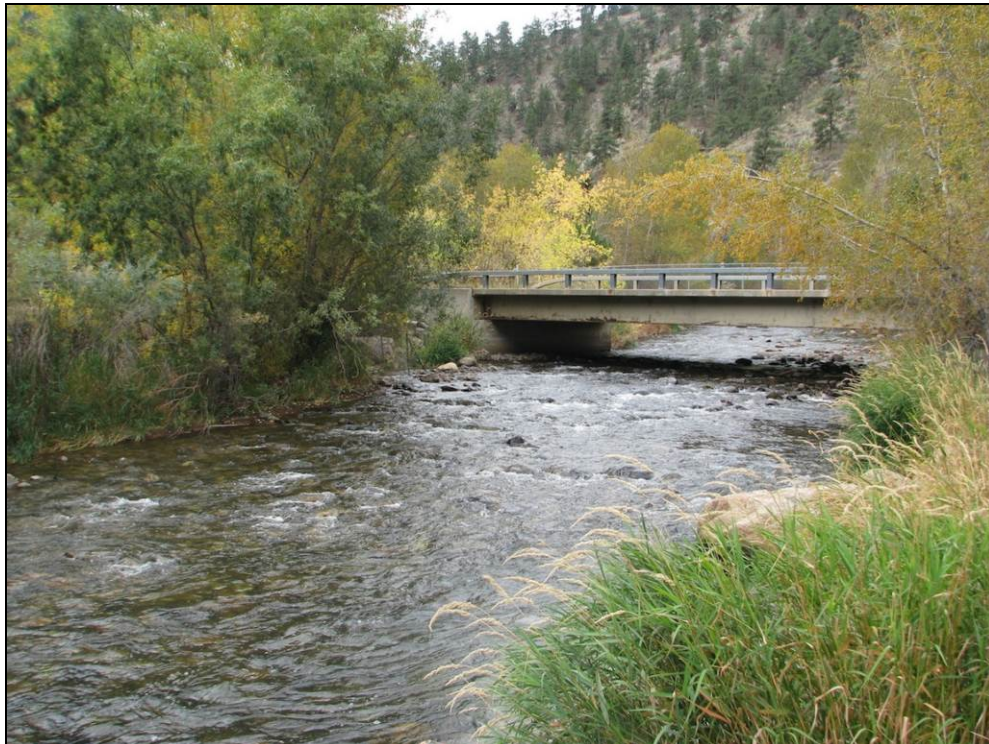
Figure 5.3. Big Thompson River low gradient riffle near Drake, 9-12-2014.

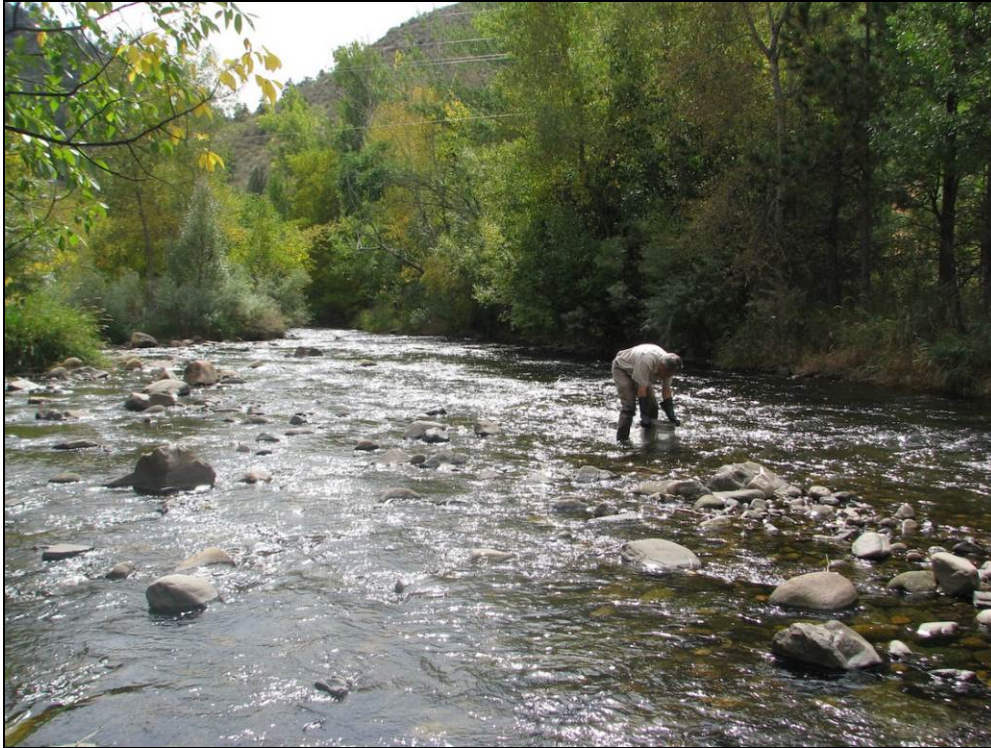
Figure 5.4. Big Thompson River low gradient riffle near Cedar Cove, 9-12-2014.

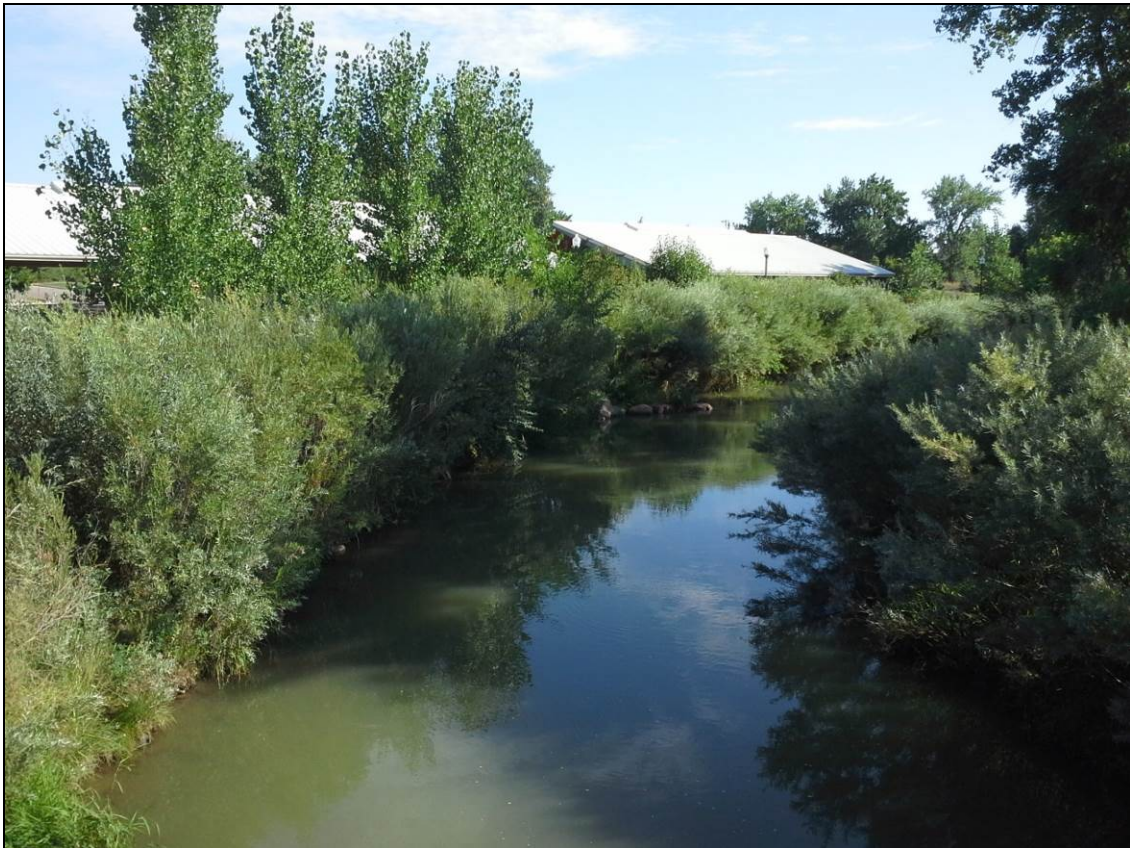
Figure 5.9. Planted riprap bank protection (left side), taken 8-29-2013, Fairgrounds Park, Loveland, CO.

In some locations the riparian restoration and bank stabilization measures can use the same treatment, **Figure 5.8**. Boulders and/or riprap planted with willows can increase the resiliency of the bank while improving the riparian and aquatic habitat as well. This approach may be useful in areas with no room for a floodplain bench. The left bank shown in **Figure 5.9** is a planted riprap bank protection used at Fairgrounds Park in Loveland. This treatment performed well during the 2013 flood event.

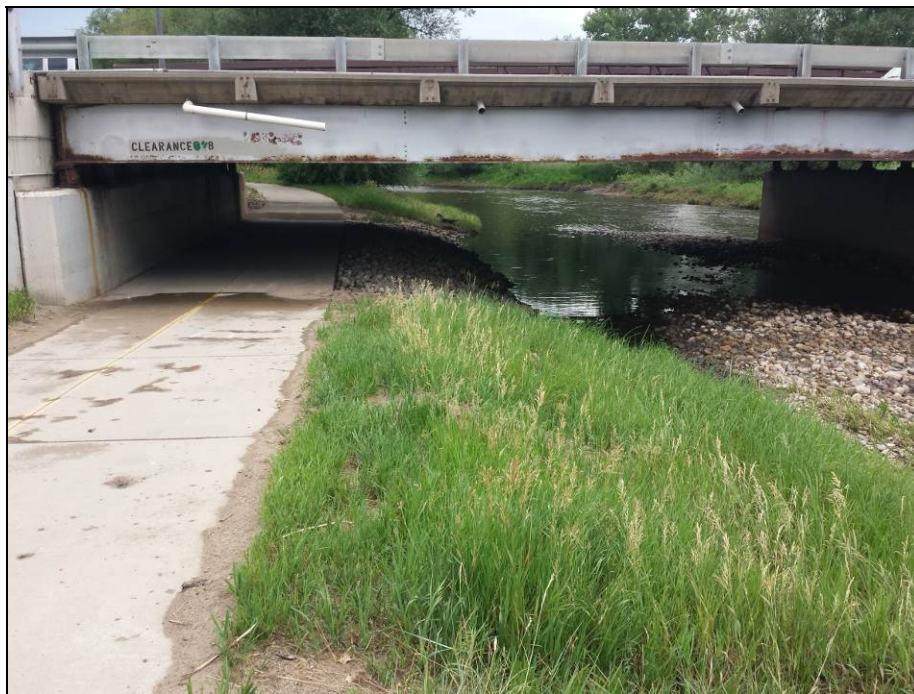
Figure 5.12. ACBs at bridge abutment, vegetated area in foreground covers ACBs.

Articulated concrete blocks (ACB) are a manufactured bank stabilization treatment (**Figure 5.11**). They can be installed at a 2H:1V slope or flatter. The benefit of ACBs compared to riprap is that they can provide similar protection to other treatments, but are not as thick and can allow vegetation to establish after installation. Even without significant soil cover, ACBs may allow sufficient vegetation to establish that they are completely covered (**Figure 5.12**).

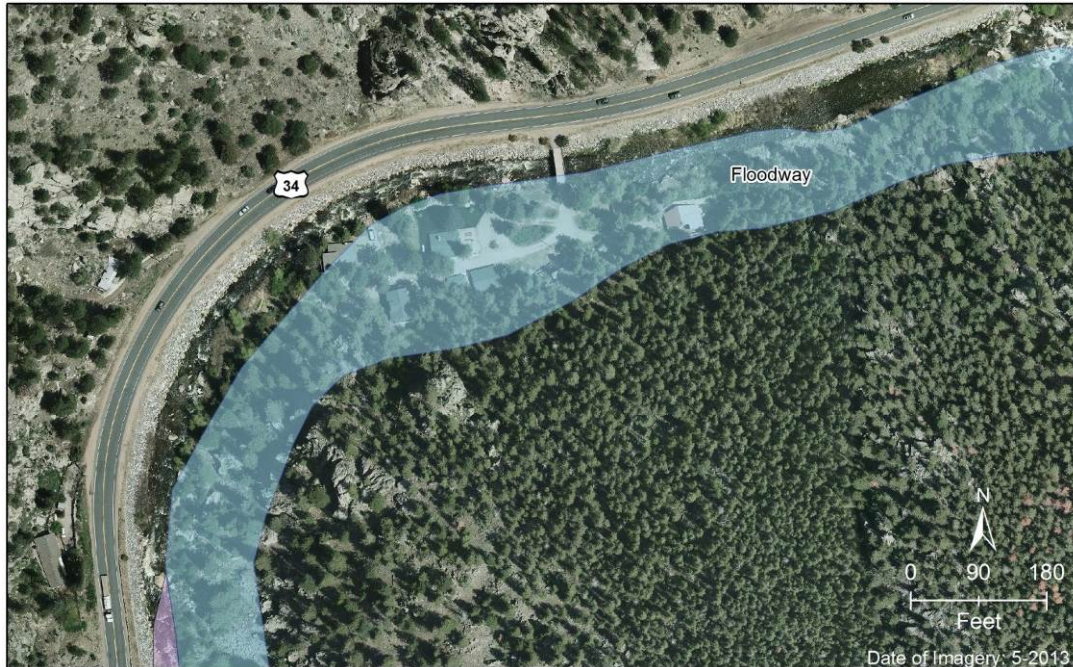
Figure 7.1. Illustration of inaccurate digital floodplain data.

- Peak 100-year flood discharges that are from outdated hydrologic studies that were performed in the 1970s using data from the 1960s and earlier (affecting the entire Big Thompson below Olympus Dam)
- Hydraulic models from the 1970s with coarse resolution, incorporating old topographic data and using outdated computation techniques (from Olympus Dam to Buckhorn Creek)
- Inaccessibility of the digital hydraulic model files from which the effective mapping was derived (upstream of Buckhorn Creek and downstream of Thompson Ranch subdivision)
- Inaccurate digital mapping of the floodplain versus topography that existed just prior to the flood, as shown in **Figure 7.1** (in various locations, mostly in the unincorporated areas)
- Structures in the floodplain that cannot be protected by means other than elevation or other type of floodproofing

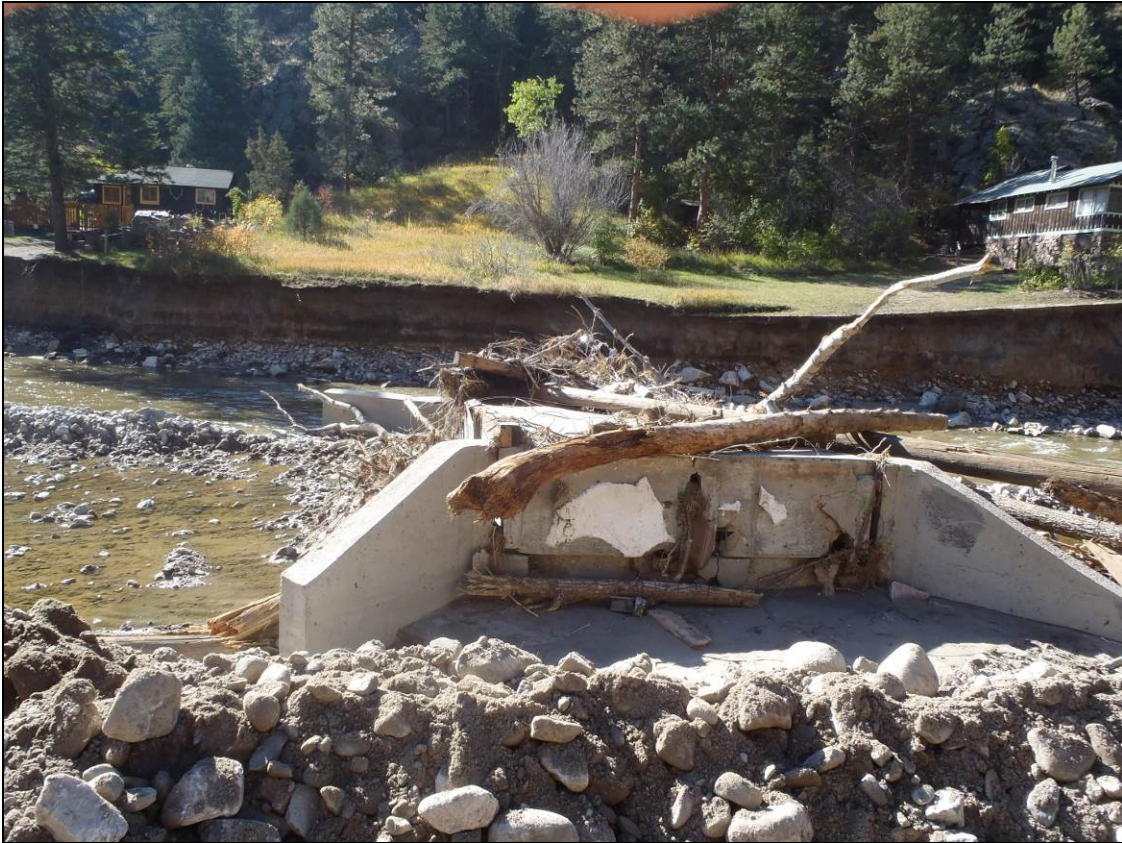
In the canyon reaches of the Big Thompson River, several of the access bridges to private properties were damaged or destroyed in the September 2013 flood. Many of these structures were completely or partially blocked by debris, causing the flows to flank the bridge around one or both abutments. The flanking of the bridges destroyed their approaches, but also caused extensive damage to US Highway 34 and to properties on the opposite side of the river. At the bridge shown below (**Figure 7.2**), the flooding around the bridge formed a new channel and left a vertical cut bank over 100 feet south of the pre-flood channel bank location.

Figure 7.2. Flanked access bridge in Big Thompson Canyon.
